## Complicated Crown Fracture and Reattachment: Case Report

**Aim:** The purpose of this case report is; It offers partial amputation with calcium silicate-based biomaterial (Biodentin) to the patient who has a complicated crown fracture in the maxillary left lateral tooth as a result of trauma, and protective and aesthetic restoration of the broken tooth piece using the internal dentin groove method.

### Case Report (HRU Int J Dent Oral Res 2024;4(2):63-68)

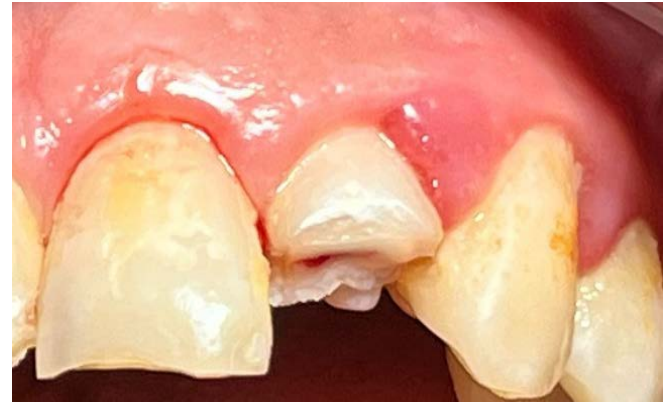
Fig 1: Intraoral view of the patient.

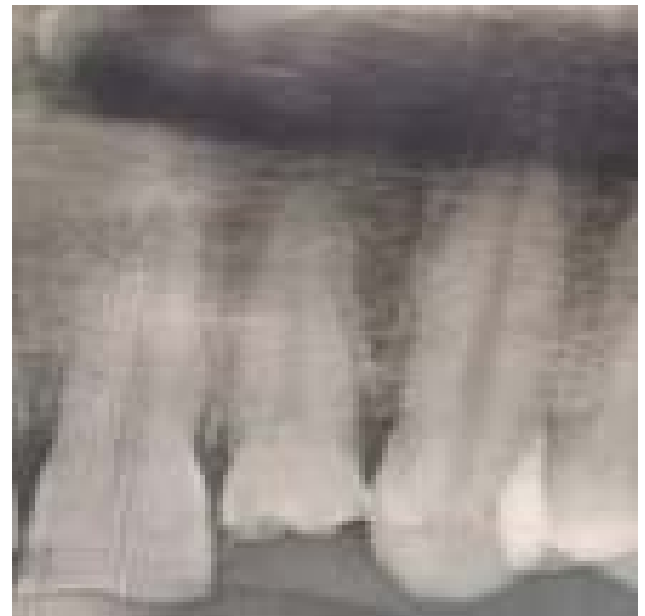
Fig 2: Radiographic image of the patient.

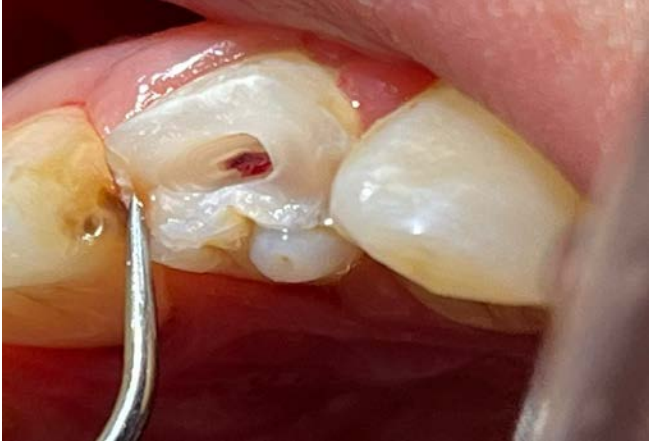
**Fig 4:** Partial amputation preparation applied to the patient.

A partial amputation cavity was opened for the patient under local anesthesia (Lidofast, Turkey). (Figure 4)

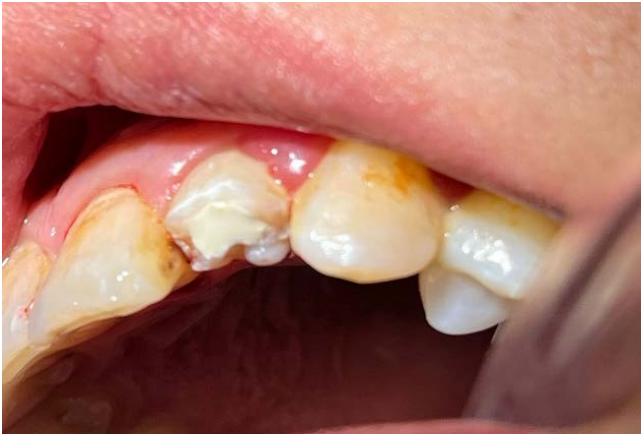
**Fig 5:** Partial amputation treatment image with calcium silicate based biomaterial.

After cotton impregnated with 5% sodium hypochlorite was placed in the opened amputation area and bleeding control and cavity disinfection were achieved, partial amputation treatment was performed with calcium silicate based biomaterial (Biodentin, Septodont, France). (Figure 5)

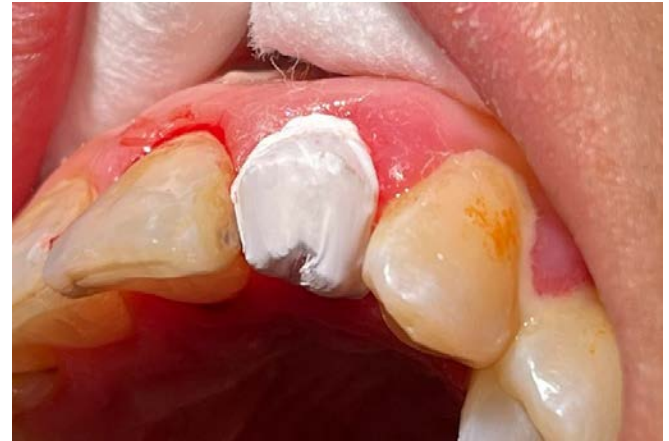
**Fig 6:** Image of the tooth with Teflon tape.

The permanent restoration of the tooth was postponed for a day because the patient reported that he could find the broken piece. To prevent microleakage and plaque formation at the forty line, the tooth surface was wrapped with two layers of Teflon tape (Swedent). (Figure 6)

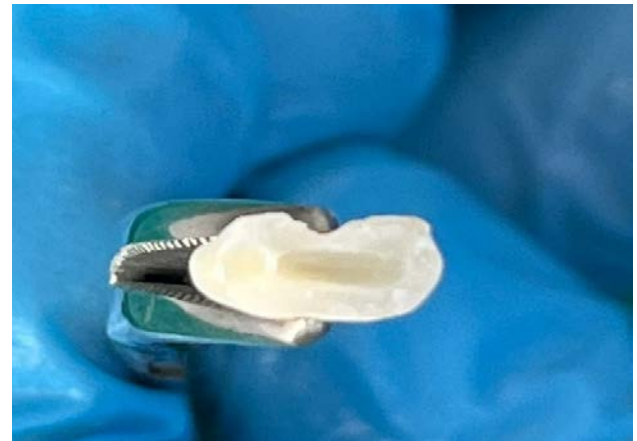
**Fig 7:** Image of the broken piece after caries removal and dentin tissue removal.

The decay on the mesial side of the broken piece was cleaned, and in order to increase the retention of the broken piece, the dentin tissue was removed with a small round bur (Meisinger, Germany) and a retention groove was opened. (Figure 7,8)

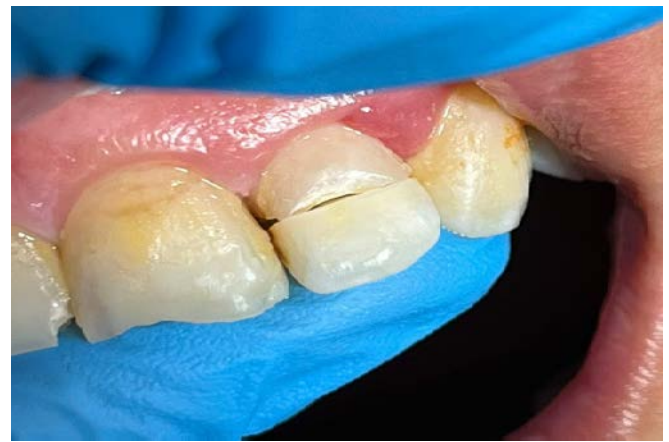
**Fig 8:** Checking the compatibility of the broken piece with the tooth.

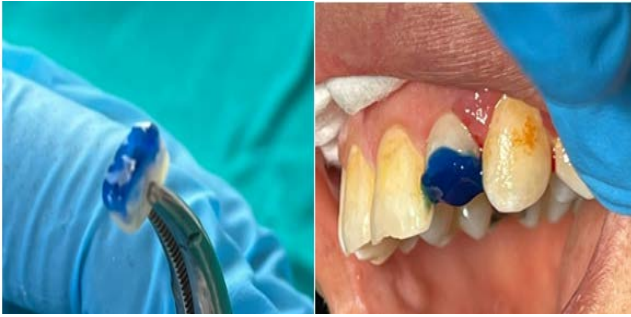
**Fig 9:** Image of 35% orthophosphoric acid applied to the broken piece and the tooth.

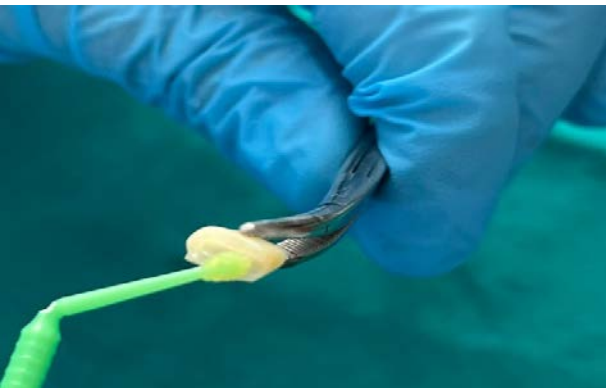
**Fig 10:** Image of the adhesive applied to the broken piece.

After 35% orthophosphoric acid was washed with pressurized water and air dried, Single Bond Universal adhesive (3M ESPE, St. Paul, MN, USA) was applied to both fracture surfaces as a bonding agent. Then, composite resin (3M ESPE Z250, USA) was placed into the dentin groove and the fragment was combined with the tooth with the help of finger pressure and polymerized with a light device (Woodpecker BUILT-INC, China). Aesthetic restoration was completed with composite resin (3M ESPE Z250, USA) by groove beveling on the fracture line. (Figure 10-14)

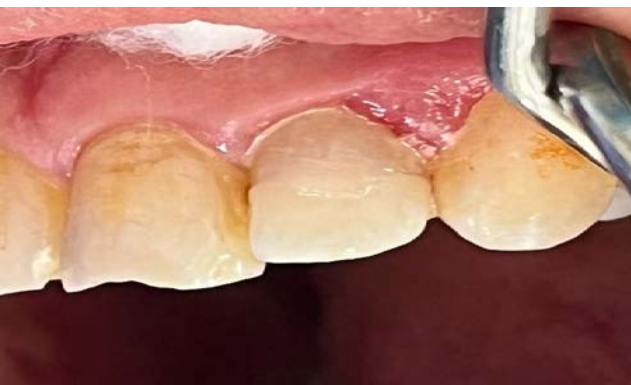
**Fig 11:** View of the broken piece after placement.

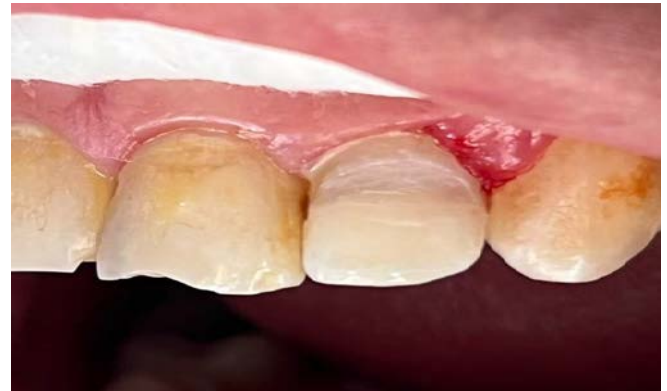
**Fig 12:** View of the beveling applied to the fracture line.

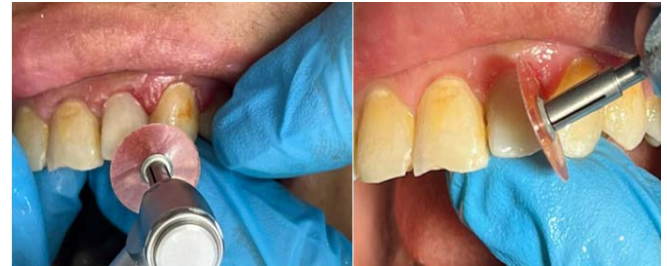
**Fig 13:** A view of the aesthetic adjustments made to the tooth and the polishing process of the restoration with finishing burs.

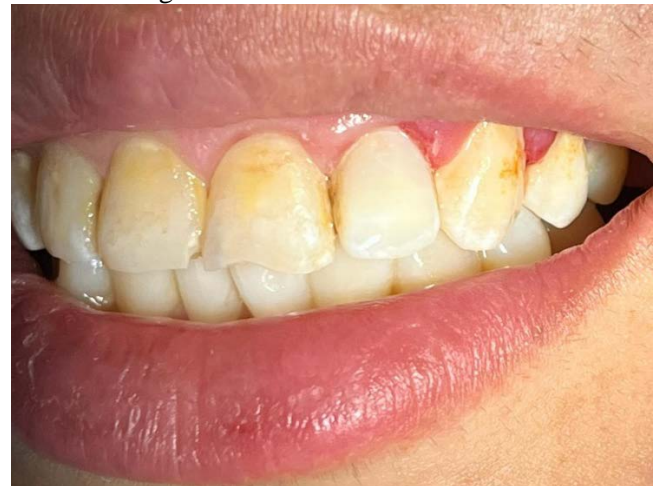
**Fig 14:** The final view of the tooth restoration.

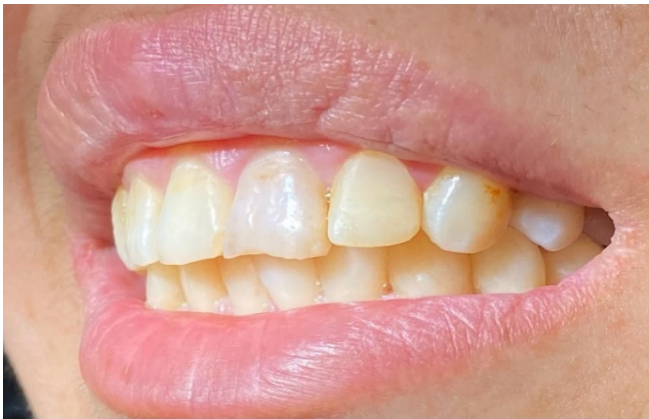
In the radiographic and clinical examinations performed at the patient's 1st and 6th month follow-up sessions after the restoration, it was observed that the tooth responded positively to vitality tests, the periapical region was healthy, there were no symptoms in the tooth, and the broken piece maintained its current shape and position. It was observed that the patient was satisfied with the result (Figure 15-17).

**Fig 16:** Intraoral view of the patient at the first month.

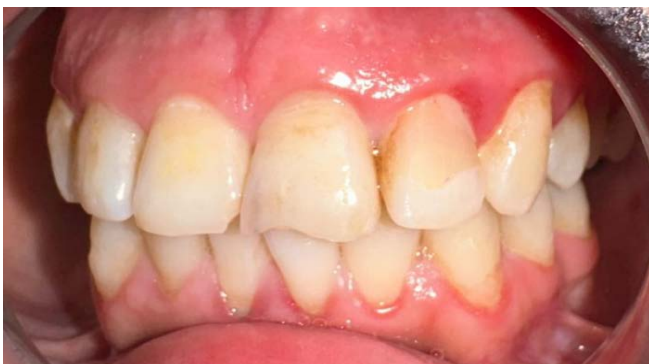
**Fig 17:** Intraoral image of the patient at the 6th month.
