Düzce University Journal of Science & Technology

Research Article

Maintenance of corroded silos: A case study

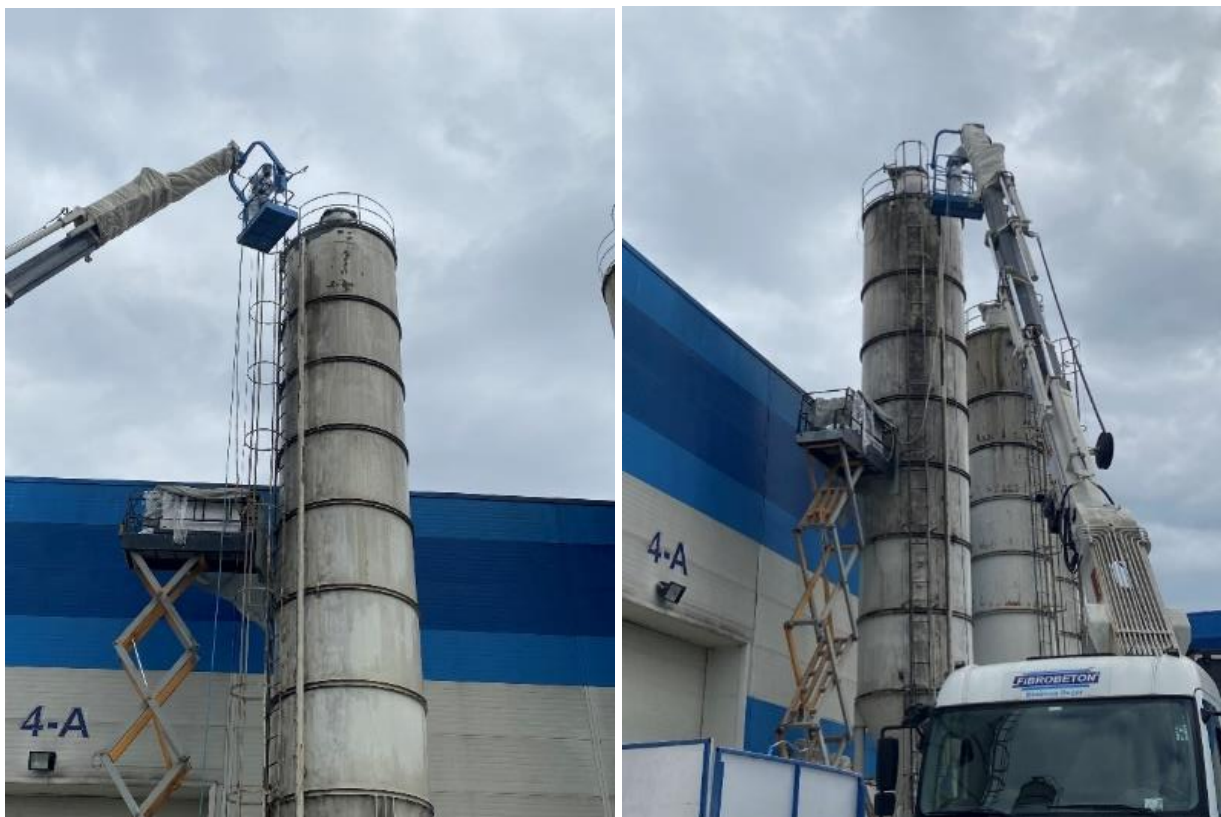
Although the two 70 tonne silos, which have been in service for around 20 years, had undergone general maintenance on several occasions, it was found that the protective properties of the paint had been compromised due to under-shell corrosion (Figures 2 and 3).

Figure 2. First state of silos

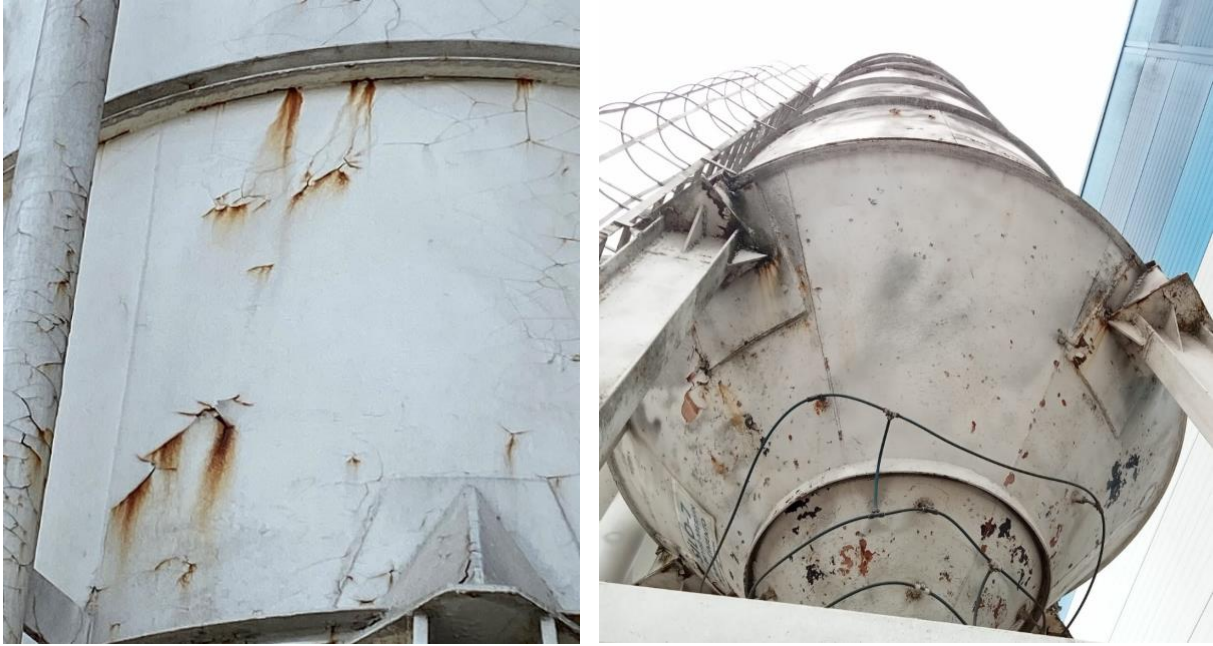
Figure 3. Condition of silos before painting

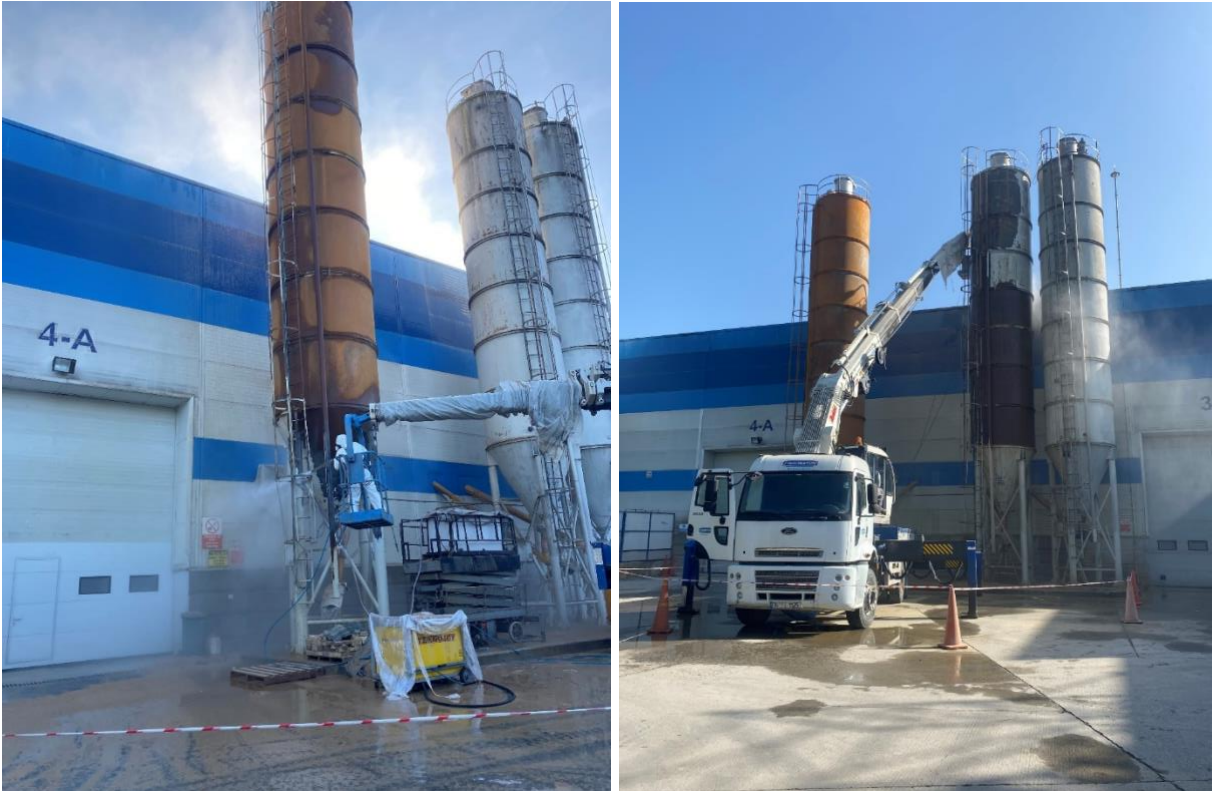
Since the roof of the Fibrobeton Yapı Elemanları San.İnş.Tic.A.Ş. [17] factory is covered with solar panels to ensure energy and resource efficiency and reduce carbon emissions, wet blasting was preferred to remove the existing blistered old paint on the surface of the silos (Figure 4).

Figure 4. Wet blasting process

Aqueous blasting was carried out at a pressure of 300 bar using silica sand with a grain diameter of 0.125 mm-1.0 mm. Immediately after aqueous blasting, an oxide film was formed on the surface of the silos due to corrosion (Figure 5).

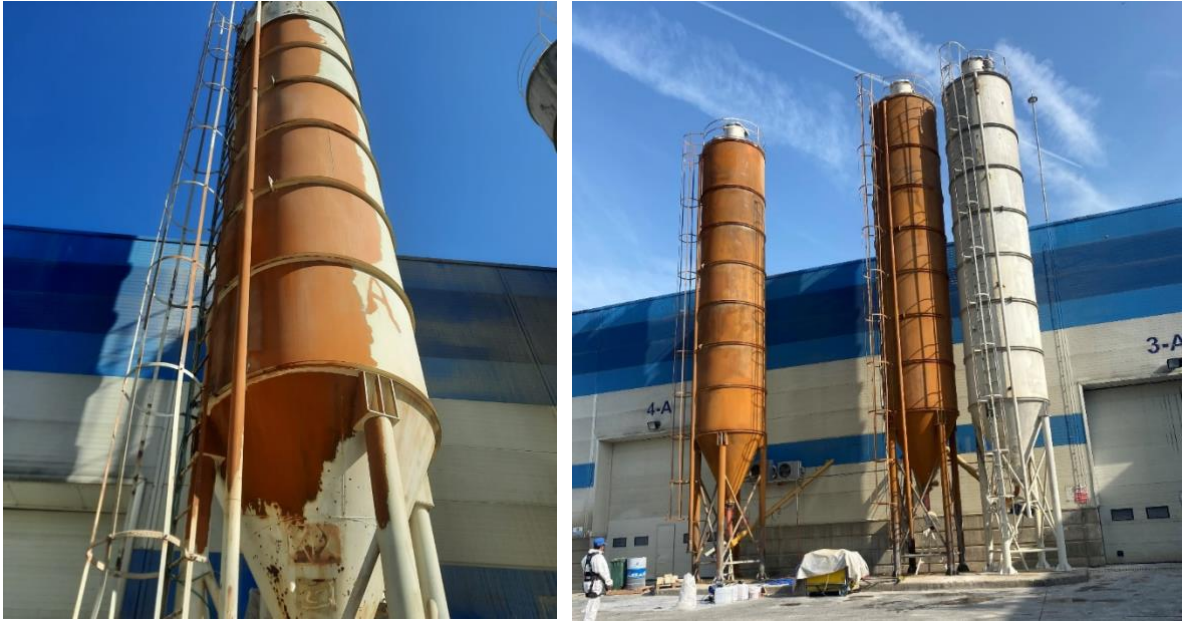
Figure 5. General view of silos after wet blasting

The removal of this oxide layer before painting is as important as the quality of the paint [18]. According to the Association for Material Protection and Performance (AMPP) [19] and ISO 8501 standards, chemical solutions can be used to clean the oxide film shown in Figure 5 [20].

This oxide film on the surface of the silos was cleaned with a patented solution (TPE Patent Application No: 2017/11354) previously tested by Coskun et al. [21]. As the solution has a density that can be applied with a high-pressure cleaner, the oxide film on the surface of the silos was removed by washing 3 times in a very short time (Figure 6).

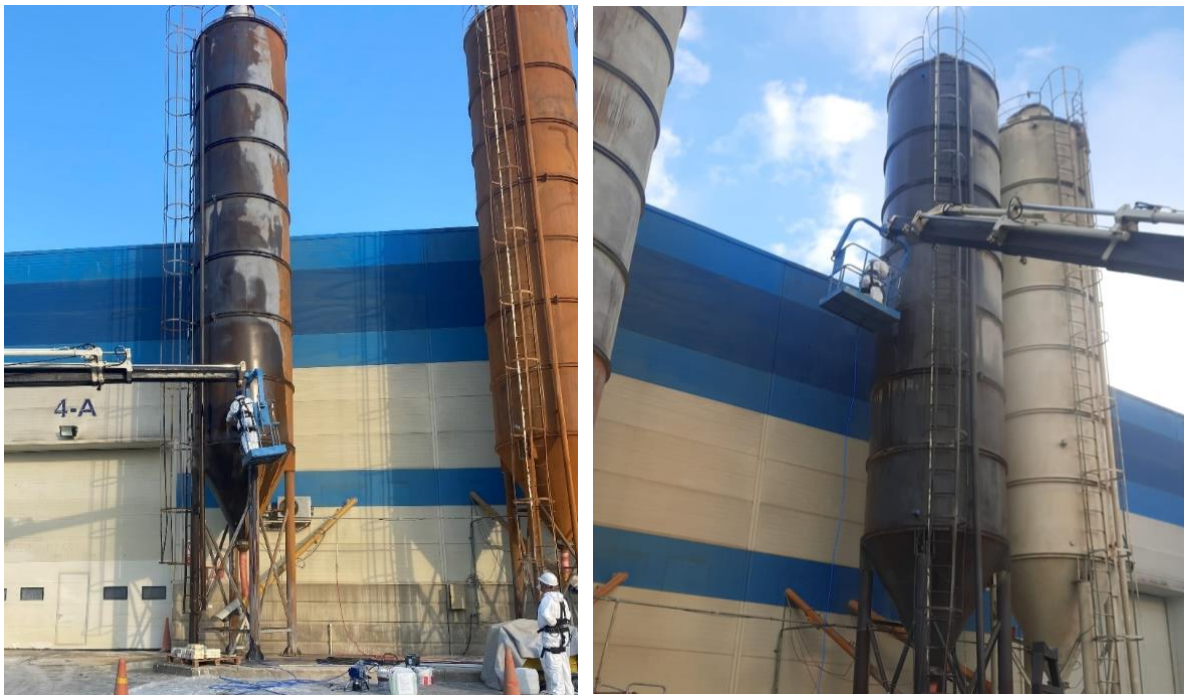
Figure 6. Washing process with chemical solution

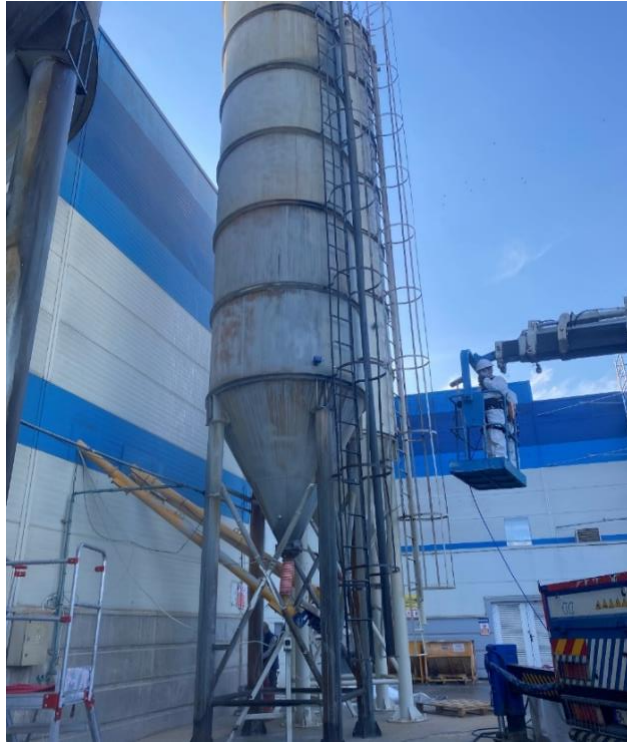
Figure 7. After washing with chemical solution

After washing with the chemical solution, a light grey layer was formed on the metal (Figure 7). In order not to leave dust on the surface, the silos were wiped with a brush and made ready for painting (Figure 8).

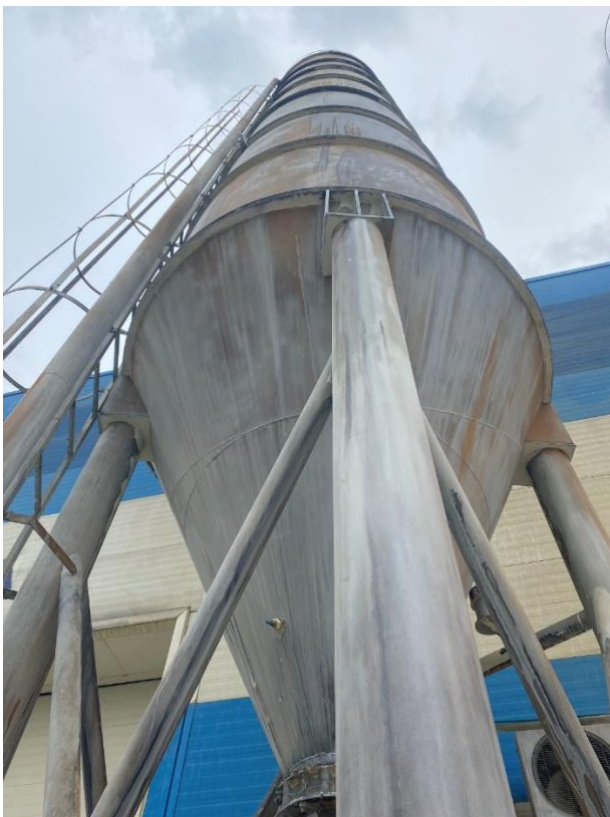
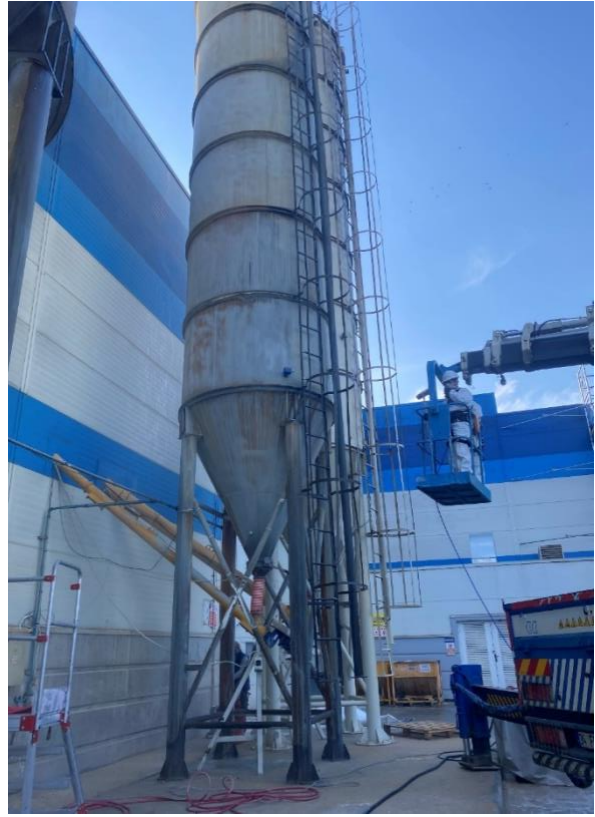
Figure 8. After washing with chemical solution and wiping the silos with a car brush

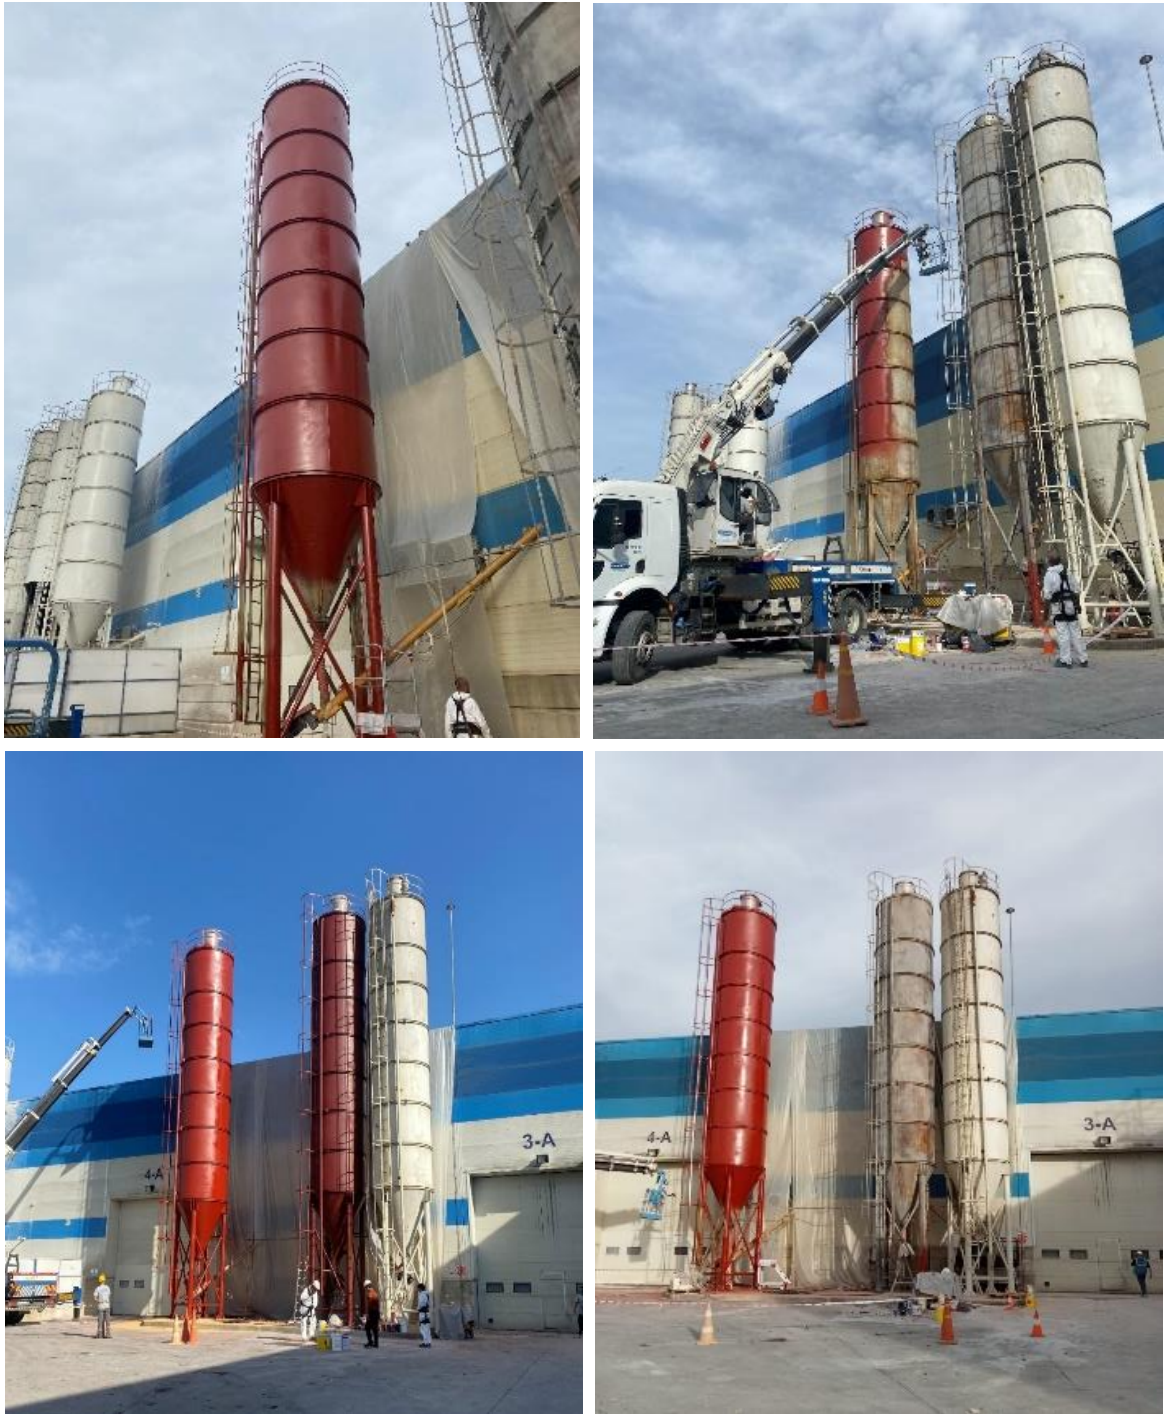
Thickness measurements were taken after the application of the first and second coats of primer and the top coat (Figures 9, 10, 11 and 12).

Figure 9. First coat primer application

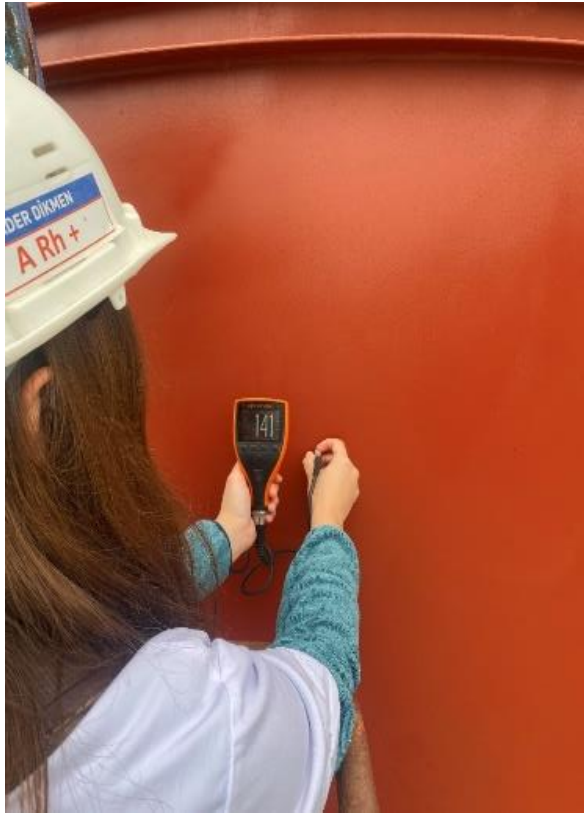
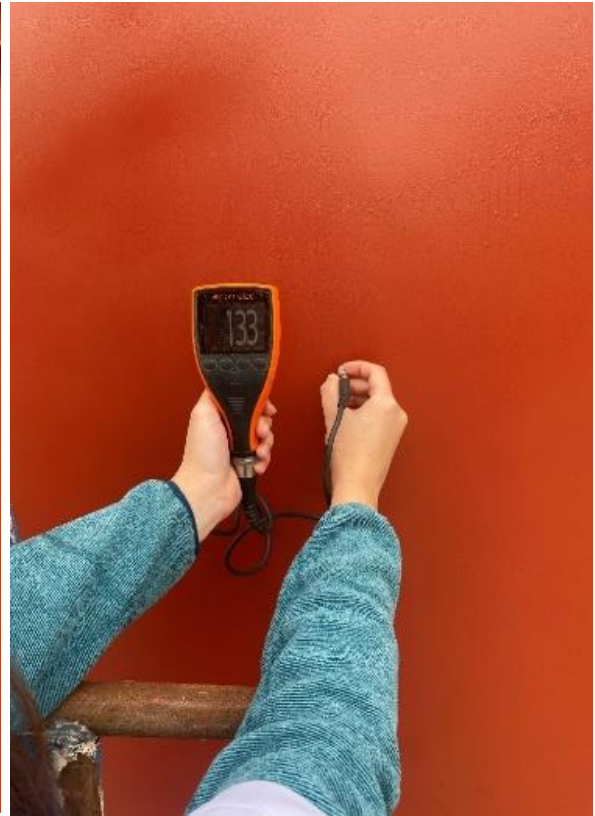
Figure 10. Measurement of primer paint thickness of silos

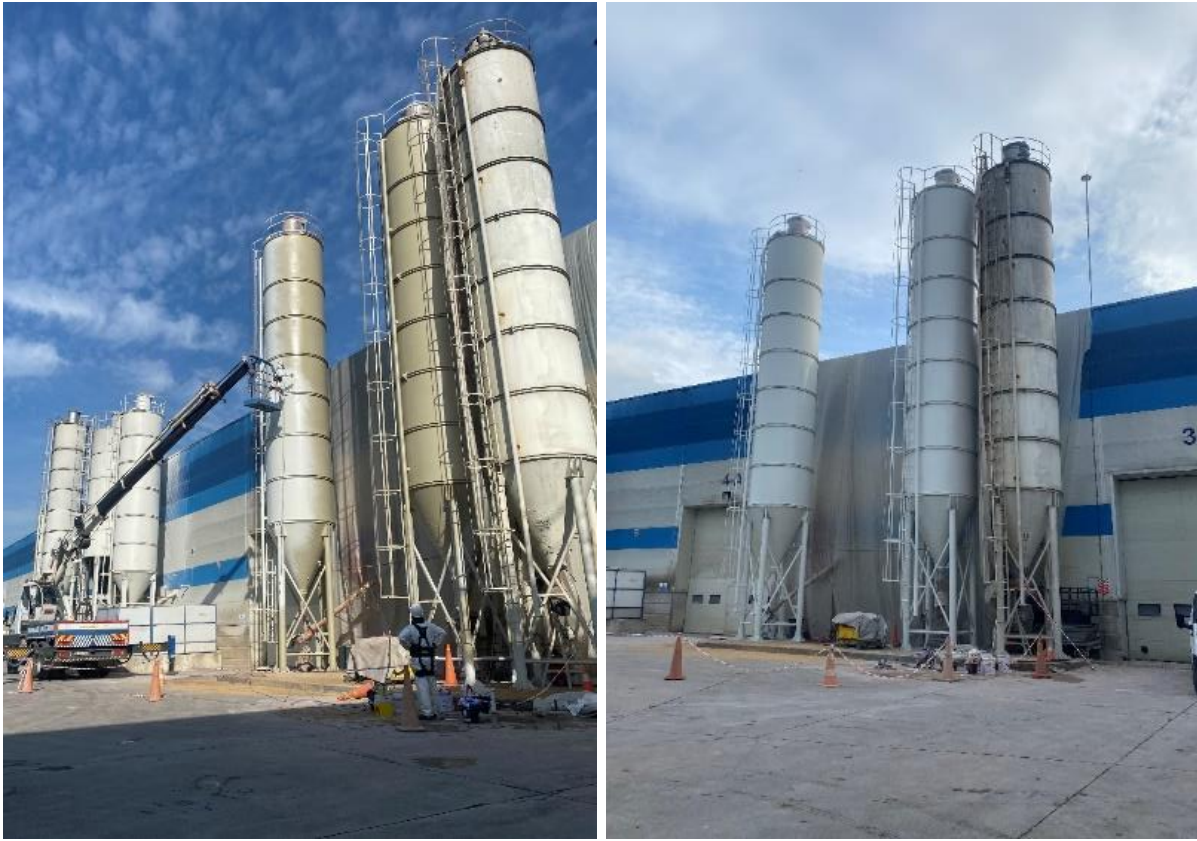
Figure 12. Topcoat paint application of silos
