Conservation and Restoration of Historic Buildings: Application of Contemporary Addition Construction Techniques in the Case of Turkey

Furkan KARAÇOR^{1,*}, Mustafa DERELİ²

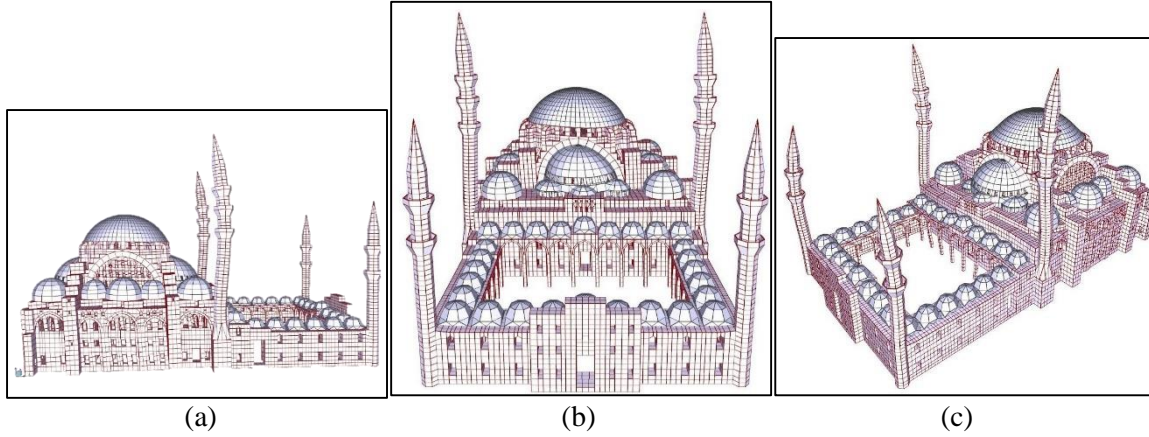
Figure 3. Istanbul Süleymaniye Mosque (a) X, (b) Y and (c) Z Axis Torsional Movement Torsion Prediction [23]

In the last stage, three-way current damage and probable future damage were estimated from the three-dimensional shape [23]. The points that may be problematic in the future were predetermined with the reverse engineering study technique. As a result of the determination, the places that should be given importance in the restoration process were determined. In the intervention stages, this process will be followed from general to specific.

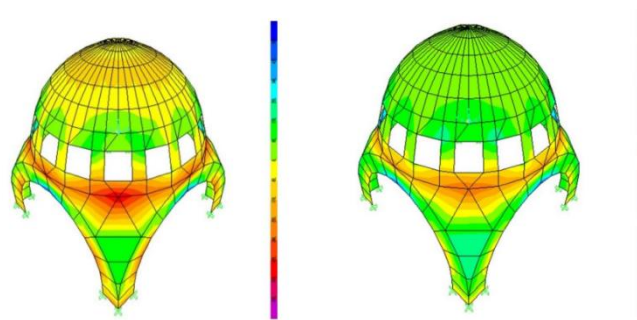
Figure 6. Existing Condition And Tensile Force After CFRP Application [28]

After CFRP application, the push and pull forces in domes, vaults and pendentives became more stable. With the CFRP work, the building has become more seismically resistant while preserving its historical and aesthetic features [28]. Since the CFRP technique uses polymer material, it can be used more frequently in the repair of historical buildings in places with high earthquake risk, as it provides significant contributions to flexibility and durability properties.

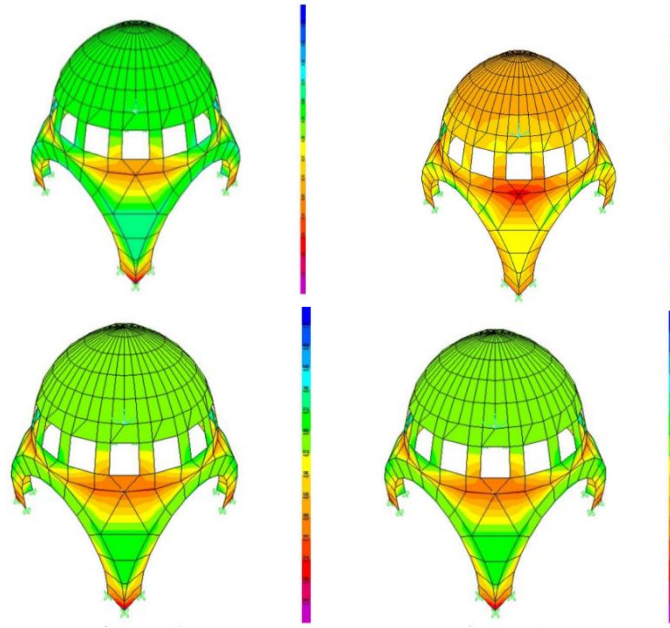
Figure 7. Current Situation And Draft Forces After CFRP Application [28]

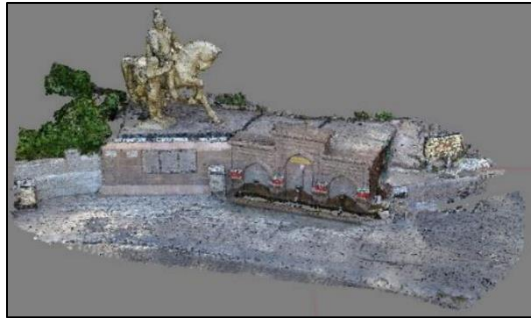
Figure 9. Point Cloud of Konya Tashkent Sultan Fountain [31]

With the point cloud extracted, it is easier to examine the current condition of the structure and to make modelling. In addition, with the improvement processes to be carried out on the extracted point clouds, it can also be a source for digital museum application.

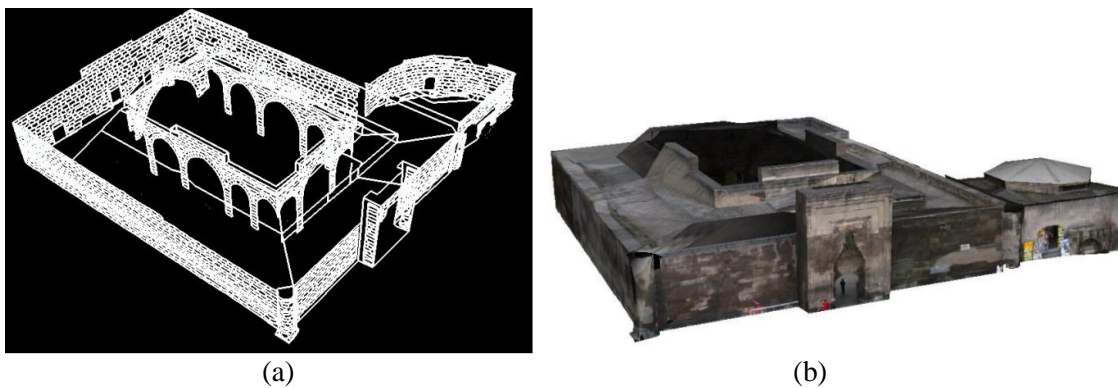
Figure 10. Kayseri Sahabiye Madrasah (a) 3D Scanning and (b) Model Created from Scanning [35]

With the scanning process, the holistic state of the building can be seen from a single centre. Afterwards, by going to the plan, section and view from this holistic state to the places, it is possible to go to the special parts of the building that are damaged or damaged and to work on them.

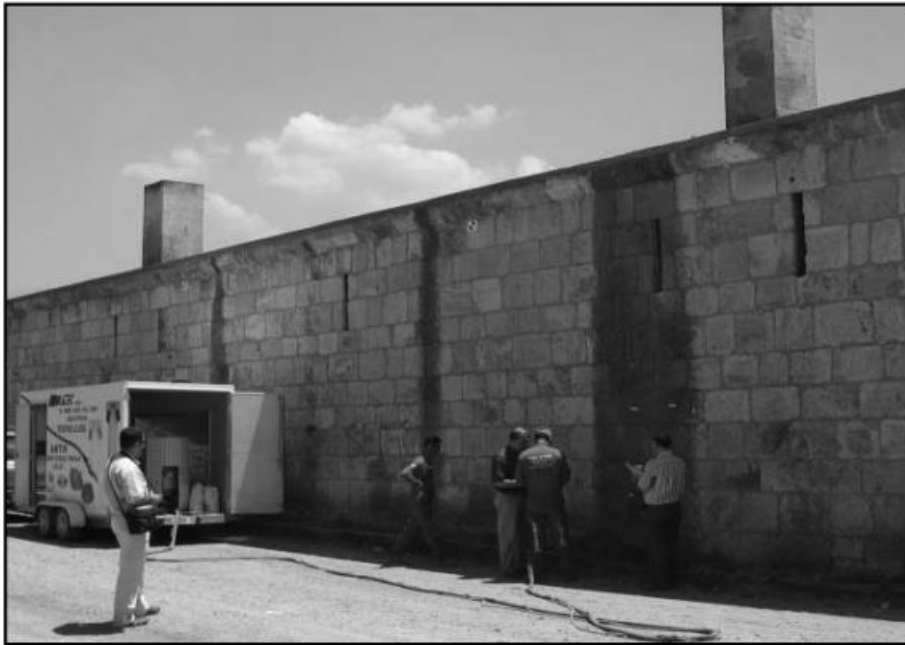
Figure 11. Process of Determining the Surface to be Micro Sandblasted [37]

Suitable places of the structure are investigated for the micro sandblasting technique. During the research, first of all, places where the formation of micro natural organisms is not very intense are selected. After a certain area is selected, a small preliminary application is made. Afterwards, it can be continued after seeing the results of the application.
