Systematical Assessment of Damages Occurred in Historical Stone Bridges

Historical Bridges,
Deterioration,
Restoration,
Conservation,
Preservation

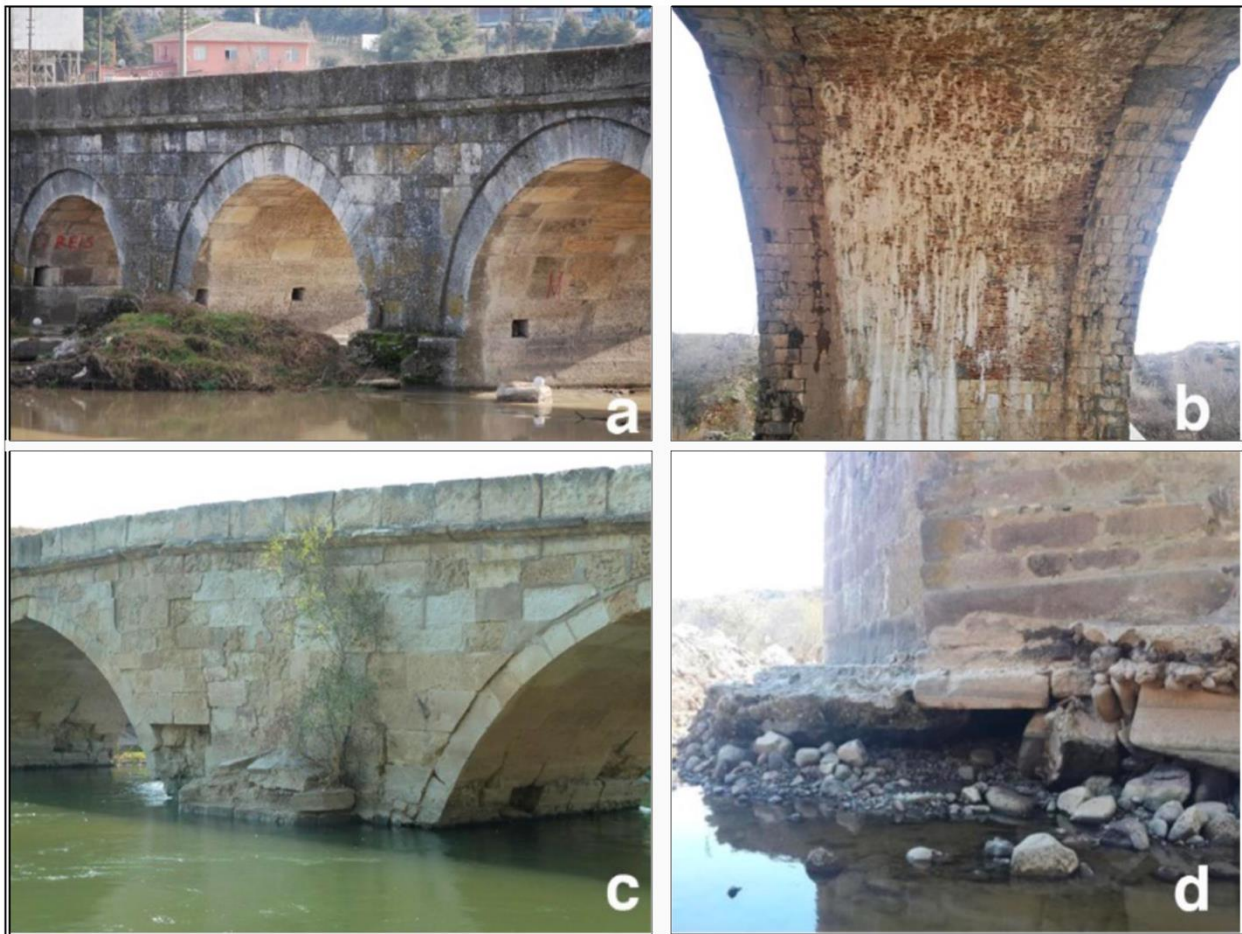
Figure 1. a) Büyükkarıştrın Bridge (Kırklareli)[23], b) Kalender Bridge (Diyarbakır)[25], c) Karabiyik Bridge (Yozgat)[25], d) Behramkale Bridge (Çanakkale)[19].

Air, whose main components are hydrogen (78%) and oxygen (21%), causes deterioration in building materials with dust and acidic gases [26]. These gases are generally concentrated in industrial and urban centers where air pollution is intense. Acidic gases such as carbon dioxide and sulfur dioxide react with stones and cause accumulation on stone surfaces [2]. This formation, called black accumulation on the surface, can be named "Soiling", "Compact Black Deposit", "Dendritic Black Crust" and "Calcereous Concretion" depending on its density [13]. Black accumulation on the surface is especially common in building stones consisting of carbonate rocks. This crust consists of gypsum formed by carbonate minerals and sulfur dioxide (SO₂) reactions. It also causes a negative appearance in terms of aesthetics. Concentration leads to a reduce in the perception of details by covering fine lines and gaps [3, 13]. As a result of the expansion of urbanization and the development of industry over time, many bridges that constructed outside the city have remained in the city limits. Therefore, the supports of ancient stone bridges have deteriorated due to exposure to acids, especially gases. This shell breaks off from time to time under the influence of water, causing loss of sections in the stones (Fig.1a).

One of the biggest problems caused by water on bridges is the changes in the ground level due to natural causes that occur over a long period. Depending on the stream's natural regime and the river basin's hydrometeorological status, changes in the base level are observed in continuous or periodic periods. These changes cause balance problems and lateral erosions on the slopes. Another problem caused by rivers is the scour around the piers due to the increase in foreign materials rubbing on the piers. This problem may cause the bridge to collapse and the foundation to settle over time [7] (Fig.1d).

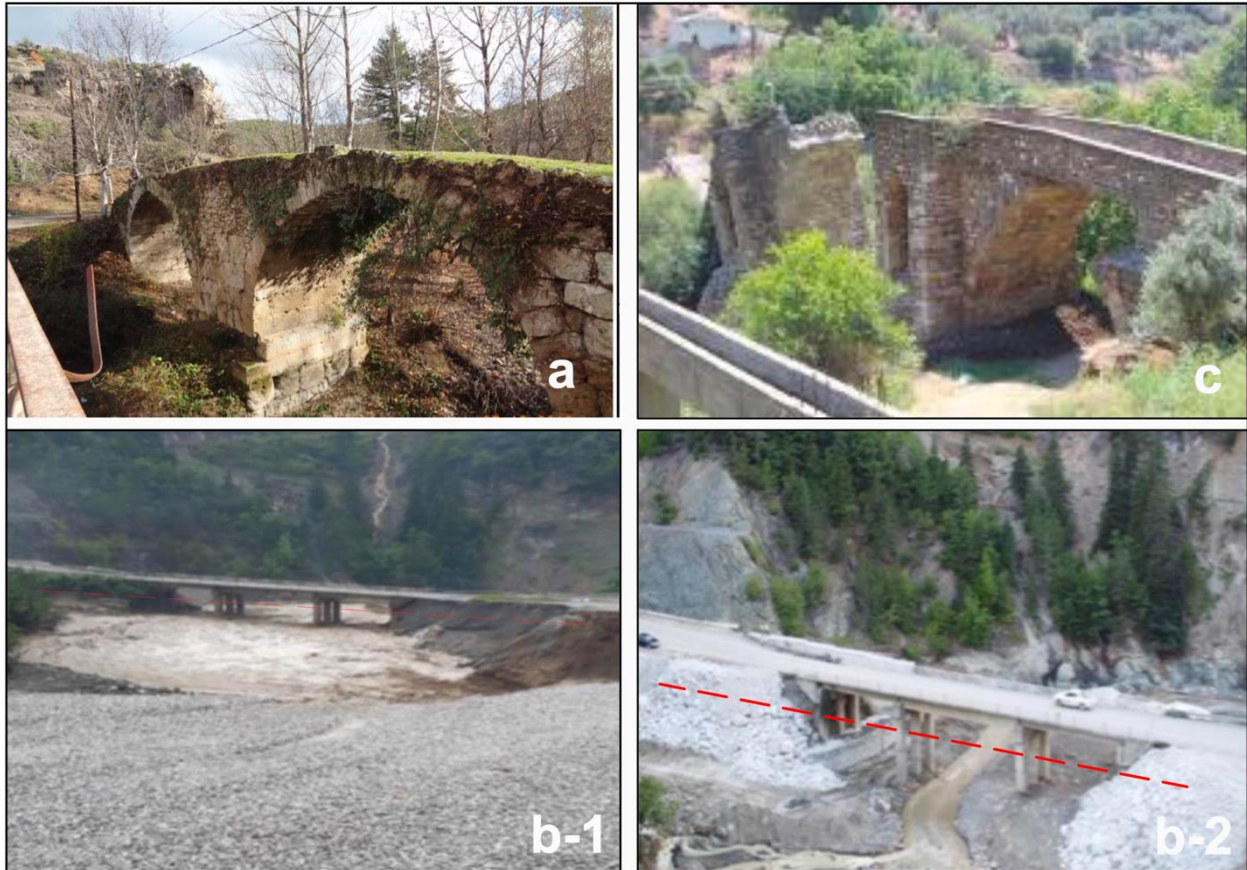
Figure 2. a) Konarı Bridge (Karabük) [25], b-1,2) İkiçay Bridge (Kastamonu) [25], c) İkizdere Bridge (Aydın) [25]

Natural disasters are factors that are unknown; and they can unexpectedly result in severe destruction to historical buildings. Within the scope of natural disasters, the two most important disasters that have a negative impact on historical bridges can be considered as floods and earthquakes. Since bridges are built over streams, they receive the most damage during floods. The damage appears primarily in the flood wounds on the flood splitter (selyaran) part of the abutment or directly on the abutment themselves. Depending on the flow rate and the amount of material it contains, flood disasters cause damage such as cavities and movements in the abutment, superficial or holistic damage to stone surfaces, or loosening of joints. In addition, another effect that has a negative impact on bridges during the flood process is the dynamic effect that occurs as a result of the materials carried by the flood hitting the bridge piers. Rock fragments, which usually occur as a result of landslides, hit the piers and deck at high speed. They have a significant destructive effect. Another negative effect of the flood is the buoyancy force exerted by the suddenly rising water level on the deck. [7]. If the pushing force of the water overcomes the shear stress and occurs at the base of the abutment, effects such as slipping, sitting or turning are also observed on the abutment [8] (Fig.2b). The red line shown in figure refers to the historical bridge that was destroyed in the flood. The piers of the reinforced concrete bridge, which was built right next to the historical stone bridge, narrowed the flow section of the water. Also, during the flood disaster that happened in the region, the historical bridge was completely destroyed in consequence of the precipitation, which was carried into the stream bed, colliding against the abutments.

Another disaster that negatively affects historical bridges is earthquakes. Bridges built with stone material with high resistance to compressive stresses under vertical loads, but they can be damaged under horizontal forces caused by effects such as earthquakes (Fig.2c). For centuries, metal elements that can absorb tensile forces, such as tensioners, clamps, and tenons, have been used in many masonry structures to resist horizontal forces [10]. In bridges, the formation of outward rotations in the spandrel walls (tempan) and emptying the fill, along with the lost facade wall, are common occurrences in earthquakes. It is thought that the collapse of the facade walls is caused by the infill wall interaction [11]. However, one of the points where earthquake damage is most intense is the arches. Cracking and openings, especially in the main arch stones with large spans or along the middle axis of the bridge, are among the causes of earthquake damage [8].
