## New Structuring in the Historic Environment: Investigation of Diyarbakır Yenikapı Street

### Abstract

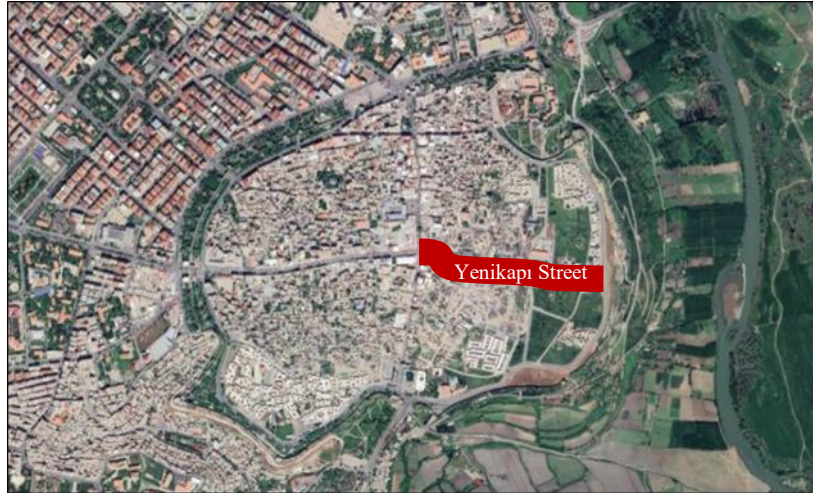
*Figure 1. Yenikapı Street (Google Earth) [26]*

Yenikapı Street, located in Diyarbakır Suriçi District and redesigned after the demolitions in 2015, constitutes the material of this study (Figure 1). First of all, a detailed literature search was conducted and the historical environment, new building in the historical environment and new building design approaches in the historical environment were explained. While conducting the literature research, magazines, books, articles, theses, yandex, google earth and on-site photographs were utilized and supported with visuals. In this context, selected examples from the world and Turkey are analyzed in terms of design approaches, and an evaluation is made by considering what kind of approach has been taken in Yenikapı Street and how successful it has been in this process.

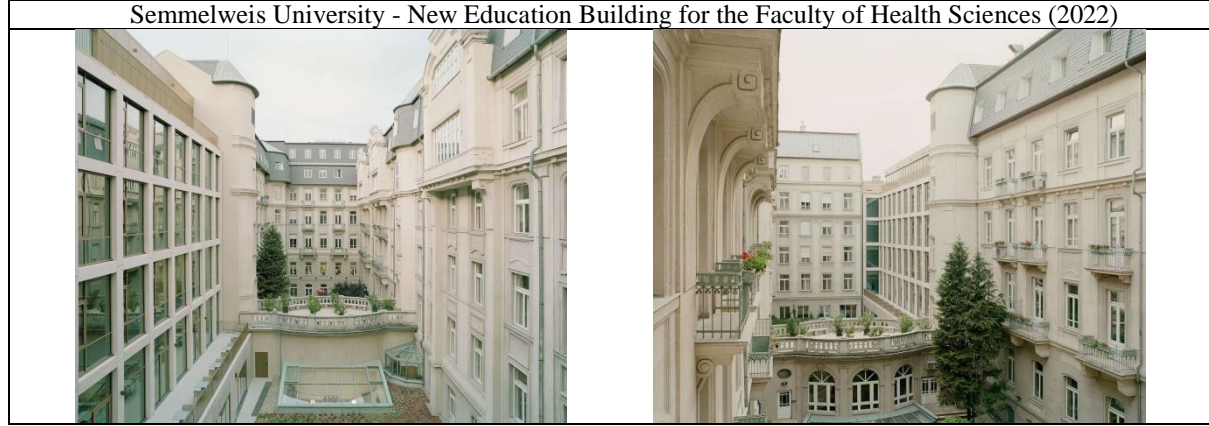
**Table 4. Hungary, Budapest [31]**

An example of new buildings built with an interpretation approach in the historic environment is the additional educational building designed for the Faculty of Health Sciences of Semmelweis University in Budapest. The Faculty of Health Sciences organized a design competition in 2016 for the expansion of an educational building dating back to the early 1900s. Studio Fragment won the competition to create seminar rooms, demonstration rooms and 2 large conference rooms. The neighborhood where the university is located often includes important cultural and educational institutions built in the 19th and

early 20th century. According to the main design concept, a new massing was designed to create a complex consistent with the existing building. Accordingly, the addition creates a completed inner courtyard and connects the two buildings at all levels. The building follows the strong characteristic rhythm of the façades of the surrounding buildings and matches the color of the existing building (Table 4).

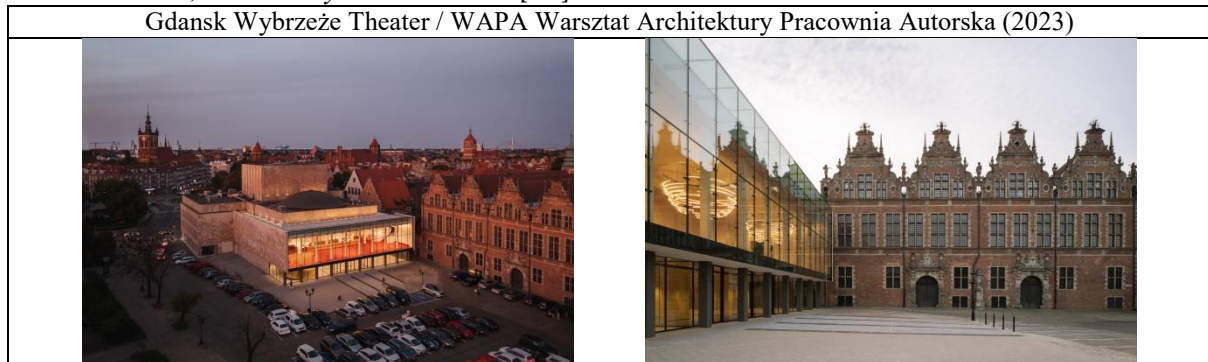
**Table 7.** *Poland, Gdansk Wybrzeże Theater [34]*

An example of this approach is the modernization of the Main Building of the Wybrzeże Theater in Gdańsk, completed in 2023 by WAPA Warsztat Architektury Pracownia Autorska. The building was constructed in the early 1960s on the ruins of a pre-war building and is located within the historical fabric of the city. It is one of the best examples of how a modern building can contrast and blend into the historic environment, with a simple and transparent massing designed with contemporary materials such as glass and steel. It is successful in reflecting the architectural characteristics of its period with the construction technique and materials used, and thanks to its glass surfaces, it allows the perception of the surrounding historical buildings. At the same time, the height of the building is respectful to the surrounding historical buildings, creating a contrast and harmony with the historical texture (Table 7).

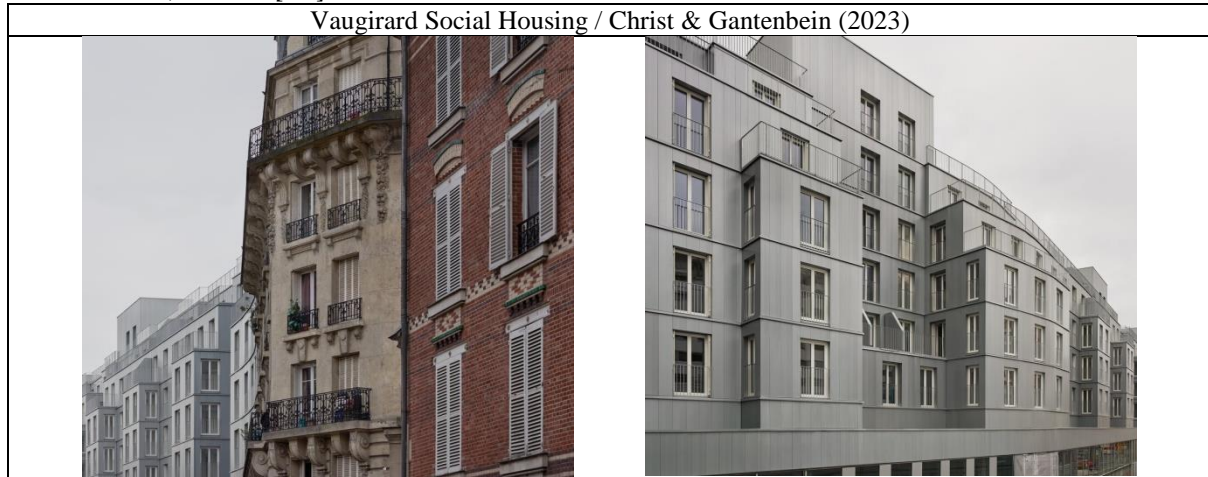
**Table 8.** Paris, France [35]

Built in 2023 by Christ & Gantenbein in Paris, Vaugirard Social Housing is an example of a building designed to contrast the historic environment. This residential design is the product of a contemporary idea of urban revitalization. Elegantly complementing the traditional residential area, the project is presented as a series of volumes characterized by setbacks and carved recesses that form a frame in a sculpted volume with a moving long façade. A metal façade wraps the exterior and the transparent lacquered steel references Parisian roofs while maintaining a raw touch. Adopting elements of the city's traditional roofing, familiar elements are reinterpreted to come together in the historical and cultural context of the city. The building is designed with contemporary materials to contrast with its surroundings, while the height of its massing allows its characteristic features to emerge without overwhelming the surrounding historic buildings (Table 8).

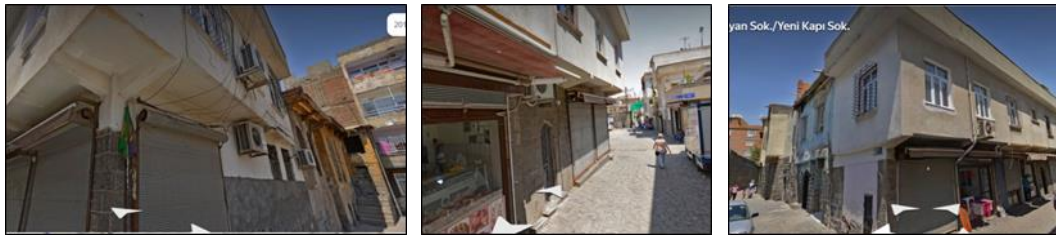
**Figure2.** Buildings on Yenikapı Street (2014) [40]

Diyarbakır's historical urban area, the Suriçi, preserved its traditional texture to a great extent until the 1940s. However, since the 1950s, the physical structure of the city, which started to expand outside the city walls, began to change. With this process, migration and population growth led to unplanned urbanization, and the Suriçi District began to lose its original character in social and architectural terms [38]. In the 1950s, a commercial axis was created on Gazi Street and İnönü Street, which were characterized as the main axis in the city, with the demolition of traditional residences. In 1990, with the migration from the village to the city due to the terrorist incidents, the existing parcels in the Suriçi District were divided within themselves and the population density increased [39]. Due to this increase in density and with the widespread use of reinforced concrete construction techniques throughout the country, users in Suriçi started to make some additions to traditional stone houses. Reinforced concrete additions, which were perceived as a sign of wealth by the users of the period, caused the deterioration of the historical texture and as a result, places without identity began to form (Figure 2).

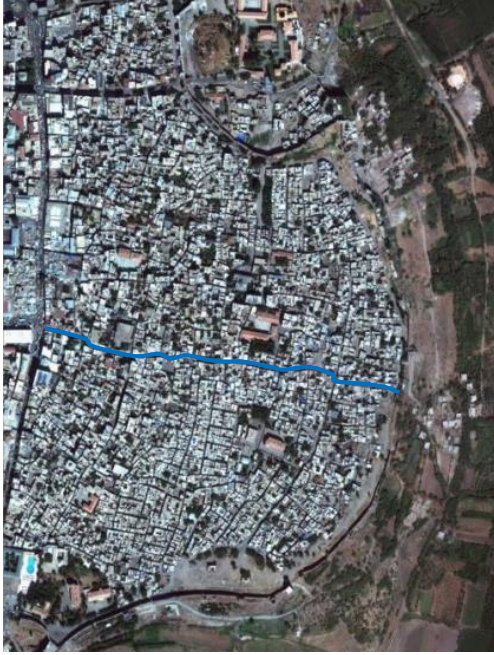
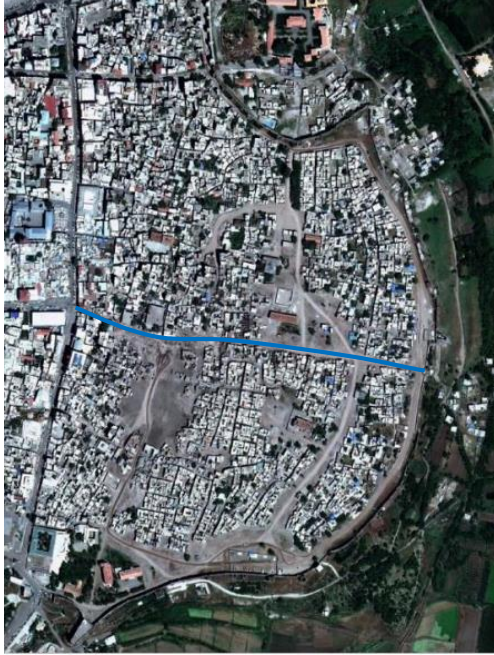
**Table 11.** Changes in Suriçi District, Diyarbakır [42]

After the demolition in 2015, many buildings on Yenikapı Street were damaged or completely destroyed. The street texture that existed before the demolition has been disrupted and turned into a linear road that has lost its original form. The texture that once formed an ecological space with its narrow and dead-end streets and courtyard walls has completely disappeared (Table 11).

Aerial Photograph of Suriçi District (2015, Before Demolition)	Aerial Photograph of Suriçi District (2016, After Demolition)

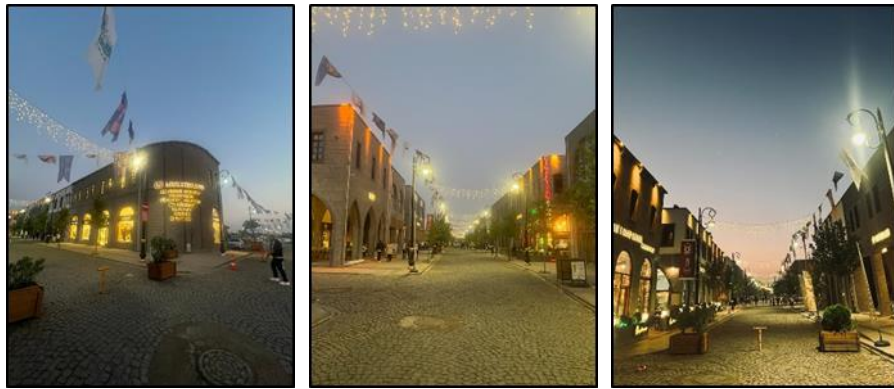
Figure 4. New Buildings on Yenikapı Street (Today)

Before the 2015 demolition, Yenikapı Street was transformed into a smaller scale commercial axis following Gazi Street. During this period, the ground floors were used for commercial purposes and the upper floors were used for residential purposes, while on the new street designed after the demolition, two-storey buildings used only for commercial purposes were built. Before 2014, the function of this street, which was a traditional bazaar with shops developing within the original texture, was changed and turned into cafeterias, restaurants, clothing stores and chain markets (Figure 4).

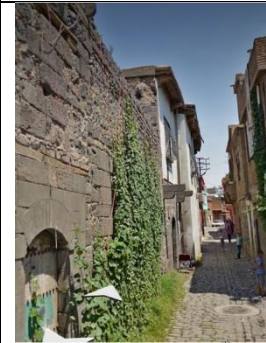
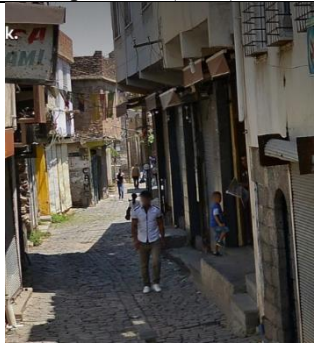
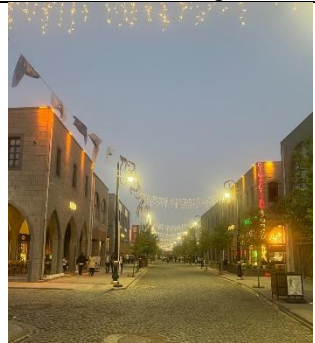
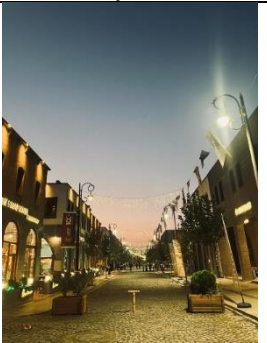
**Table 15.** Changes in Yenikapı Street

Before the demolition in 2015, while the protrusions on the street façade of the buildings and the elevation differences between the heights of the buildings provided shaded areas on the street, the shaded areas on the street disappeared due to the fact that the newly designed buildings were on the same elevation and the distance between them increased. With the widening of the street and the increase in the distances between the buildings, gaps have been created that are not suitable for the hot and dry summer climate of the city (Table 15).

Old street texture of Yenikapı Street (2014) [32]		Yenikapı Street as it is today

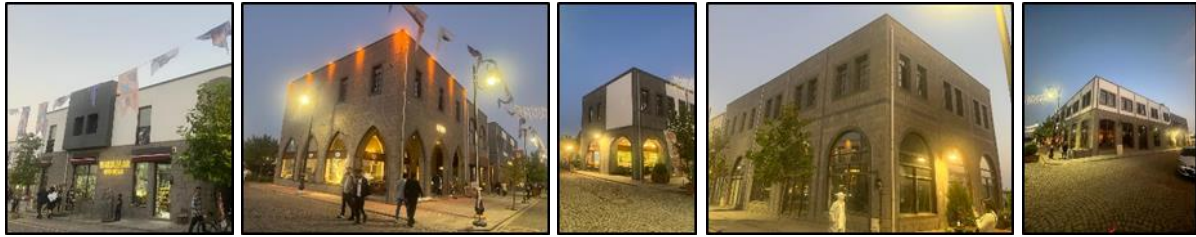
The commercial spaces on Yenikapı Street were designed to mimic elements of Diyarbakır's traditional building culture. Arched and flat windows, iwan openings, bay windows and cabriolets, which are the most common architectural elements seen on the façades of buildings in the historical texture, are used in the newly designed buildings by changing their shapes and proportions. While the elevation differences in traditional buildings due to climatic effects give an aesthetic quality to the city silhouette, in the new buildings all upper elevations are equal and uniform (Figure 7).

**Figure 7.** Façade designs of new buildings on Yenikapı Street
