Utilization of Optical Fiber System for Mass Movement Monitoring

Index Terms—Landslide monitoring system, Early warning system, Optical fiber, BOTDA, Mass movement.

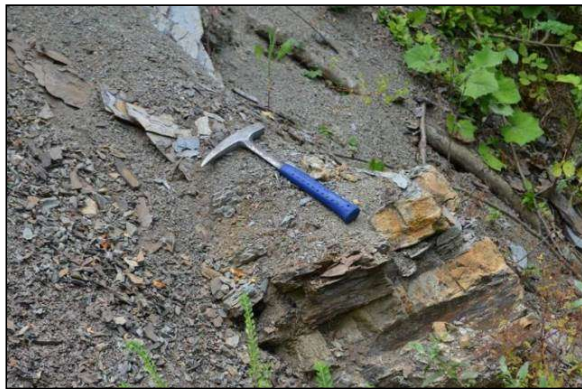
Fig. 4. A view of the rock mass of the İncebel formation.

The study area is located within a valley that lies within the stream bed of the Sarılık Stream. As the result of the field study that was conducted to understand the general geology and to determine the engineering geological properties, the lithology was defined as a sandstone-siltstone alternation. Fig. 4 gives the appearance of the formation in the field.

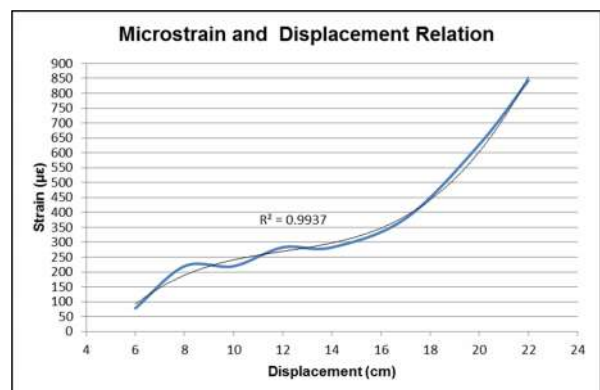
Fig. 5. Graph showing the strain- displacement relation.

The system utilized was made up of optical fiber cables and a device called Optical Time Domain Analyzer (BOTDA). The BOTDA working principle is based on Brillouin scattering and the device is responsible for both sending light to cables and collecting backscattered light. This device is named as a time domain analyzer as it uses the time between sent and backscattered light to detect changes that occur on the cable [16]. When the Brillouin frequencies of the sent and backscattered lights are equal, a peak forms on the measurement graph [17]. The location of this peak point shifts by any change on the cables. As a result, strain changes on the cables are detected quantitatively. The strain-mass movement relation of the system attained by sensitivity analyses can be seen in Fig. 5.

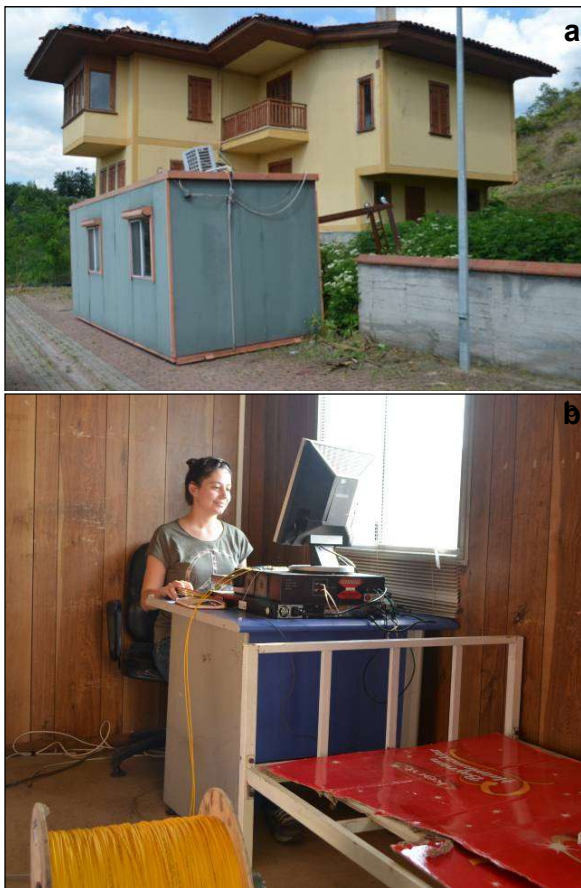
Fig. 6. a) The container's location behind the crown of the landslide b) An inside view of the container and the optical fiber system components.

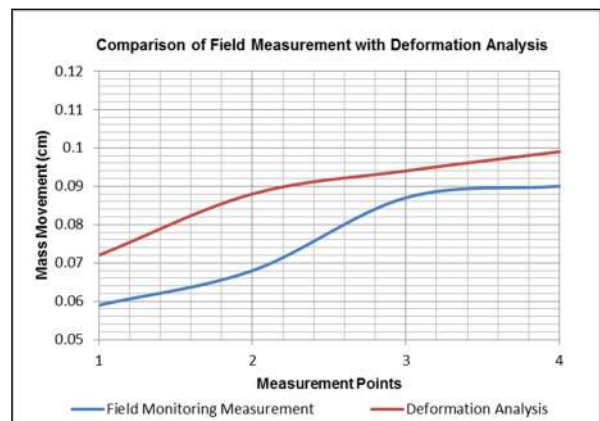
Fig. 8. Graph showing a comparison of the results obtained from the field monitoring measurements and the deformation analysis obtained from FEM.

In addition, a comparison of the field monitoring results obtained from the four cable line segments in the field and FEM modeling of the deformation analysis results are also plotted in Fig. 8. From this figure it can be seen that apart from the differences, the results are relatively consistent. The differences might have been due to initial testing and modeling configuration and/or temporary poles that were fixed near the surface.

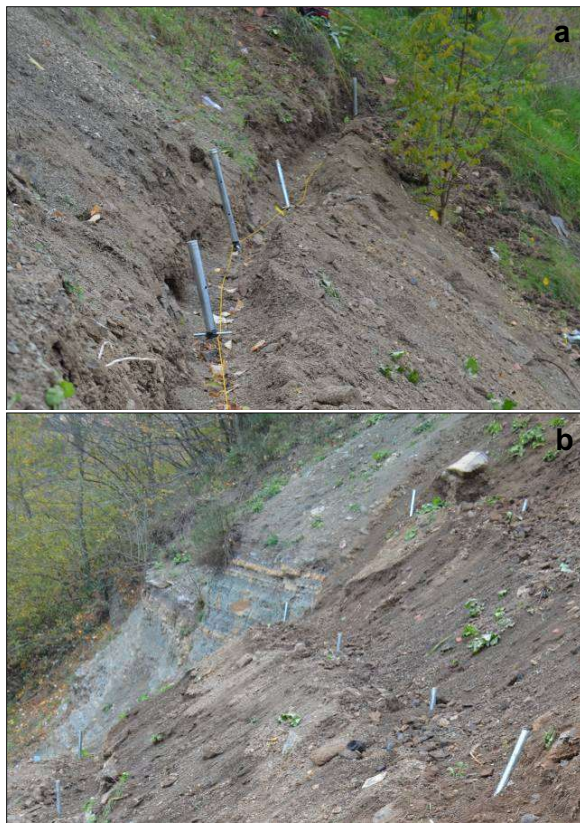
Fig. 9. a) A close up view (during the installation phase) and b) A general view of the cable fixing points (upon installation) within the landslide footprint area.

After the preliminary studies were checked and corrected, finally, the metal fixing poles were buried in a reliable depth at suitable locations determined by the controlling study to collect continuous deformation data from monitoring. The cable fixing points of the optical fiber network can be seen in Fig. 9. After the optical fiber cable network system was implemented to the landslides, sensitivity analyses compatible to field conditions were conducted and simultaneous deformation measurements were started to be collected continuously. In the study area, the deformation data obtained from the monitoring system has been collected continuously since 4 months. Additionally, seismic activity obtained from the AFAD strong motion station and precipitation data obtained from the meteorological stations of Kocaeli have been gathered and then integrated into this system to control the primary factors that might cause movement of landslides. In particular, the effects of intense precipitation and water level increase in the stream that could directly affect the relative movement of a landslide (i.e., deformation changes) have also been directly detected in the monitoring system. These results also demonstrate the reliability and accuracy of the monitoring system.
