CHARACTERIZATION OF EPOXY RESIN AND SILLE STONE POWDER BASED COMPOSITE MORTARS

ABSTRACT: Sille stone, extracted from the Sille region of Konya (Türkiye) province, is an andesitic stone used in the construction of historical buildings. Sille stone is subject to deterioration due to long-term natural and environmental factors. Repair mortars are used to prevent damage to the stones used in the construction of historical buildings. In this study, Epoxy resin (ER)/Sille stone powder (SSP) composite mortars were produced for the restoration of historical buildings and the properties of these composite mortars were investigated. In the production of composite mortars were prepared by contributing SSP into epoxy resin in varied ratios such as 60-75% wt.%. When 60% SSP filler was added to the ER matrix, the compressive strength of the resulting composite increased by approximately 66% compared to neat ER. Moreover, an increase in mechanical strength and a decrease in water absorption were observed in composite mortars due to the increase in SSP. In conclusion, the high strength, low water absorption rate and pore properties of epoxy matrix composite mortars provide great potential for res

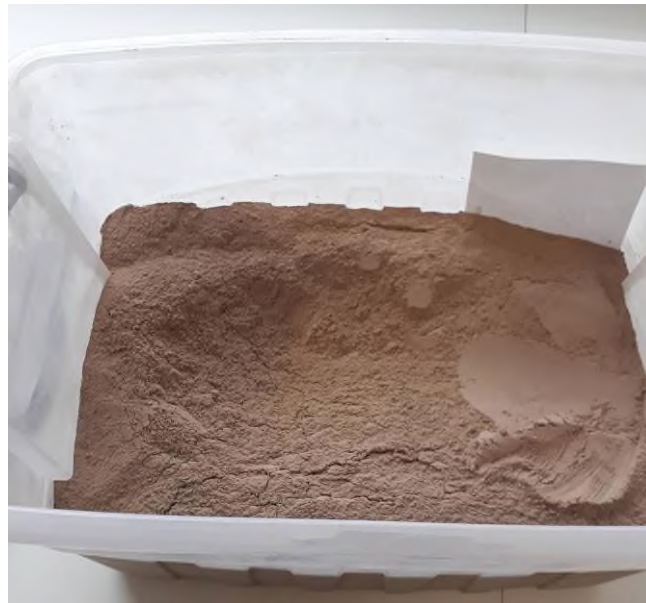
Figure 1. Photograph of the SSP used in the study

The SSP used for the production of composite mortar was taken from a quarry in Sille region of Konya province. Since Sille stones were shaped in various sizes before being used as building materials, stone powders were collected from the quarry for experimental studies (Figure 1). Sieve analysis was performed for particle size distribution of SSP taken from the quarry. Stone powder was sieved using a sieve device (Retsch AS 200) and sieves of different sizes (63, 150, 250, 500, 1000, 2000 and 4000 μm). Each of the sieve set apparatus was placed with 100 gr SSP and then shaking was done for 10 minutes. At the end of this process, the powder remaining in each sieve was weighed and recorded. In the particle size distribution of SSP, approximately half of the particles are below 63 μm , while less than 10% of the particles are larger than 500 μm (Figure 2). Some features of the SSP used in the experimental study are given in Table 1. The chemical content of SSP is given in Table 2. It was determined that the chemical content of SSP was highest as SiO_2 66.67% and Al_2O_3 13.24%.

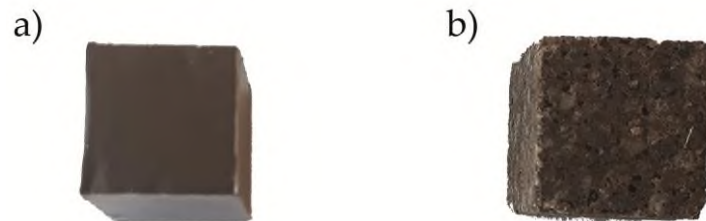
Figure 3. (a) Photograph of the composite sample produced within the scope of the study, (b) Photograph of the Sille stone

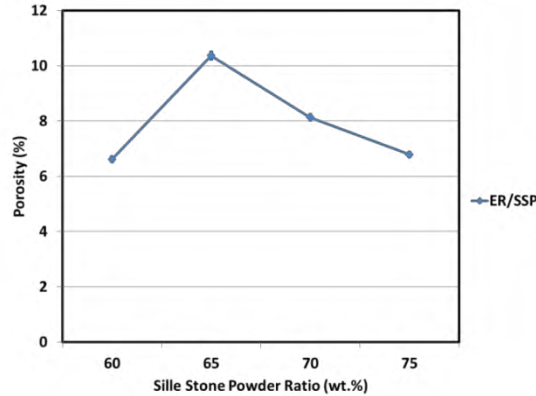
Figure 5. Graph of porosity (%) values of ER/SSP composites

When the porosity ratios of ER/SSP composites are examined, the amount of voids decreases depending on the increase in the amount of SSP in all composites except ER/SSP-2 composite. According to the graph in Figure 5, it is seen that the porosity ratio of the ER/SSP-2 composite sample is higher than the porosity ratio of all other composites. The increase in the amount of voids in the material causes an increase in the water absorption rate. This situation causes deformations in the interior and exterior of the building such as humidity, blooming and rotting. The fact that the void ratio of the ER/SSP-4 sample developed within the scope of the study is the lowest, may help to reduce the damage caused by water absorption in the structure. Moreover, the use of this composite in the restoration of cultural assets may contribute to the long-term preservation of the structure.

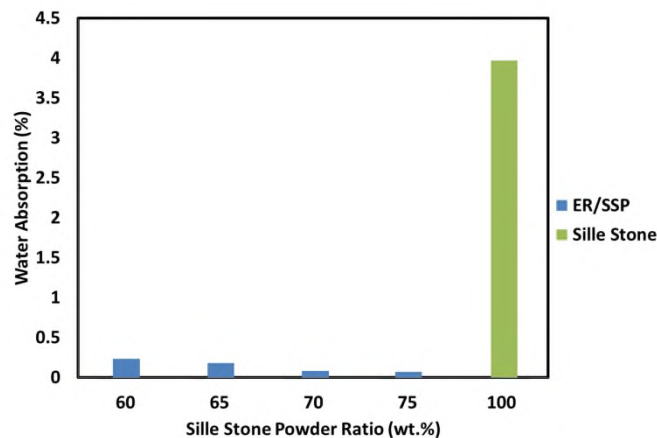
Figure 6. Graph of water absorption rate values of Sille stone and ER/SSP composites

comparison chart is given in Figure 6. According to the data in Table 5, it is seen that the water absorption rate of ER/SSP composites is lower than that of Sille stone. Moreover, in ER/SSP composites, the water absorption rate decreases due to the increase in the amount of Sille stone powder. It has been determined that the water absorption rate of the ER/SSP-4 composite has the lowest rate compared to all other composites. According to this test result, the fact that the composites are affected by water in the use of restoration repair mortar, and that it is less than Sille stone, prevents the deterioration of the structure caused by water. However, in the restoration of cultural assets, the low water absorption rate of the composite mortar prevents the damage caused during the freeze-thaw process due to atmospheric effects and the structure is preserved for a longer period of time.

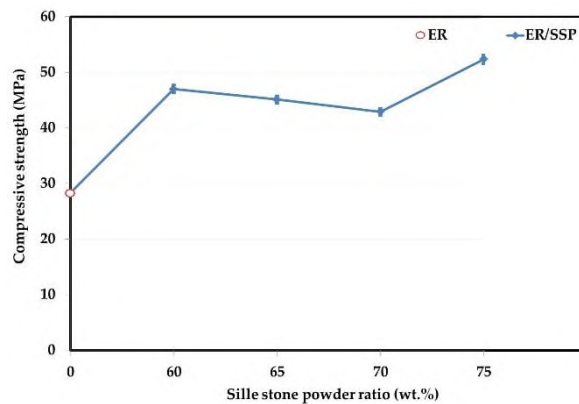
Figure 8. Compression test result graph of ER/SSP composites

Compression test results of ER and ER/SSP composites are given in Table 7 and Figure 8. According to the data in Table 7, the strength value of ER/SSP composites is between 42.90 MPa and 52.36 MPa. Moreover, according to the compression test result, it was determined that the strength value of ER/SSP composites was higher than the strength value of neat ER (Figure 8). However, with the addition of 60% SSP filler to the ER matrix, its strength increased by 66% compared to neat ER. When the amount of SSP was increased from 60% to 70% by weight, the strength value of the composite decreased. The formation of agglomeration in the intermediate phase between the stone powder and the epoxy matrix causes a decrease in the adhesion strength of the matrix and a decrease in the strength of the composite. Nevertheless, when the amount of SSP was increased from 70% to 75% by weight, the stone powder was homogeneously dispersed in the epoxy matrix, and the decrease in the porosity ratio increased the strength value of the composite. When this result is compared with the flexural test result, the strength value of the composites gives similar results.

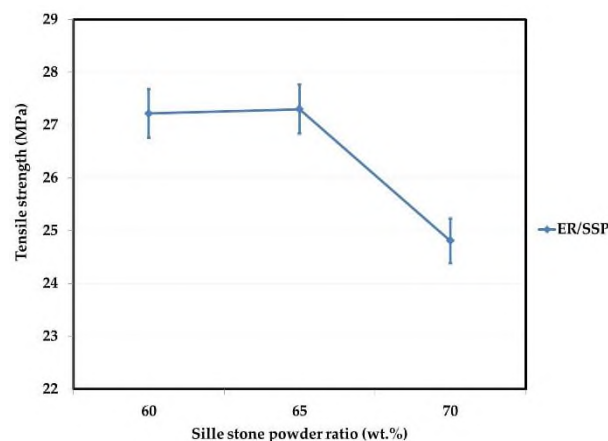
Figure 9. Tensile test result graph of ER/SSP composites

The tensile test results of the ER/SSP composite are given in Table 8 and Figure 9. As shown in Table 8 and Figure 9, the tensile strength of ER/SSP composites is between 24.81 MPa and 27.30 MPa. Moreover, it was determined that ER/SSP-2 composite had the highest tensile value compared to other composites. When the amount of stone powder is increased from 60% to 65% by weight, an increase in tensile strength is observed, while a decrease in tensile strength is observed when the amount of stone

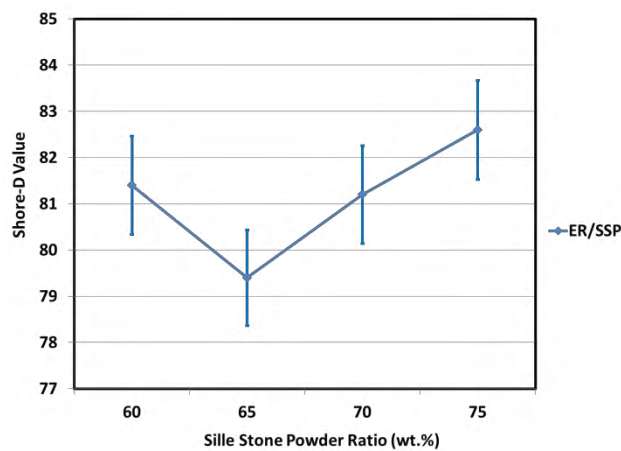
Figure 10. Shore-D hardness test result graph of ER/SSP composites

The hardness test results of the ER/SSP composite are given in Table 9 and Figure 10. As seen in Table 9 and Figure 10, the hardness value of ER/SSP-4 composite is higher than the hardness value of all other composites. Moreover, an increase in the hardness value of the composite was observed when the amount of SSP was increased from 65% to 75% by weight. To explain the factor affecting this situation, the hardness of inorganic fillers can be attributed to the higher hardness of organic fillers [49]. Adding harder stone powder to the epoxy matrix can increase the hardness of the composite.
