The Impact of Locally Available Materials on Architectural Heritage: Preliminary Findings from the Güzelşeyh Pavilion, Türkiye

Felat Dursun^{1,2} ¹Department of Conservation and Restoration of Cultural Heritage, Izmir Institute of Technology, Izmir, Türkiye²Department of Mining Engineering, Dicle University, Diyarbakir, Türkiye (e-mail: felatdursun@gmail.com; felatdursun@iyte.edu.tr)

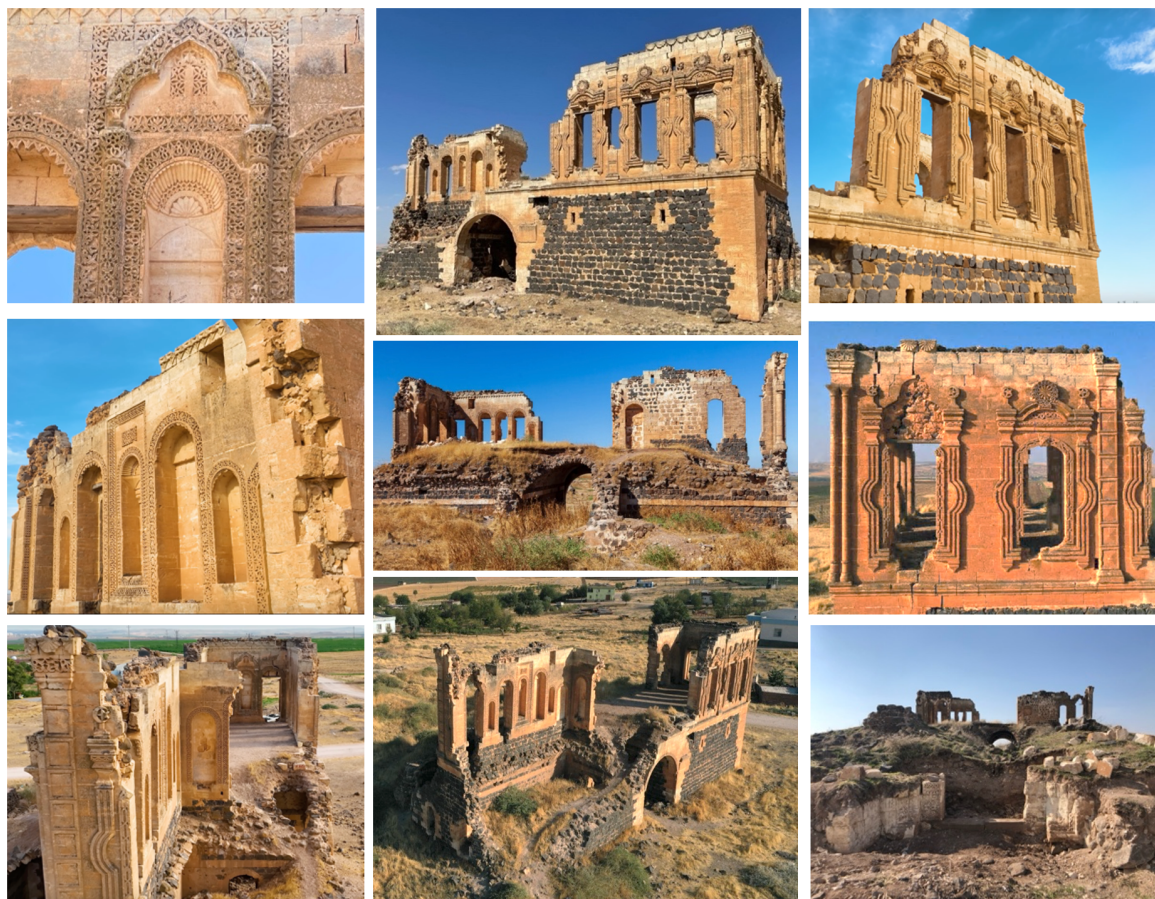
Figure 1. Façade views and principal construction materials of the GP (Bottom right image sourced from [22])

The structure, originally constructed using traditional masonry techniques, has unfortunately fallen into a state of partial ruin over time due to prolonged neglect (Figure 1). The pavilion consists of the ground floor and the first floor. The ground floor was used as a madrasa, and the upper floor was used as a pavilion [23]. The ground floor, rectangular and aligned east-west, is accessed through two entrances in the same direction. These entrances lead to a central corridor flanked by 16 rooms. While the rooms on the west side remain relatively intact, those on the east side have collapsed in places with damage extending to the foundation level (Figure 1). The first floor, oriented perpendicular to the ground floor, was originally accessed by a staircase, which has since been demolished. This floor consists of two rooms in a rectangular form along the north-south axis and a central space [23]. The upper cover of the rooms has been completely demolished (Figure 1), and portions of the floor have also collapsed. This transition is significant as it reveals how the building's original fabric changed over time.

Basalt served as the foundational material on the ground floor, used on the flooring and in load-bearing walls due to its strength. On the first floor, dressed limestone became the dominant material, contributing to the building's decorative carvings, ornamentation, and arches, which enhanced its aesthetic value. The most common ornamentations in the building are those with plant and geometric patterns. Although these decorative elements are concentrated on the first floor, it is possible to see remarkable ones carved in limestone on the exterior facades (especially on corner borders, portals, arches, windows, and hood molds) [22–23] (Figure 1).

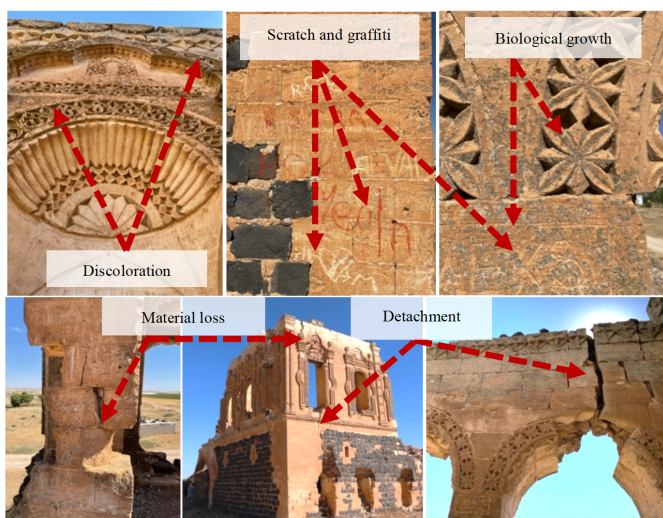
Figure 3. Some of the decay forms observed in Güzelşeyh (Bottom right image sourced from [22])

The type, extent, and distribution of decay forms were analyzed as part of the field studies. Although the current abandoned state of the building limits a comprehensive assessment, an attempt was made to describe the weathering forms observed in the remaining standing sections (Figure 3). It was observed that the basalt, especially in areas in contact with the ground, showed signs of decay, including discoloration, chipping, and blistering due to water exposure. On the other hand, the limestone exhibited more severe deterioration, primarily characterized by significant material loss.

Additionally, the limestone showed signs of chipping, fading, erosion, discoloration, deposits, fractures, cracks, scratching, and biological colonization (Figure 3). Although less common, efflorescence was also noted at certain lower elevations. The forms of decay observed affected not only the building stones but also the iconic reliefs. Damage from both human activities and atmospheric conditions has accelerated the deterioration process. Today, this damage combines with other forms of decay, further threatening the surviving parts of the structure.

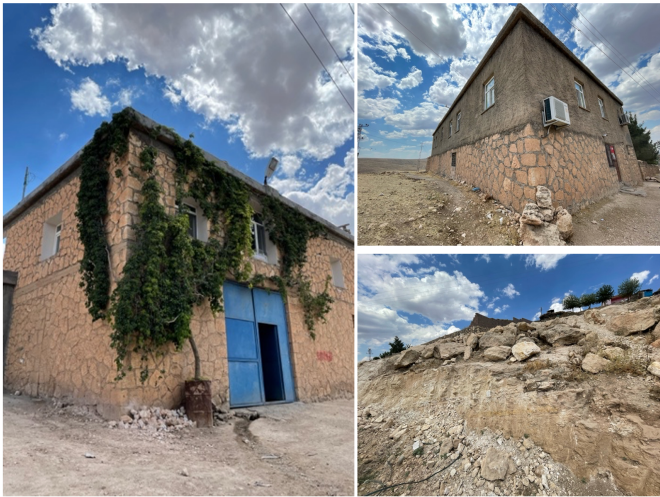
Figure 5. Limestone-built structures and potential quarry sources in Bağacık village

The limestone used in the pavilion is part of a widespread Eocene-aged carbonate formation in the region. However, despite the formation's overall continuity, the sediments display lateral variations. In this context, two specific levels with building stone potential were identified—one near Zerzevan Castle and the other in Bağacık Village. Petrographic and geochemical analyses identified Sample 4 from Bağacık as a potential match for the pavilion's limestone. This sample shares key characteristics, such as color, texture, and mineral composition—including dolomite content—making it a possible choice for future repairs. Moreover, field observations confirm the presence of quarries in Bağacık that historically supplied building stones for local structures, like the village houses (Figure 5).
