Üniversite Kampüs Yapılarının Erişilebilirliği: Niğde Ömer Halisdemir Üniversitesi Üzerinden Bir Değerlendirme*

Seval YILMAZ^{1**}, İpek FİTOZ²

Accessibility of University Campus Buildings an Evaluation on Niğde Ömer Halisdemir University

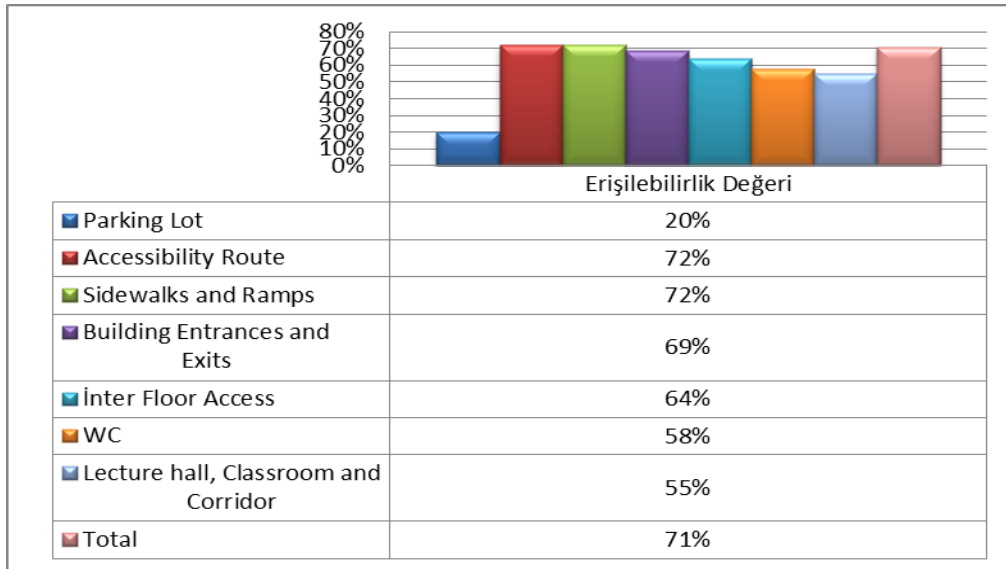
Table 4. Congress and Culture Center accessibility compliance rates

The building, which is located on the left side of the main campus entrance and has hosted many social and cultural events, was included in the sample group due to its user density and diversity. According to the evaluation results, the compliance rate of the Congress and Culture Center is 71%. The compliance rate of the parking lots located right behind the building entrance is 20%. According to a general assessment of the accessible routes and portions, the building's accessibility is in acceptable shape, with the exception of the parking lots' accessibility and its distance from public transportation. The stairs at the entrance of the building have been solved, but since the elevator has been solved inside the entrance, its visibility has been prevented. Another problem identified is that only one solution has been produced as a disabled toilet. Flexibility and accessible solutions have been considered in the designs of the halls on the first floor. Accessible spaces and areas can be provided for everyone with the improvement works to be carried out in the problematic areas and spaces identified as a result of the current situation analysis.

- Parking lots and building entrances are more than 30 meters apart. Since moving the parking lot and building entry would be challenging, the path leading from the parking lot to the building should be set up according to the guidelines, making sure that people with physical disabilities can enter independently and conveniently.

- Emergency exit instructions and directions should be organized in a way that everyone can easily see.
- Improvements should be made in the building in accordance with the regulations for the visually and hearing impaired.

- Guidance and information systems within the building should be improved so that visually and hearing impaired people can use them.
- There is only one independent disabled restroom on each floor. Since this situation will create a feeling of exclusion for individuals and there may be an increase in the number of users during events, conferences or exhibitions, troublesome situations may arise. In this context, separate cabins should be designed inside the men's and women's toilets, and if possible, all cabins should be arranged in a way suitable for the use of all user groups.

- The dimensions of the fittings in the toilets should be changed/regulated in accordance with the standards.
- The existing lecture halls do not have ramps of the required size and dimensions. Only in Hall 1071, access is provided using the elevator system. These solutions should also be applied to other lecture halls. The halls on the first floor, which are designed with flexible and accessible solutions and can be combined when necessary, serve all kinds of events and user groups.

- Color contrast should be created in fixed and movable furniture in the building.
- Audible, tactile and stimulating signs and arrangements should be included in the building entrance and corridors where circulation is intense; accessibility of hearing and visually impaired people in the space should be increased.

- Perception of the main elevator located far from the building entrance may pose a problem for the first time visitors. Necessary guidance is required.
