## Nevşehir Virgin Mary Church Conservation and Reuse Process

### Research Article

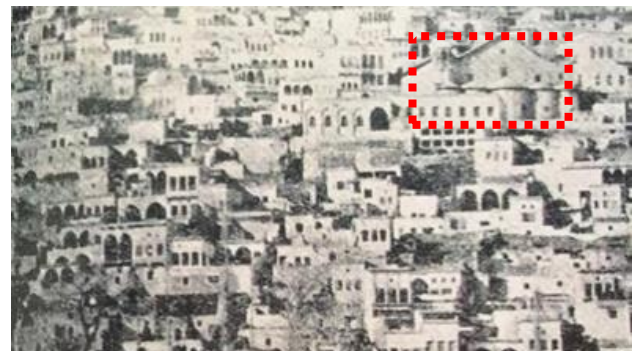
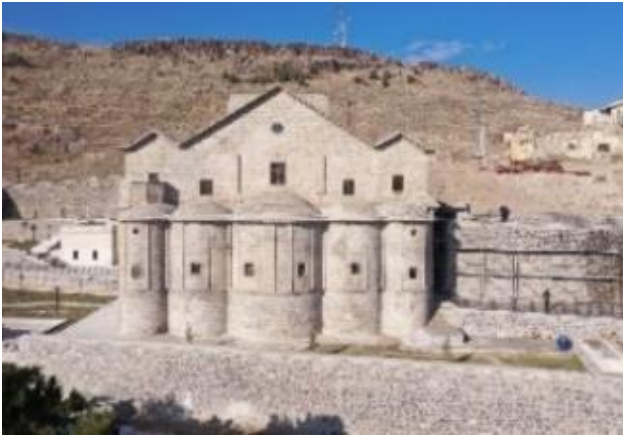
**Figure 2.** General view of the Church of the Virgin Mary [25, 26].

Cappadocia and Nevşehir have rich historical, documentary, aesthetic, artistic, symbolic, social, economic, religious, and spiritual values [45]. During the Byzantine rule, Nevşehir was known as "Nissa", while during the Seljuk and Ottoman periods, it was called "Müşküre", and it is stated that it was a small village during this period [22]. During the Ottoman period, especially between 1718 and 1730, when Damat İbrahim Pasha was the grand vizier, Nevşehir, formerly known as Müşküre, became one of the most important settlements in the region. It is known that a significant number of non-Muslims lived in Nevşehir and its surrounding settlements during this period [23]. The Church of the Virgin Mary (Koimesis Theotoku Church) is located in the center of Nevşehir, in the Cumhuriyet Neighborhood, in the area formerly known as the "Church Façade". The Church of the Virgin Mary, located on a hill overlooking the city, on the east side of Kahveci Mountain, south of Nevşehir Castle, was built during the reign of the high priest Paisios and opened on October 16, 1849 and dedicated to Mary [24]. (Fig. 2).

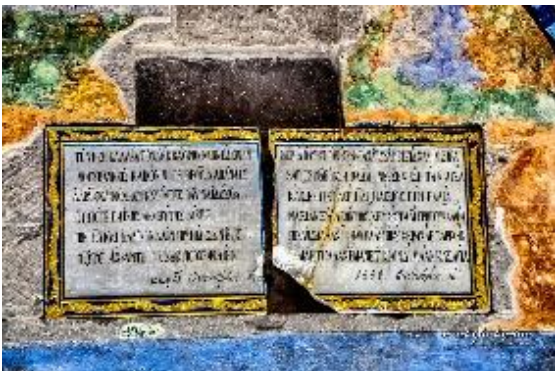
**Figure 3.** The Inscription of the Building [29].

Eyice (1977) cites a yearbook written in the Karamanlı language in Nevşehir and states that there were two church buildings in the city. Accordingly, the Hagios Georgios Church, which is located in the city center and bears no trace other than the remains of a four-storey bell tower, is the first example of buildings in the region [27]. The building, which is defined as the second church, has two inscriptions, one in Greek and the other in Turkish. The Turkish inscription reads; "May the life of Sultan Abdülmecid Khan be blessed/ Because it was built thanks to him/ This church in Nevşehir/ Kayseriya priest Paisios pir-i valia/ Naziansu Leontios ustad-ı Grekor journeyman/ Bi Hamd-Allah is completed, rest in peace/ Read the history of the town of maan entrusted to Veledetullah/ 1849" " (May it be Majid and its life be Sultan Abdul Majid Khan/ It was built thanks to Zira/ Nevşehir bu Kilisa/ Kayseriya priest Paisios pir-i valia/ Naziansu Leontios ustad-ı Grekor journeyman/ Bi Praise be to Allah, it was itmam, read it, refresh history/ It was entrusted to Waladatullah maan town/ 1849)" (Fig. 3) and the name of the owner and the master was indicated. Based on this information, it is thought that the second church building in question is the Church of the Virgin Mary [28].

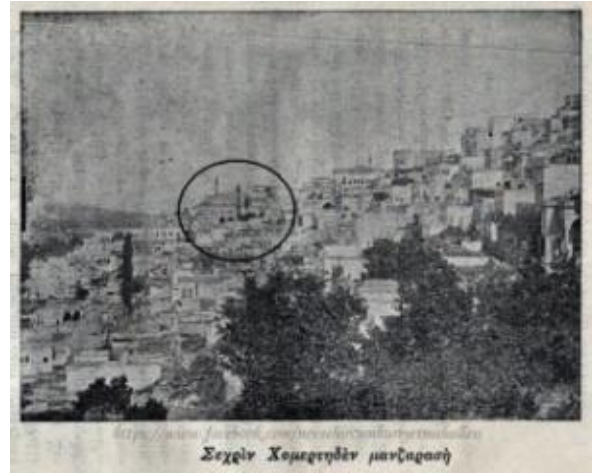
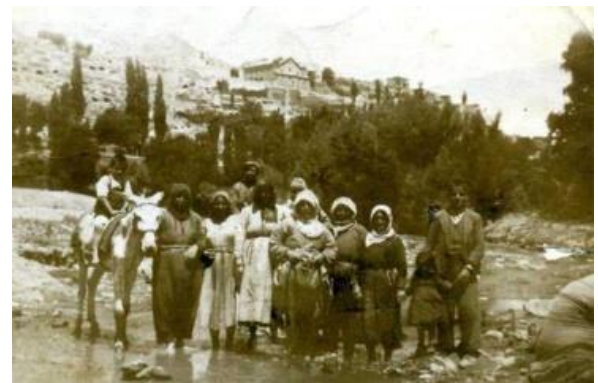
**Figure 4.** Old photos of the church [25].

The Church of the Virgin Mary (Koimesis Theotoku Church) has been identified as one of the largest churches in the region, with a length of 29 meters and a width of 23.50 meters [24]. The construction dates of the churches in Nevşehir are dated between 1729 and 1889. It is known that the Church of the Virgin Mary in Nevşehir and the Church of the Twelve Apostles in Özlüce were built in the same year, 1849. Considering the Ottoman

sultans mentioned in the inscriptions or coinciding with the construction period, it is emphasized that the reign of Sultan Abdülmecid came to the fore in terms of the construction and repair of the buildings [24]. (Fig. 4).

Metropolitan Paisios of Kayseri is known as the founder of the Church of the Virgin Mary. Paisios took part in the construction of the Church of the Virgin Mary in Nevşehir, as well as the churches of Saints Georgios, Constantine and Helena in Mustafa Pasha and the Holy Cross in Cemil, and the Church of the Virgin Mary was built by an architect named Leontizu Gregor Kalfa from Nazianzus, according to the inscription that does not exist today [24]. (Fig. 4).

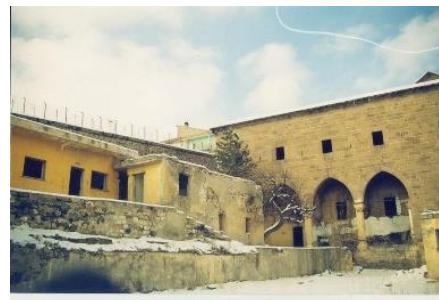
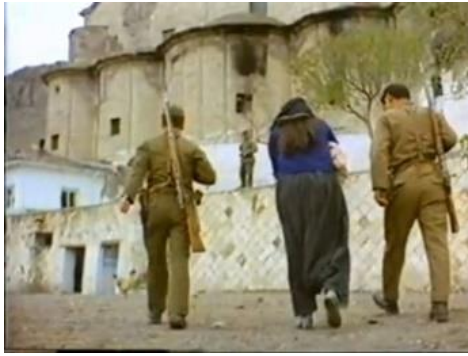
**Figure 6.** Photos of the use of the church as a prison [25].

The population exchange between Turkey and Greece in 1923 caused the Greek population in the region to leave the region and the church to become dysfunctional [30]. After this process, the building was abandoned to its fate in a state of disrepair for many years. Although the frescoes and stonework of the building were damaged during this period, the building continued to preserve its architectural values and symbolic importance. The church, which was one of the largest buildings identified in the Cappadocia region and abandoned after the exchange, was converted into a prison in 1950 in line with the need. The building was used as a state prison between 1950 and 1983 during the Republican period [31] (Fig. 6).

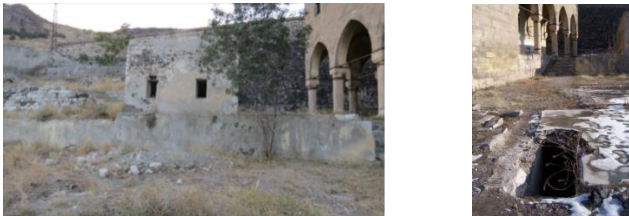
**Figure 9.** Photos from the annex and dungeon [25]

Within the scope of the prison function of the building, various changes were made in the façade openings and layout plan. In this context, the two arches on the north side of the western façade of the building were closed with rubble stones to create a new space, the doors opening from the façade to the side aisles were closed, an iron railing was added to the main door, and the window on the north floor was closed due to the functional necessity on the first floor. On the south side of the building, a new door was opened on the west side, a meeting structure was built on the east side of the façade, and the polygonal bell tower on the south aisle on the east side of the façade was demolished. No significant changes were made on the east side of the building, except for the demolition of the bell tower, and a new rubble stone space was added to the west façade on the north façade for the use of the Second Period prison. The original entrance door and the window to the east were closed and a new door was opened on the ground floor [25] (Fig. 9).

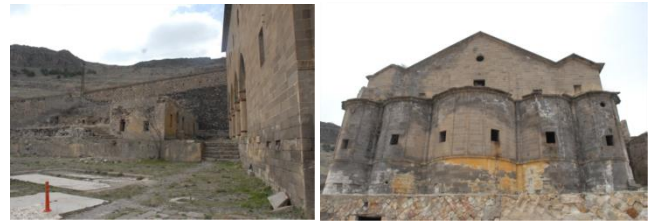
**Figure 11.** Photos of the church after the use of the prison [25].

Within the scope of the requirements of the prison function, it can be stated that functional, spatial and structural changes have been made in the building and its decorations have been lost. These changes caused the building to lose its original religious identity, but at the same time, the building gained an important place in the social memory of the period. Important names such as Aziz Nesin, Yılmaz Güney, Kemal Tahir and Fener Greek Patriarch Bartholomew were working in the prison. In addition, in 1973, the movie *Mahpus*, starring Türkan Şoray, was shot in this church [42]. In this context, the building has become an important focal point not only from an architectural point of view, but also from a socio-political point of view (Fig. 11).

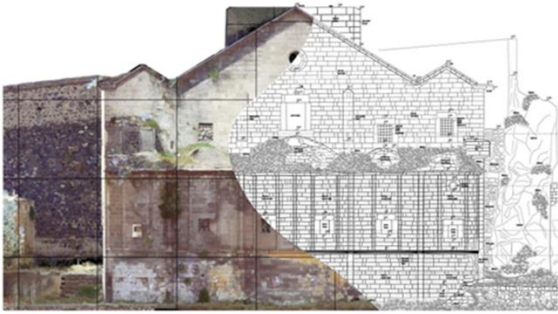
**Figure 12.** An example of the restoration drawings of the church [25].

For the repurposed buildings, it is of great importance that the interventions to be made in order to adapt to the new purpose of use are planned in a way that does not harm the original spatial organization and façade character of the building. In this context, the re-functioning of the building as a museum has contributed positively to its use in accordance with its original spatial and architectural character (Fig. 12).

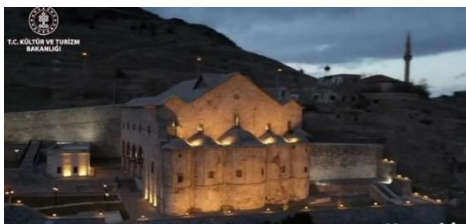
**Figure 13.** Photograph of the church after restoration [43].

In order for conservation practices to be carried out effectively, the first step is to carry out a thorough survey of the building or area to be protected and to prepare the measurements and drawings accurately, completely and without errors [33]. In 2016, the survey drawings, restitution, restoration projects and intervention plans of the building were carried out and approved by Çağ Restoration and Shape Architecture Restoration, and the data of these projects were used in the article in accordance with the permissions obtained. The restoration of the Church of the Virgin Mary in Nevşehir, which was carried out on behalf of the Ministry of Culture and Tourism between 2021 and 2023, was carried out under the supervision of the Kayseri Directorate of Survey and Monuments [34] (Fig. 13).

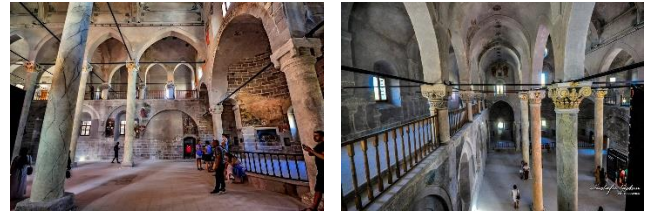
**Figure 14.** Photograph of the church after restoration [29].

carried out, and within this framework, the first evaluations and analyzes of the building were carried out. In the examination, it was determined that the structure was in poor condition due to the effects of time, previous repairs and negative traces of the function. The restoration approach is designed according to the principle of "interventions that do not disturb the originality of the structure with the least intervention". In this context, restoration methods are classified as "Completion, Consolidation, Cleaning and Renewal". (Fig. 14).

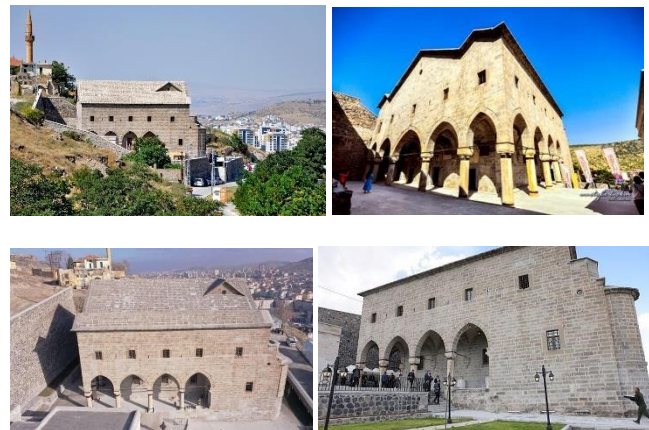
**Figure 15.** Photo of the church after restoration [29, 35, 36].

Within the scope of the restoration decisions, it was decided to dismantle and remove the walls and floors built during the prison period in accordance with the technique in a way that would not damage the load-bearing system of the building, thus making the building suitable for its original plan scheme and spatial layout (restoration report). It has been stated that the removal of the reinforced concrete carcass system and rubble stone masonry walls, which were added to the building later, will reduce the static and earthquake loads of the building, and the damages caused by the anchoring of the reinforced concrete system to the stone columns can be repaired (Static report). In addition, within the scope of the removal of the additions, it was stated that the window and door openings filled with rubble stone and stone should be removed without damaging the stone walls, and new ones should be built in their place in accordance with their original materials. (Fig. 15).

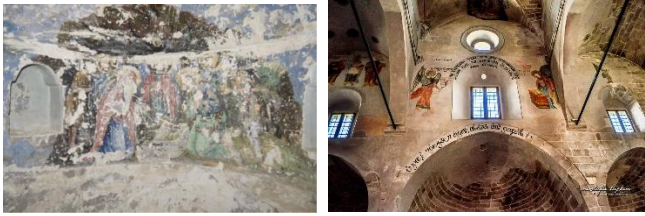
**Figure 16.** Photos of frescoes before and after restoration) [25, 29].

With the use of the building as a prison structure, the façade materials and openings that were added to the building and were incompatible with the building were restored. In the restoration works carried out throughout the building, damage assessment studies

were carried out on stone walls and vaults, intervention methods were determined, deformed stone walls, vaults, column capitals and stone moldings were cleaned and renewed. It was decided to remove the cement-based plasters on the existing retaining wall and the additional pieces made of briquette material on the upper levels of the courtyard wall and replace them with the original masonry material (basalt rubble) [25, 37] (Fig. 16).
