*International Journal of Engineering and Geosciences (IJEG),
Vol; 3; , Issue; 2, pp. 056-060, June, 2018, ISSN 2548-0960, Turkey,
DOI: 10.26833/ijeg.380752
Research Article*

DETERMINATION OF BUILDING MATERIALS WITH IR-THERMOGRAPHY IN HISTORICAL BUILDINGS

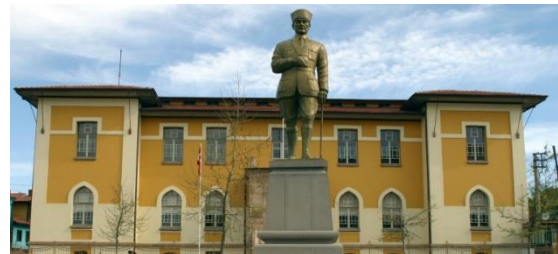
Figure 1. Republic Historical Museum – Eskisehir (source: <https://www.anadolu.edu.tr/kampuste-yasam/muze-ve-sanat-merkezleri/cumhuriyet-muzesi>)

The building has a basement, ground floor, and first floor, making a three-floors construction. The height of the basement is 3 meters, the ground floor 4.70 meters, and the first floor 4.50 meters. The buildings' first structural system was masonry. The external walls were made of cut stone, the interior walls were lath-and-plaster, slabs, stairs, ceiling, and doors were timber work and the entrance part of the building was floor arch (Nalçakan 1995). Later in the years' unknown reconstruction has been made and most of the materials used in the building remained unknown until today (Figure 1).

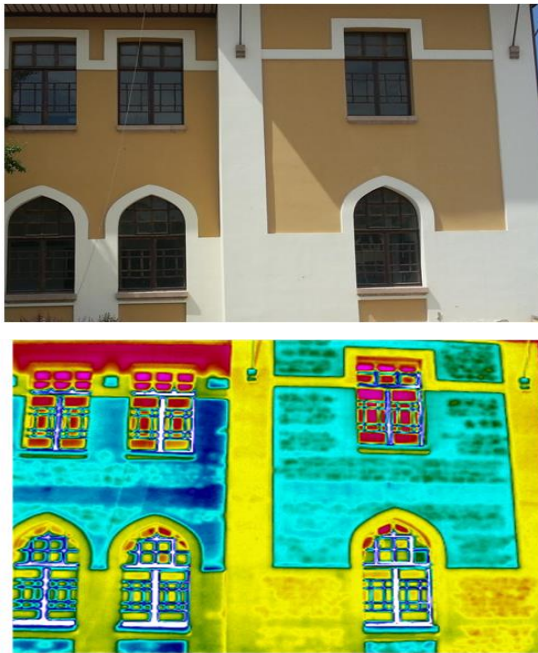
When the building materials were heated with heaters, the differences between the materials in the

Figure 2. Visible and thermal image of the same scene of the inspected building

images became clear. Since the air temperature is higher in May, the heater was not used because it was possible to observe the difference between the materials. During the monitoring with the thermal camera, the temperature inside and outside of the building was measured. Of the different thermal conductivity of the brick, stone and concrete materials, they were distinguished very clearly by the IR thermography method. In thermal records, interior walls' material was slightly different from surrounding concrete frame as seen in Figure 3.

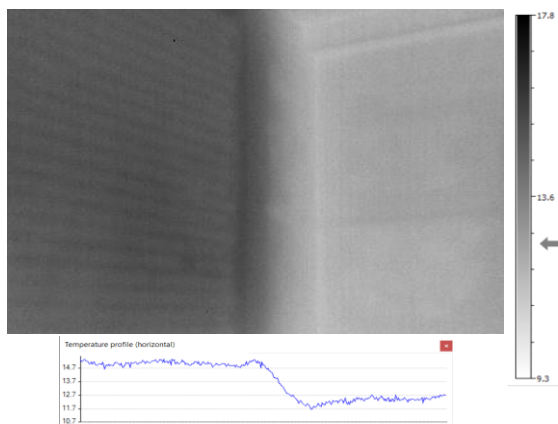
Figure 3. Thermal difference between the interior brick wall (left) and exterior stone wall (right).

The interior walls were observed with a thermal camera and the wall material was predicted to be brick due to the formation of the blocks and pointing stuff. For confirmation of the prediction, plaster was removed on several walls and it was seen that the inner walls have been constructed with brick blocks.

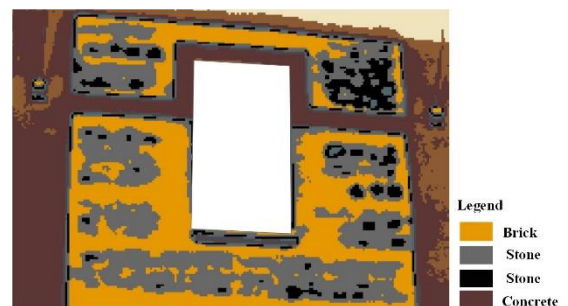
The result from the unsupervised classification were helpful in determining the stone and brick area. The classification was made according to the observed temperature. The results from the unsupervised classification are presented in Figure 7.

Figure 8. Results from the classification
