From Via Militaris to Ottoman Times: A Brief History and A Restoration Proposal for the Büyükkarıştıran Bridge

Keywords: Büyükkarıştıran Bridge, Restoration, Sinan the Architect, Via Militaris, Cultural Heritage

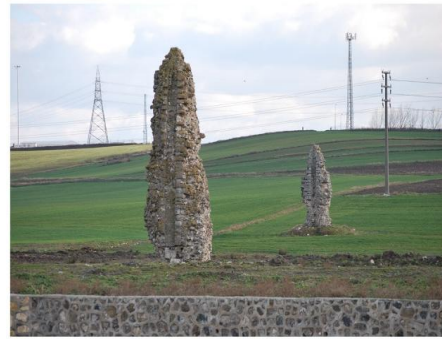
Figure 16. Water gauges in Büyükkarıştıran (Ayberkin, 2016).

Furthermore, relics belonging to three water gauges have been discovered, indicating the water transmission to the hammam building during surveys (see Fig. 16).

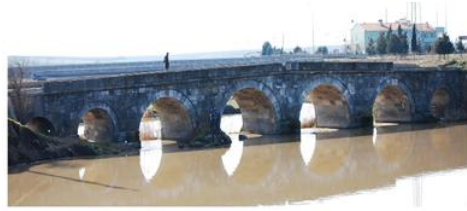
Figure 17. Büyükkarıştıran Bridge Northern side view (Ayberkin, 2017).

The Büyükkarıştıran Bridge is constructed with seven arches and boasts a total length of 45.32 meters and a total width of 5.40 meters. The bridge slabs are curved with a 5% slope on both sides, and the height of the largest arch varies from 3 meters to 4.50 meters. The arches are built 7 cm inwards from the spandrel walls. However, it is noted that the parapets of the bridge have been improperly renovated with concrete, resulting in a height of 0.45 meters (see Fig. 17).

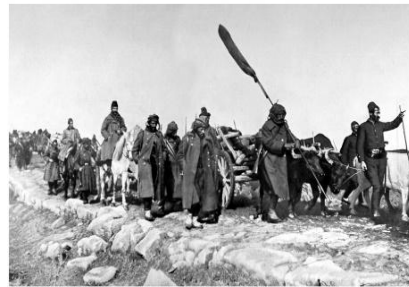
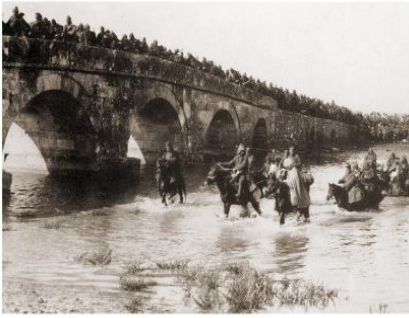
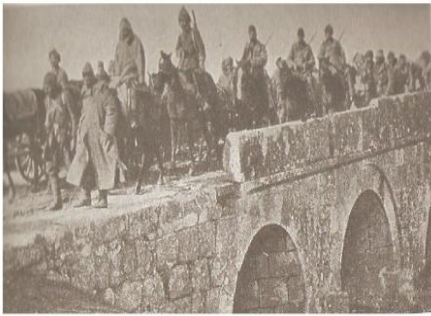
The first visual documentation of the structure dates back to a photograph from 1909, captured during the Balkan Wars.

Comparing the old photos with the current situation,

- Some parts of the bridge in the west direction are under the ground today,
- Cutwaters were complete,
- Parapets have been changed,
- The original marble floor coverings of the bridge were replaced,
- The elevation of the bridge's surroundings has been altered due to construction activities, leading to changes in the water level and subsequent soil accumulation around the bridge.
- Arches/Barrels are not deformed yet,
- The north facade (Upstream Facade) has different stones from today and thus undergoes a repair between 1912 and today,
- It was found that the first arch in the west direction of the Surveying Project, which is called Arch 1, did not have the arch spring profile in 1912, but it was added later.
