## Integration of Ottoman Baths with Contemporary Cultural Functions: The Case of the Zeyrek Tiled Bath and Museum

Tanrıverdi, Z. (2025). Integration of Ottoman Baths with Contemporary Cultural Functions: The Case of Zeyrek Tiled Bath and Museum. Cultural Heritage and Science, 6 (1), 78-91.

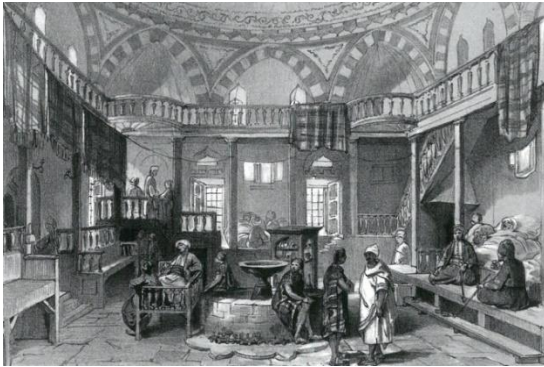
**Figure 1.** Tiled Bath Men's Cold Room engraving (11)

Lastly, it is important to note that the bath buildings were carefully designed with acoustics in mind. The plasters used in the construction had sound-retention properties, ensuring that the resonance within the space was optimized for the intended use (10) (Figure 1).

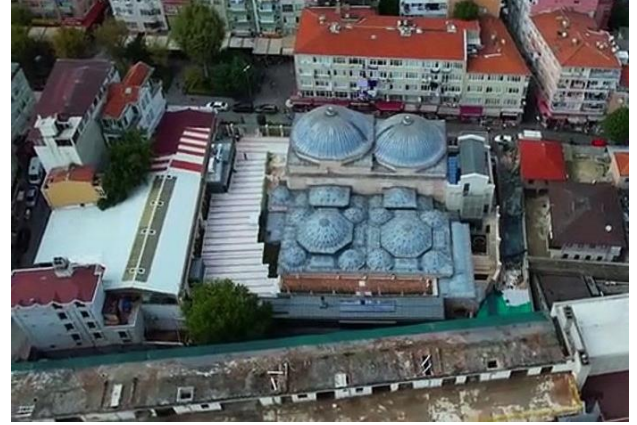
**Figure 5.** Zeyrek Tiled Bath and Museum aerial photograph <sup>2</sup>

The bath remained in active use until 2010. In that year, restoration efforts commenced under the Tiled Bath Conservation, Repair, and Sanitation Project, which

aimed not only to restore the physical structure but also to revive its cultural and social significance within the community, while preserving its original functions as a bath. After 13 years of meticulous work, the building was reopened, through the collaborative efforts of experts from various disciplines (28) (Figure 5).

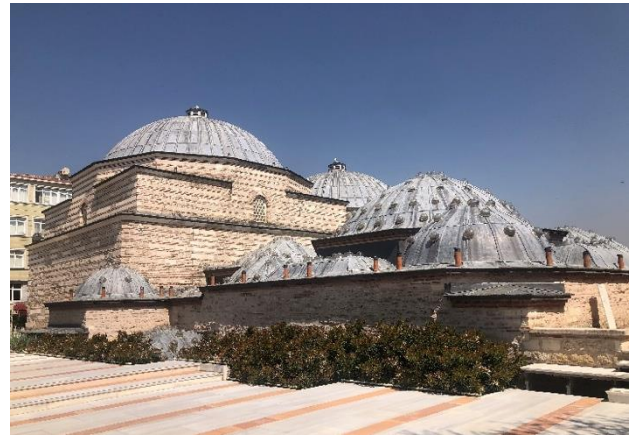
**Figure 6.** South-west facade of the bath (Photo: Author, 2025)

The masonry structure, constructed using the alternating stone and brick wall technique, is situated above cisterns dating to the Byzantine period (Figure 6).

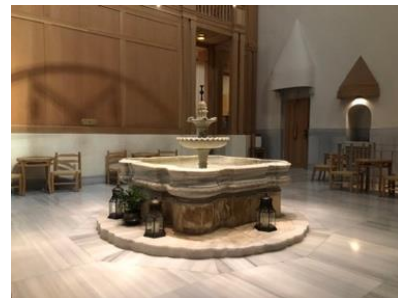
**Figure 8.** Fountain in men's cold room (Photo: Author, 2025)

Another notable example of stone ornamentation in Tiled Bath is the *kurnas*. A total of 52 marble *kurnas* have been identified in the bath. Those in the men's section are more robust and elaborately crafted than those in the women's section. The *kurnas* from the original construction feature chamfered edges and corners adorned with *muqarnas*, while those reflecting the Late Baroque and Empire styles exhibit varied forms, incorporating beveled edges or 'C'-shaped curves. Similarly, small arched niches designed for placing shoes (*başmak*) are arranged beneath the benches in both the women's and men's cold rooms (22).

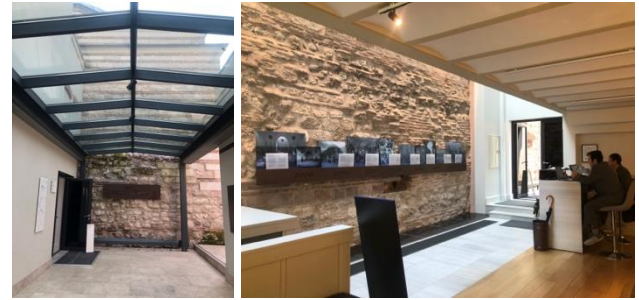
**Figure 12.** (a) Glass-covered hall b) The ticket sales entrance (Photo: Author, 2025)

such as soap, loincloths, towels, and souvenirs, in the sales area. They then proceed through a glass-covered hall to the side entrance for ticket sales, which grants access either to the baths or to the remains of the cistern and the museum (Figure 12).

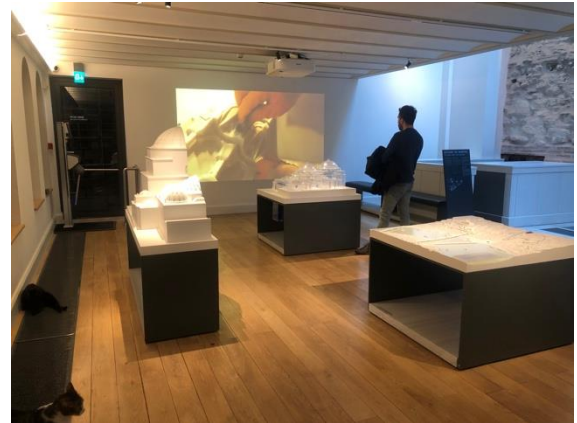
**Figure 13.** The foyer area of the museum (Photo: Author, 2025)

After completing the information and ticketing procedures, visitors can explore exhibition models illustrating the architectural and water systems of the bath, as well as the restoration process, through a wall projection in the foyer area (Figure 13). From this area, they can either visit the remains of the Byzantine Cistern uncovered during excavations beneath the bath, or proceed to the museum building, which was added later.

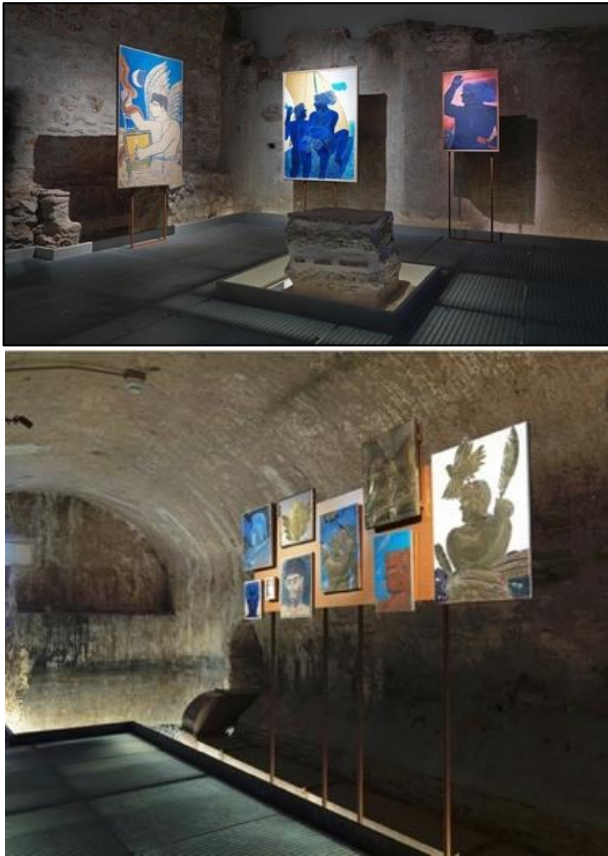
**Figure 14.** Alekos Fassianos, *Sailing to Byzantium* Exhibition in the cistern (Photo: Author, 2025)

piers. From here, they can proceed the second section, a vaulted tunnel passage. At the end of the passage, a small opening leads to the third vaulted chamber, where graffiti depicting galleys and galleons can be seen on the walls. These depictions have been interpreted as evidence linking the bath's construction to the Ottoman naval commander Barbaros Hayreddin Pasha, possibly created by galley convicts or levies under his command. Another prevailing interpretation suggests that this space was used as a warehouse or played a role in the construction of the building during the 16th century and in subsequent periods [28]. The remains of the cistern sections of the bath have also been repurposed for various temporary artistic and cultural events. For instance, in the exhibition *Sailing to Byzantium*, which opened to art lovers on October 24, 2024, the artist aimed to establish a dialogue between the multifaceted heritage of the baths and the cistern. The exhibition was well received by visitors, and was subsequently extended beyond its original closing date of December 31, to February 22, 2025 (Figure, 14).

On the other hand, the remains of the Byzantine cistern, uncovered during archaeological excavations as a part of bath's restoration process, along with the galleon graffiti found on its walls, intrigue many visitors. Additionally, the occasional hosting of temporary art exhibitions within the ruins significantly contributes to the promotion and utilization of the bath.

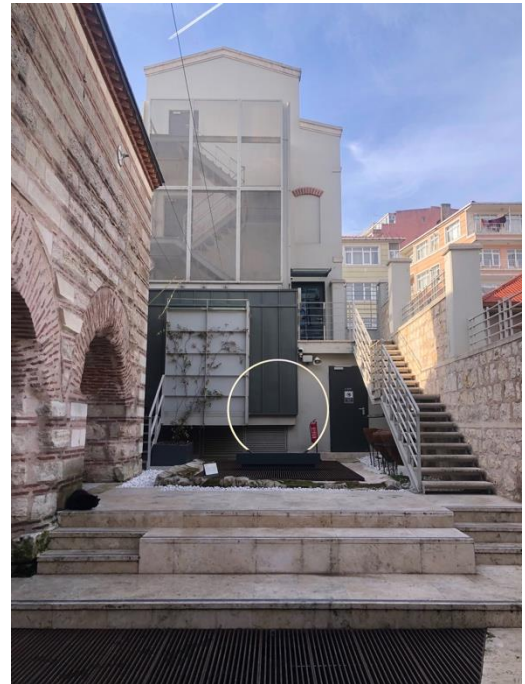
**Figure 15.** Symbolic representation of the bath water well (Photo: Author, 2025)

After footing the staircase, they encounter a symbolic water well—no longer extant and displayed in the open— as well as the original draw well beneath the iron railing (Figure 15). Wall niches along the path contain illuminated panels that explain how water was brought to the bath via the Kırkçeşme waterway and how it was distributed through the bath’s internal water system.

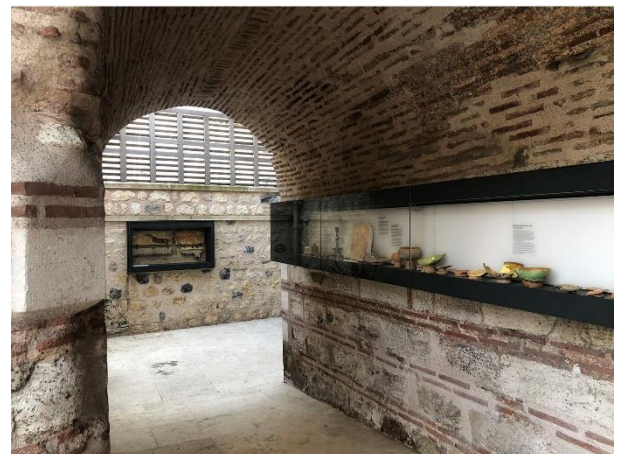
**Figure 16.** A vaulted ramp with archaeological findings displayed in glass cases (Photo: Author, 2025)

Next, visitors pass through a vaulted ramp, where archaeological findings uncovered during excavations are displayed in glass cases mounted along the walls, before reaching the entrance to the annex museum (Figure 16).

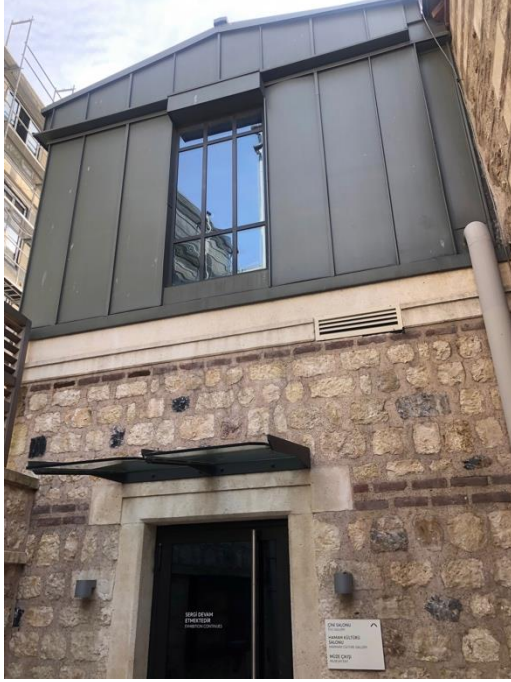
**Figure 17.** The entrance facade of the museum (Photo: Author, 2025)

The narrow, two-storey, rectangular museum annex is situated to the southeast of the main bath building. With its modest height, the use of rubble stone on the ground floor, and minimalist metal façade elements on the upper floor, the annex exemplifies an architectural approach that is both respectful of and harmonious with the historic structure. Access is provided through a single-leaf glass door (Figure 17).

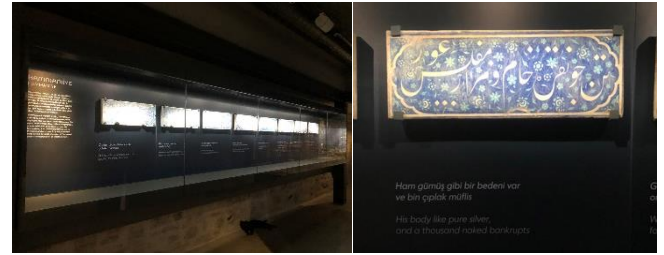
**Figure 19.** The *hamamiye* ceramic plates exhibition on the first floor (Photo: Author, 2025)

On the first floor of the museum, accessible via staircase, a section is dedicated to exhibition of the intangible cultural heritage associated with the bath culture. In this space, eight ceramic plates featuring *hamamiye* poems are displayed in glass showcases along the southeast wall, accompanied by Turkish translations presented beneath each plate. An analysis of the Persian poems reveals that their central theme is the bath (Figure 19).

The eight rectangular tiles were identified as part of a series inscribed with *Hamamiye* Persian poems that center on bathing culture. Beneath these tiles, *muqarnas* ornaments were discovered, suggesting that the tiles were installed in the 18th century, likely after the fires that had affected the baths. This finding raises the possibility that the *Hamamiye* tiles may have originated from another bath. However, experts who have conducted studies on this subject assert that the *Hamamiye* tiles do indeed belong to this bath. Nevertheless, they note that the tiles are not in their original locations, and several are missing [34]. As part of the restoration works, it was decided to reveal the original *muqarnas* texture beneath the *Hamamiye* tiles. Consequently, the tiles were removed from the wall and, following conservation efforts, were relocated to be displayed in the additional museum building (Figure 19).

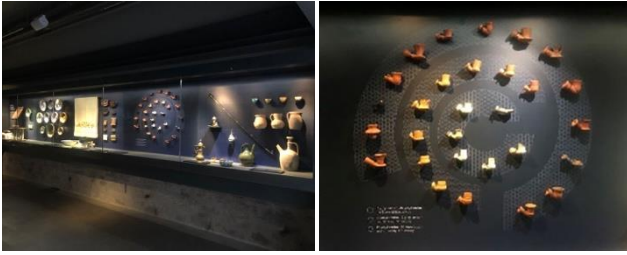
**Figure 21.** Ethnographic and archaeological artifacts exhibitions in glass showcase on the first floor (Photo: Author, 2025)

The continuation of the southeastern walls features glass showcases displaying ethnographic artifacts related to traditional bathing culture such as bath bowls, mirrors, and loincloths as well as small objects, including pipes and pottery, unearthed during archaeological excavations (Figure 21). On the opposite wall, visual and textural materials present depictions of baths from both Western and Ottoman archives, accompanied by explanatory panels.

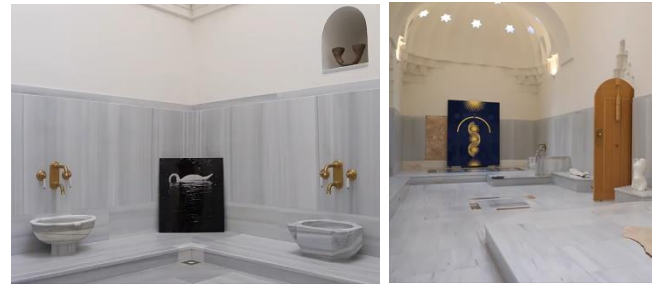
**Figure 23.** The *Healing Ruins* exhibition at Tiled Bath (Photo: Author, 2023)

Before the installation of the heating system and the conversion of the space into a bathing area, the exhibition *Healing Ruins*, inspired by the discovery and restoration of historical remains uncovered during the preservation of the bath, was presented to the people of Istanbul. The exhibition aimed to encourage visitors to reflect on the healing impact of restoring not only historical structures but also social and spiritual heritage. Open to the public in Istanbul from September 30 to November 30, the exhibition featured sculptures, paintings, photographs, and drawings by 22 artists from Turkey and abroad, displayed alongside site-specific sound and video installations within the bath (Figure 23).
