# Anadolu Araştırmaları Anatolian Research

## Appendix to the Byzantine Churches of Nikaia: Newly Discovered Building at the Iznik Tile Kilns Excavation

Recent research and archaeological excavations in Iznik, known as Nikaia in ancient times, have uncovered significant new findings from the Byzantine period. One of these findings is from the Iznik Tile Kilns excavation, which has provided detailed information on Ottoman tile and ceramic production techniques and processes for many years. During the excavation seasons from 2019 to 2024, the remains of a previously unknown Byzantine religious building were discovered adjacent to the kilns, differing from the general context of the excavations. The excavation area was utilized by Ottoman-era tile and ceramic workshops for many years. First, the workshops and then the modern residences built in the region after the workshops lost their function ruined the Byzantine structure. The excavations suggest that the building was likely the main church, with a side chapel located to its north. The main church suffered significant destruction due to the tile kilns established on its site during the Ottoman period, though part of its apse rema

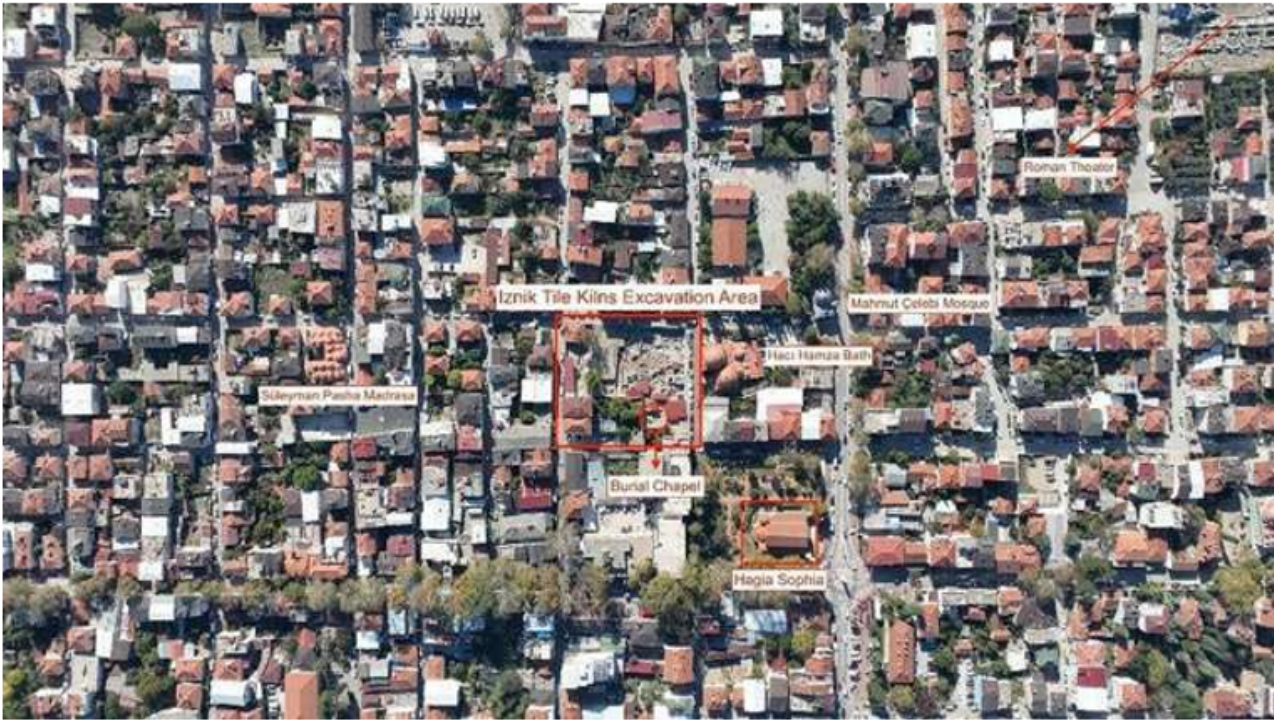
**Figure 1**

*Aerial photograph of the Iznik Tile Kilns Excavation area and its surroundings*

The Iznik Tile Kilns Excavation site is located near the ancient city center, to the east of the Baths of Murad II and close to the Church of Hagia Sophia (Figure 1). The earliest excavations in the area were initiated by Oktay Aslanapa in 1964. This site was used as a tile and ceramic workshop from the 14th century, when the Ottomans captured Iznik, until the end of the 17th century. Between 2019 and 2024, excavations revealed the ruins of a Byzantine building alongside evidence of ceramic workshops and production from the Ottoman period. This indicates that the excavation area has a complex history of use by various civilizations for diverse purposes. This study presents and evaluates the excavation phase, architecture, and small finds of the newly discovered ecclesiastical building.

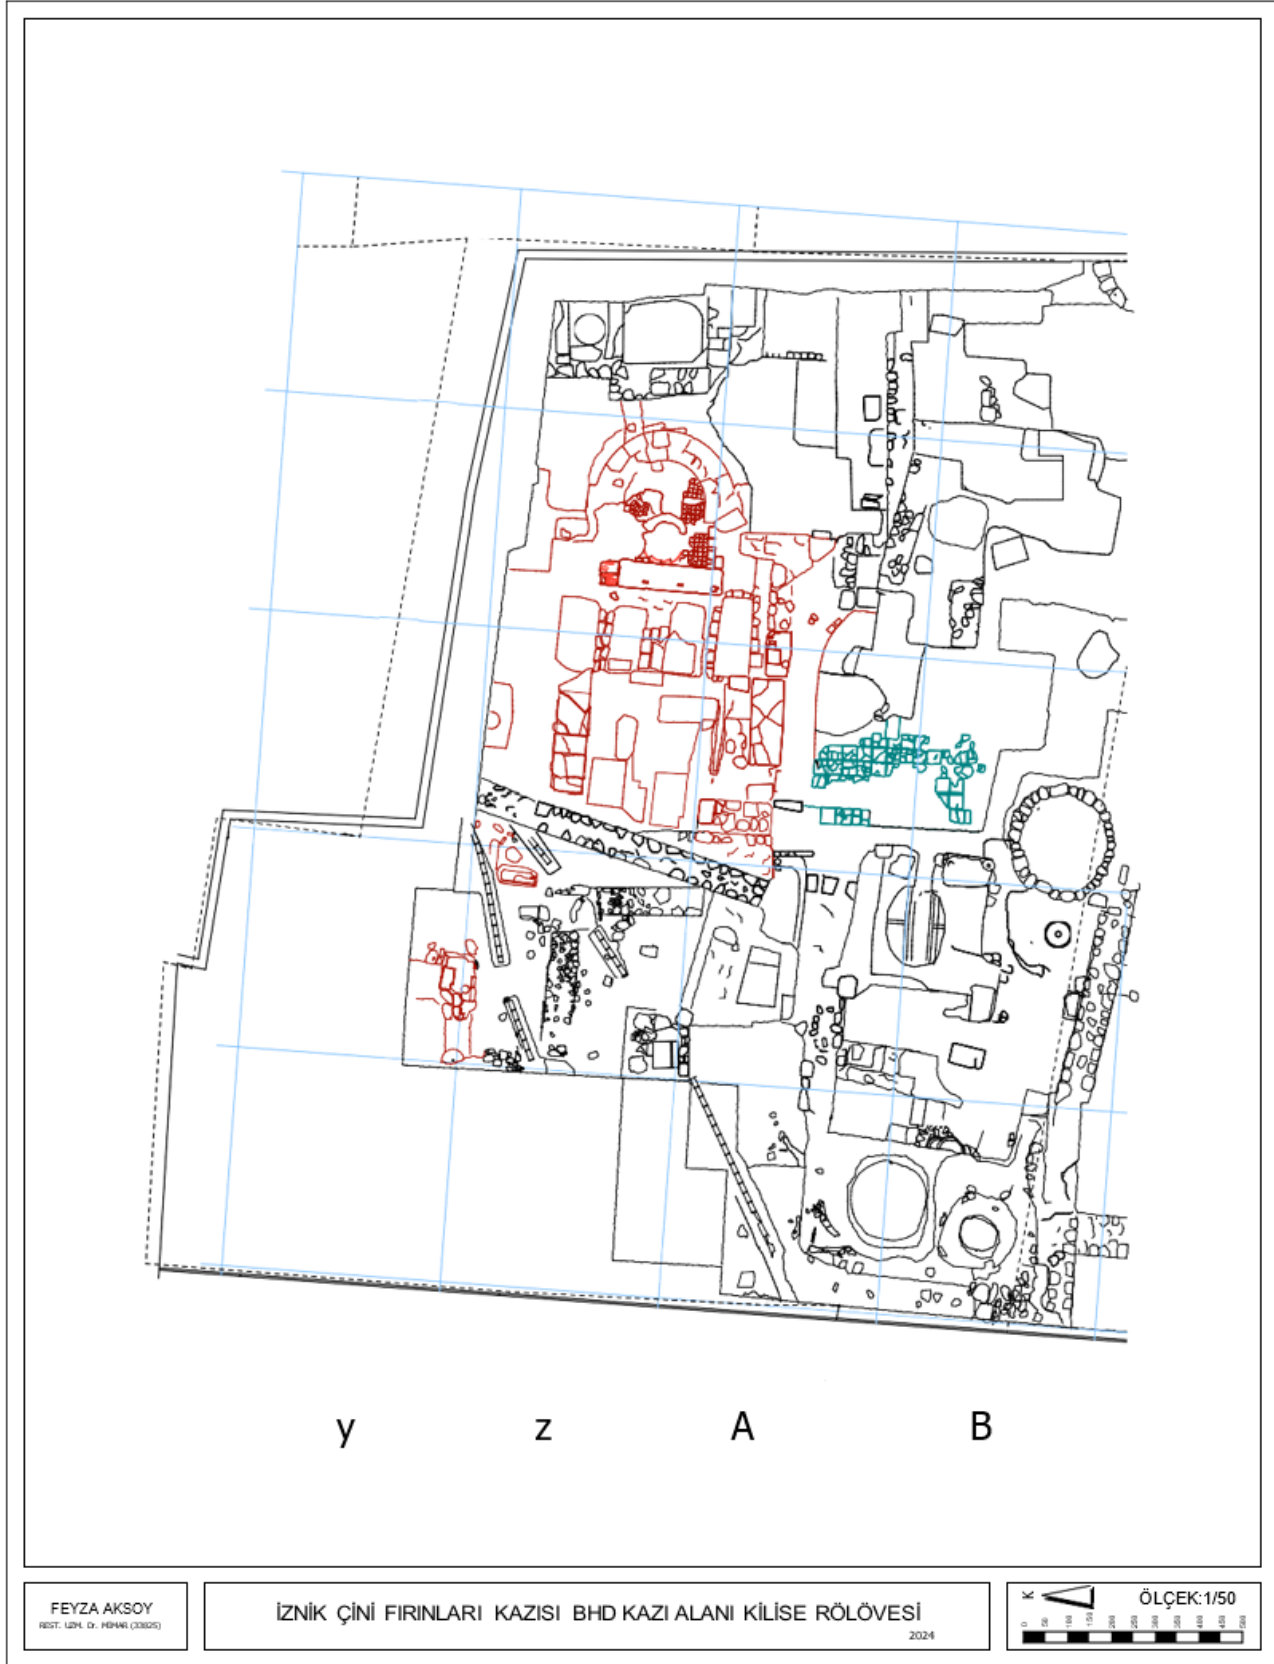
**Figure 3**

Plan of the remains of Byzantine buildings at the Iznik Tile Kilns Excavation site

Aerial photographs of the archaeological site reveal a structure that curves eastward, located next to the south wall of the chapel. Architectural data obtained from the excavations conducted between 2019 and 2024 suggest that this structure, likely the main church, was damaged by the construction of a group of ceramic kilns in the area during the Ottoman period. Consequently, only a small section of its apse has survived to the present day at a depth of -272 cm. Excavations to the north of these remains uncovered the apse and naos of the chapel at a depth of -280 cm (Figure 2 and Figure 3).

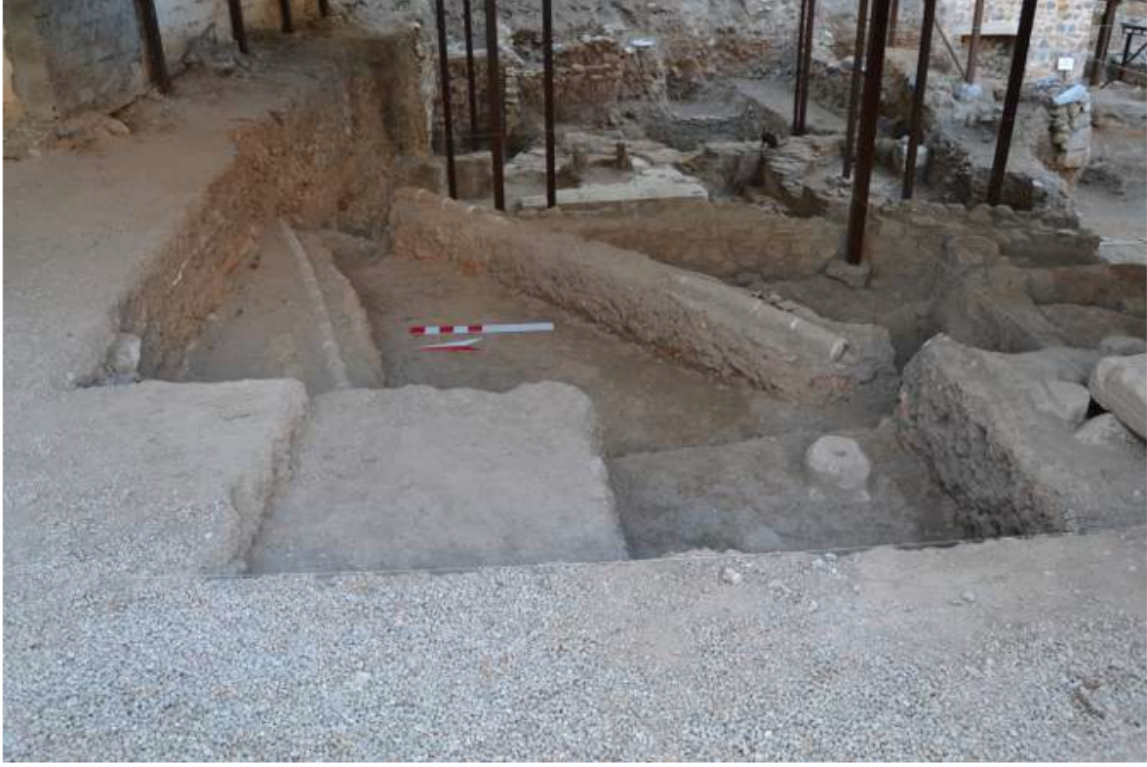
**Figure 5**

*The Ottoman and modern additions that damaged the narthex of the chapel, 2024*

The chapel, which is oriented east-west, was damaged by Ottoman-era kilns and modern houses, particularly their foundations and cesspits. Excavations uncovered findings related to the naos and apse. However, the area of the chapel's narthex did not produce any relevant data, as modern house foundations and terracotta water pipes from the Turkish period have destroyed this section (Figure 5). The surviving apse and naos of the chapel measure 515 cm in width and 550 cm in length. Most of the uncovered walls are at ground level, with the highest section reaching approximately 50 cm.

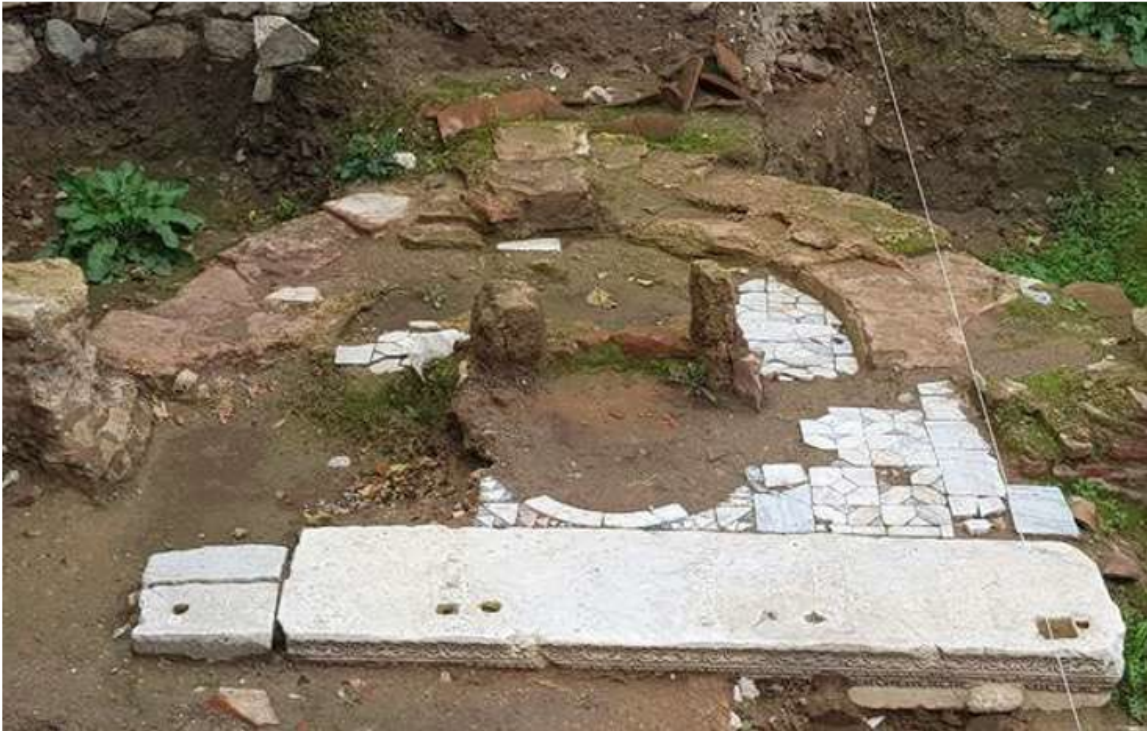
**Figure 6**

*Apse of the chapel and opus sectile pavement, 2022*

There is a semicircular apse to the east of the chapel, featuring an interior measuring 190 × 130 cm. The floor of the semicircular apse has an in-situ opus sectile pavement, which has been largely destroyed today (Demirsar Arlı, 2024: 392). There is a central discus with a diameter of 85 centimeters in the front part of the apse area. Although the interior of the discus is fragmented, the outer line made of white marble is partially intact. In the corner spaces of the panel containing the discus, there is a decoration of triangular stones of different sizes, placed toward the center with pointed ends (Figure 6).

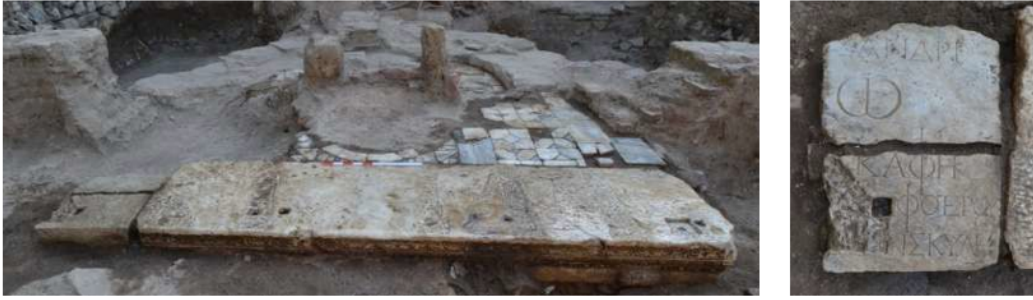
**Figure 8**

*Reused pieces, 2022*

The stylobate of the tempon, which separates the bema and naos of the chapel, consists of two spolia, with a total length of approximately 290 cm. One is the lid of a Roman sarcophagus, decorated with lotus and palmette motifs on one side (Figure 8). The other piece, inscribed with text, is a fragment of a 2nd century sarcophagus. Additionally, there is another inscribed fragment in the building, a piece of a 5th-6th centuries grave stele<sup>3</sup>, which was reused as spolia in the brick cist grave located next to the chapel's south wall (Figure 9).

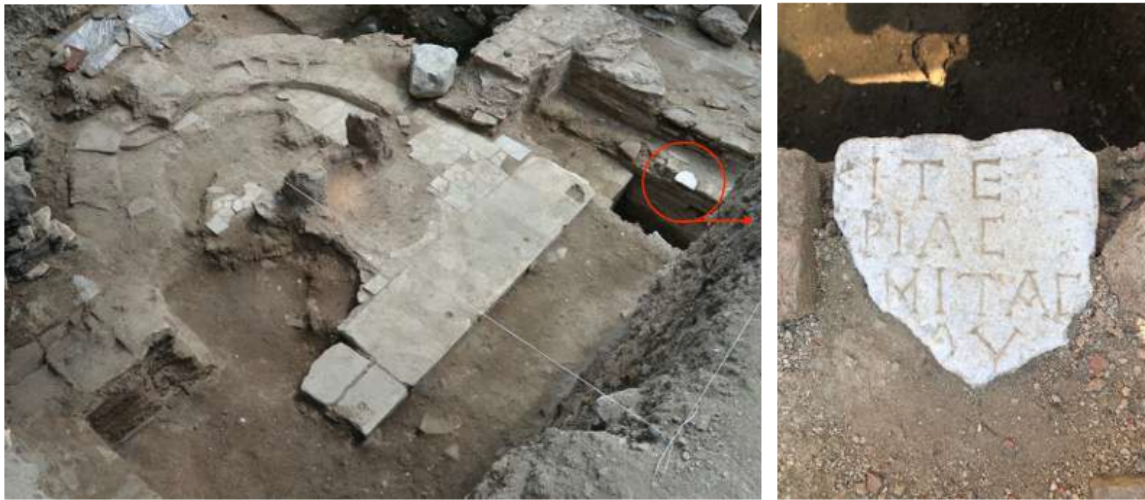
**Figure 9**

*Grave stele fragment reused in the brick cist grave*

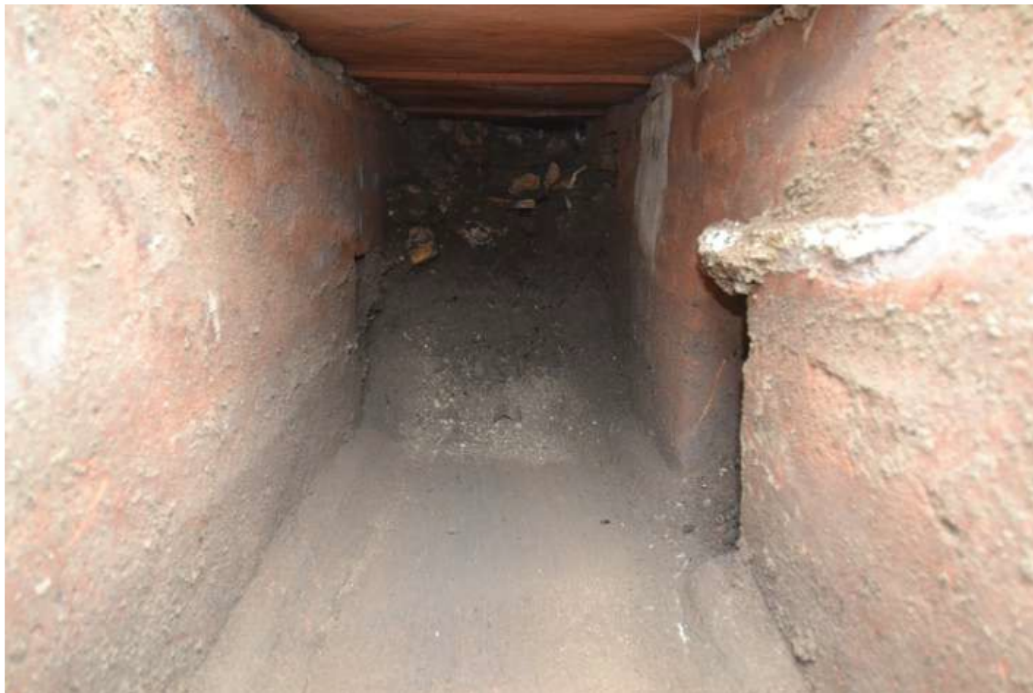
**Figure 10**

*Hydraulic plastered channel used as a burial area, 2023*

Numerous graves were discovered on the floor of the chapel's naos during its excavation. Some graves had stone lids, and some had terracotta lids. In addition, the inner part of the hydraulic plastered water channel, extending from north to south under the naos floor and probably dating back to the Roman period, was used as a burial area. (Figure 4 and Figure 10).

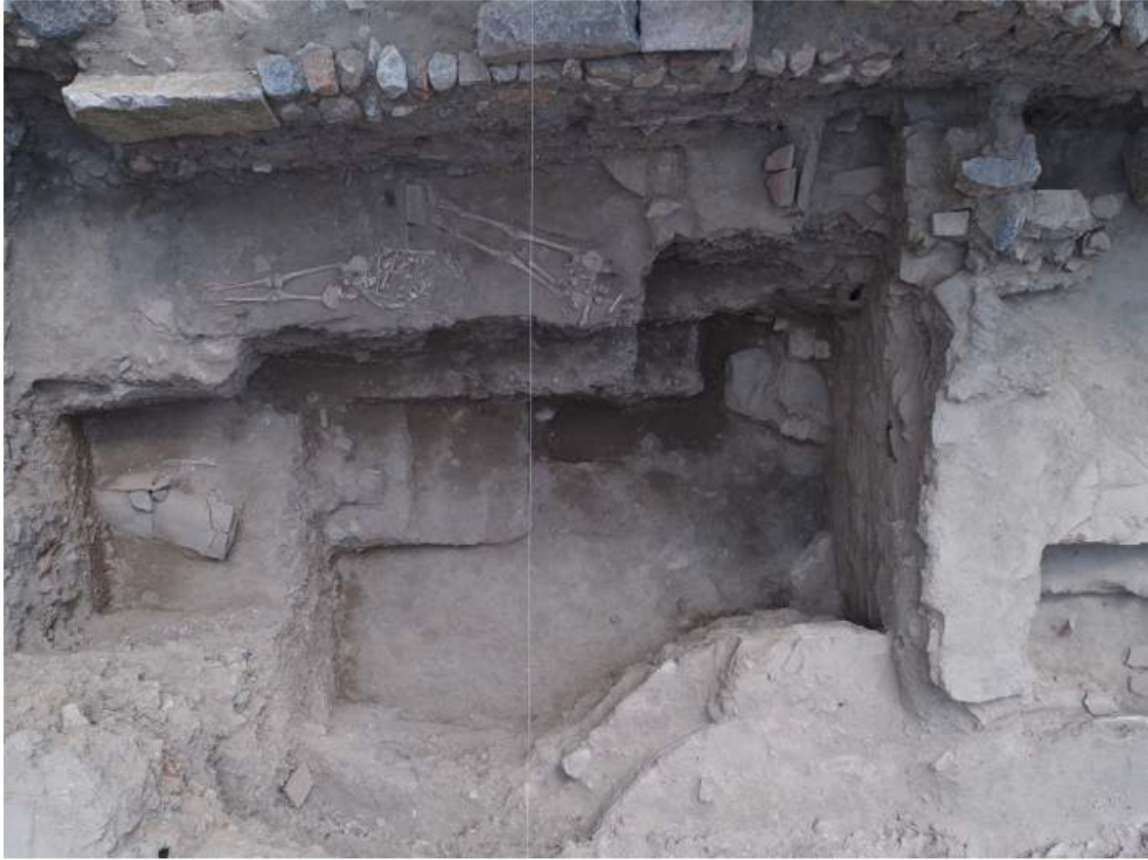
**Figure 12**

*Simple earth graves and roof tile graves in the southeast of the chapel ruin*

During the 2015 and 2016 excavation seasons, two graves were identified in pits directly opened into the soil in the southeast direction of the chapel. The skeletons of adult individuals were laid flat on their backs in these graves. The preserved bones of the skeletons are in the context of primary burial and completely preserve their anatomical posture. The posture of the skeletons and the position of the bones indicate that the pit was filled with soil after the body was placed inside it. In addition, two tile graves were identified. With the discovery of the chapel and the likely main church in the following years, it was realized that these graves were also related to this religious structure (Figure 12). The convex roof tiles used in the graves, which were recovered intact during the excavation and measured 58 cm high, 33 cm wide at the top, 37 cm wide at the middle, 35 cm wide at the bottom, and 2.5 cm thick<sup>5</sup>.

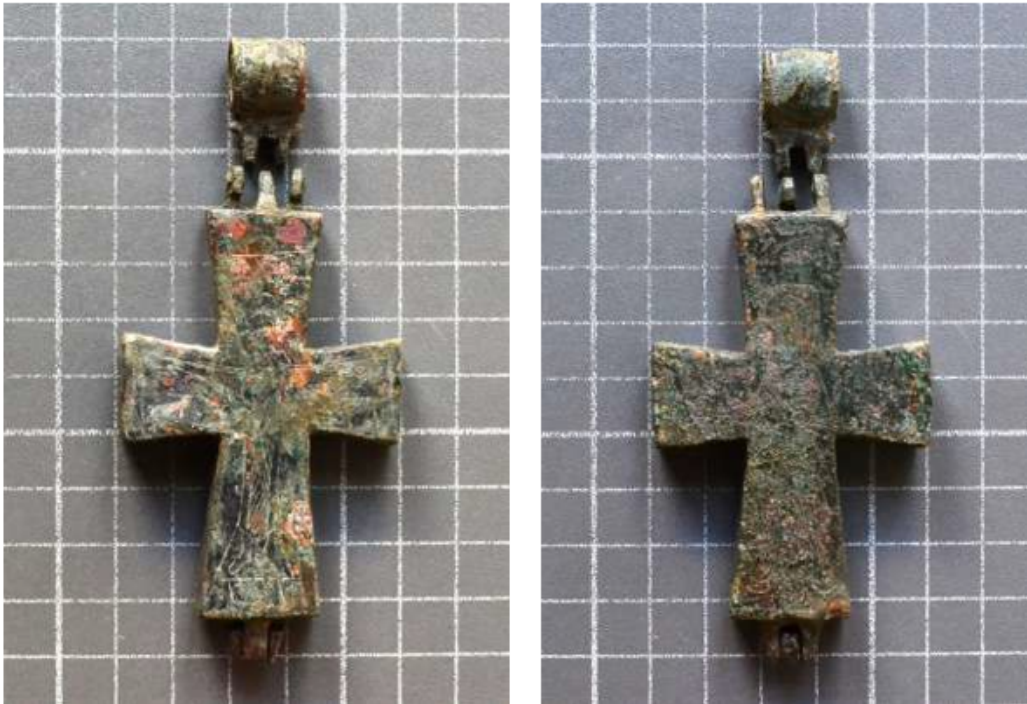
**Figure 13**

*A reliquary cross depicting Christ and the Virgin Orans*

Three copper-alloy reliquary crosses were discovered, each shaped a Latin cross. In the complete reliquary, the cross is hinged at both the top and bottom, with a hanging loop at the top. Although corrosion complicates identification, the reliquary features engravings on both the front and back. The front side depicts the Crucifixion, with Christ dressed in a colobium. Above his head is a simple tabula ansata inscribed with the letters X. On the reverse side, there is an image of the Virgin Mary praying with her hands outstretched in the Orans pose (Figure 13).

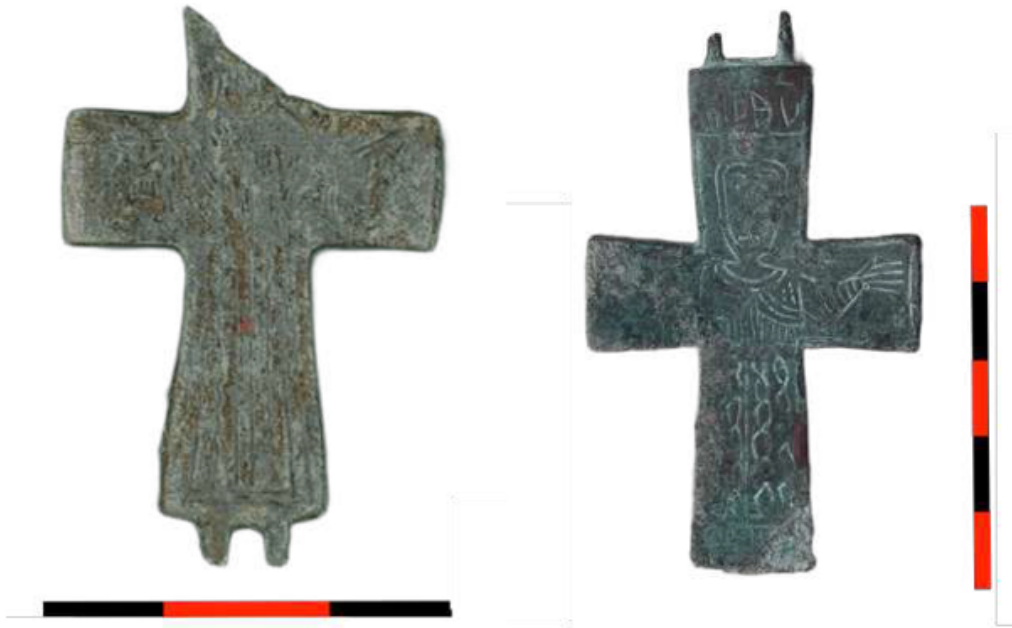
**Figure 14***Pieces of reliquary crosses*

One of the cross reliquaries has a broken upper vertical arm, resulting in the head of the figure in the orans gesture engraved on the reliquary being missing. The other reliquary cross, found during the excavation of the narthex, depicts the Virgin Mary in the orans position. Above the figure is the inscription *MP ΘΥ*, an abbreviation for *Mather Theou* (Mother of God) (Figure 14).

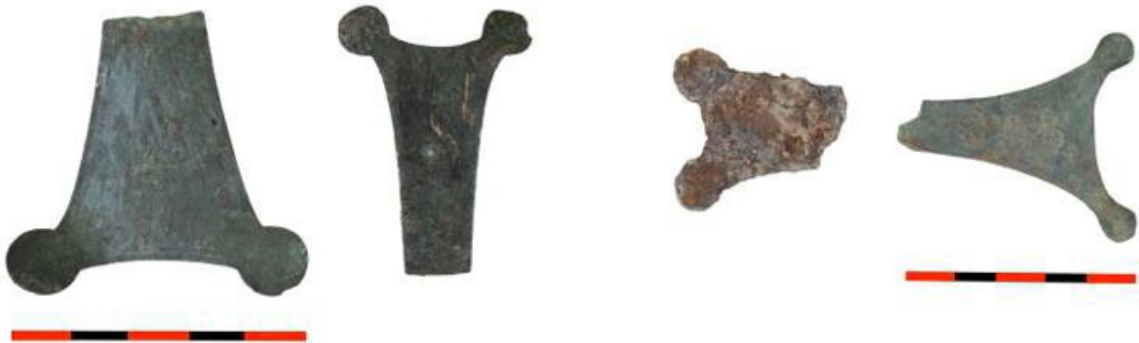
**Figure 15***Pieces of different crosses*

During the excavation of the chapel, four crosses made of copper alloy were discovered (Figure 15). Each cross arm extends and widens outward from the center. Three of the cross arm pieces feature flat circular discs in the corners, while the other has bulbs in the corners. One of the cross arms has unidentified markings. The edges of another cross arm have two rows of incised lines, and that arm features a small hole in its lower part. This hole, used to hang pandelia, indicates that this arm is the horizontal arm of the cross. Pandelia is an attribute indicating ceremonial use<sup>8</sup> (Sandin, 1992: 10). The small, portable crosses found during excavations at the Iznik Tile Kilns may have been used for consecration or liturgy by the clergy (Galavaris, 1994: 96).

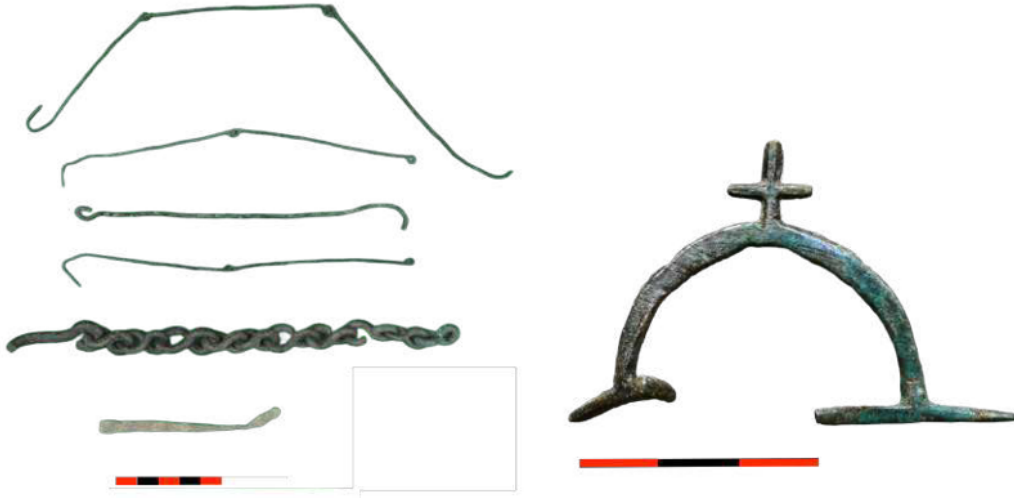
**Figure 16**  
*Metal findings*

Other metal finds include hangers, a chain, and a handle. The chain, made of copper alloy, was likely used to carry or hang items (Figure 16)<sup>9</sup>. Another metal piece, also crafted from copper alloy, is identified as a handle based on its shape, although the specific vessel it belongs to remains unknown. This semicircular sherd features a small cruciform handle at the apex, with the two sides of the circle flattened to project outward<sup>10</sup>. Additionally, three long metal rods with round sections are connected by a chain and have shorter hooks. These metal hangers, in the form of hooks, were commonly used in glass oil lamps<sup>11</sup> (Figure 16). Glass sherds were discovered during the excavation of the chapel. Only one of these fragments has a distinct handle and may have belonged to a glass lamp (Figure 17).

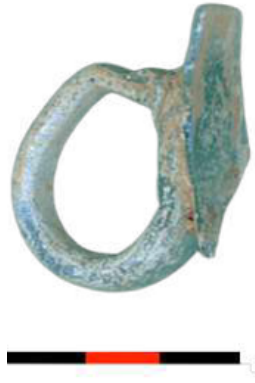
**Figure 17**  
*Glass handle piece*

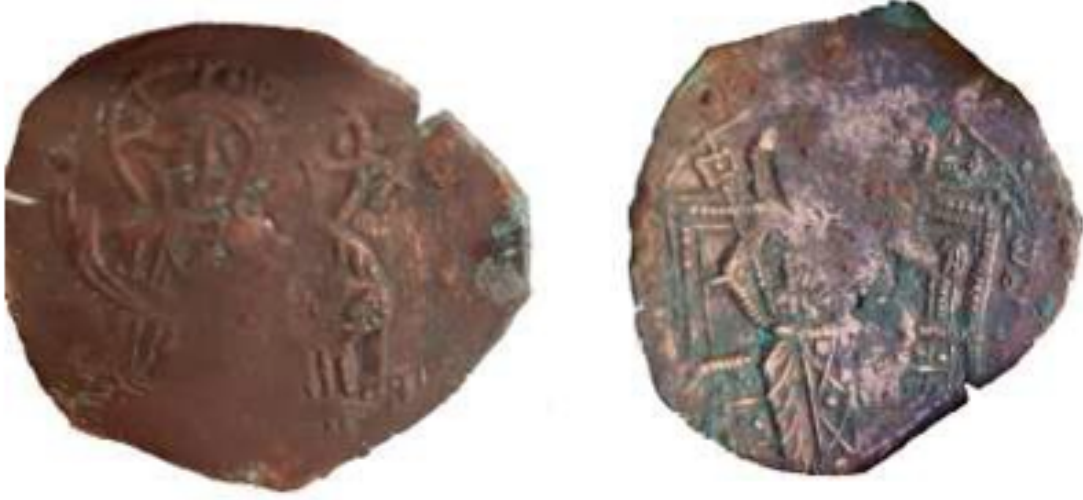
**Figure 18**

*Copper trachea of Michael VIII Palaiologos*

A pair of slightly corroded copper coins, believed to have been minted in Constantinople, was discovered during the excavations. The obverse of one coin depicts a bearded Christ wearing a tunic and a cross nimbus, with his right hand raised in a blessing position and “XC” visible. The reverse features the emperor seated

on a high-backed throne, holding a labarum in his right hand and a globus in his left. Based on the legible inscription on the left side of the reverse, this coin is attributed to Michael VIII Palaiologos<sup>12</sup> (Figure 18).

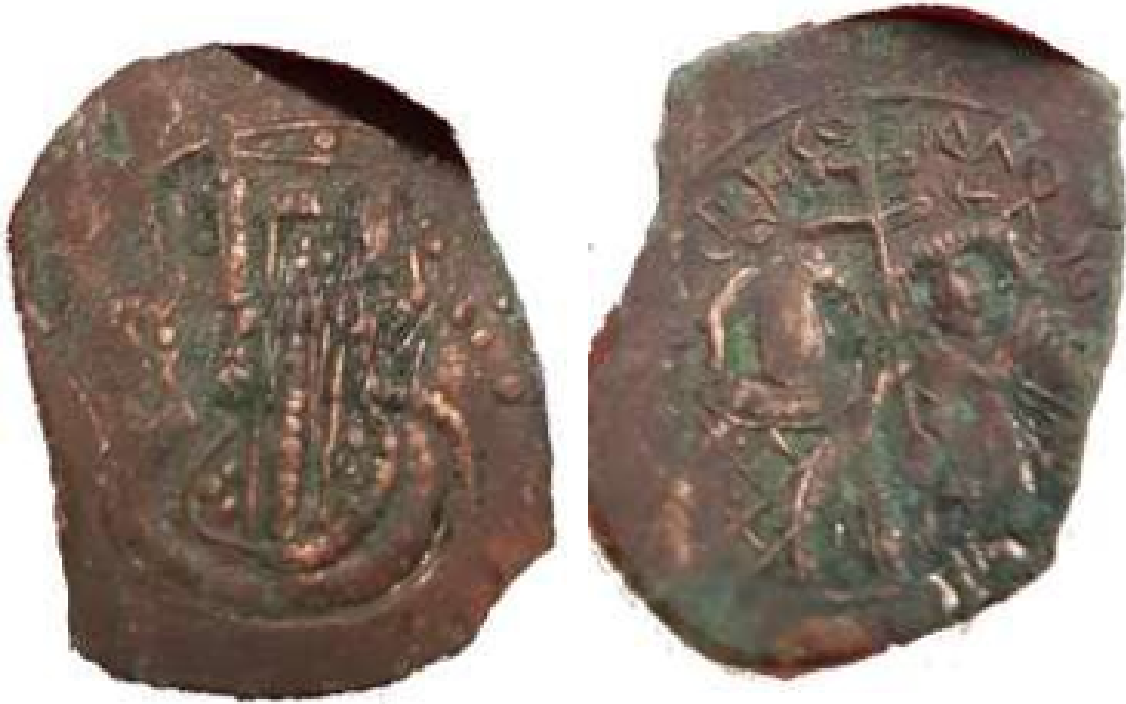
**Figure 19**

*Coin of Michael VIII Palaiologos and Andronicus II*

The obverse of the other coin shows an elaborate labarum resting on a crescent-shaped cushion, while the reverse displays two emperors holding a patriarchal cross between them<sup>13</sup>. This coin is dated to the reign of Emperor Michael VIII Palaiologos and Andronicus II (Figure 19).
