## Damage and Interventions to Historical Masonry Buildings: Good and Ill Practices

Elizabeth VINTZILEOU<sup>1\*</sup><sup>1</sup> National Technical University of Athens, Greece, [elvintz@central.ntua.gr](mailto:elvintz@central.ntua.gr), Orcid No: 0000-0002-4891-7091

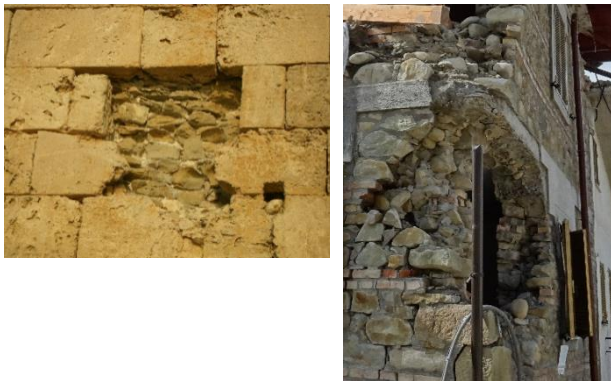
Figure 1. Typical construction typologies of stone masonries in Greece, Italy and Türkiye

There is a vast variety of construction typologies of masonry, both on the faces of bearing elements and within their thickness. Quite frequently, the exterior face of masonry is of more elaborate construction than the interior one and it remains unplastered. Therefore, within the thickness, there are two leaves of different construction typology either in contact between them (two-leaf masonry) or with a space between them (three-leaf masonry). That space may be of more or less solid structure, made of small stones and large mortar quantity. As a rule, the exterior leaves of masonry are not transversely connected, using header stones (Fig. 1).

The seismic vulnerability of those construction typologies is two-fold: (a) The material filling the space between the two exterior leaves of masonry being of poor mechanical properties, the actual resisting thickness of the masonry elements is substantially smaller than their nominal thickness. Thus, the bearing capacity in compression, shear and out-of-plane bending is significantly reduced as compared to a solid wall of the same thickness. More

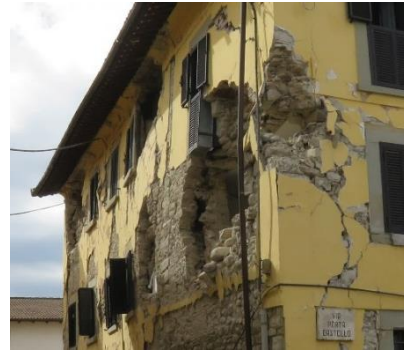
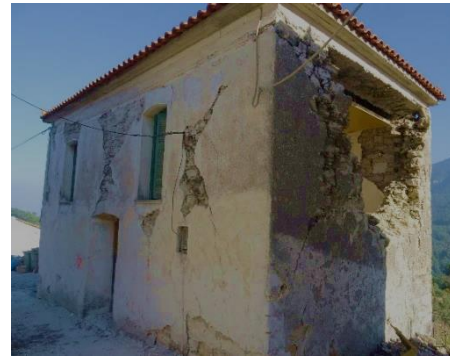
Figure 2. Delamination of three-leaf masonry and damage due to seismic actions in Amatrice and in Samos

importantly, (b) the weak bond between the exterior leaves and the filling material can be broken, either due to decay or due to previous even small to moderate earthquakes. Thus, with the masonry transversely delaminated, the bearing elements become more slender, the exterior leaves resist the seismic action separately from one another, both in- and out-of-their plane. The consequence of this behaviour was repeatedly observed after strong earthquakes (Fig. 1 and Fig. 2).

Thanks to the improved bond of masonry materials within the thickness of the bearing elements, delamination of masonry is significantly delayed or avoided and the severe damages shown in Figs 1 and 2 are prevented.

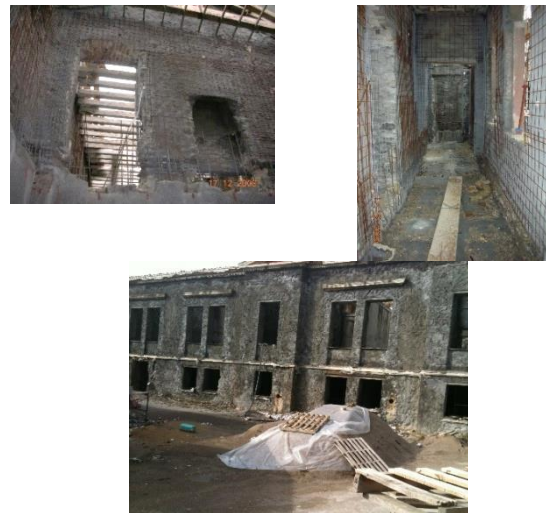
Figure 6. RC jacket applications in listed stone masonry buildings in Greece

Another technique, frequently applied in the past and currently prohibited by the competent authorities in several countries, is RC jacketing of stone masonry walls. In addition to the obvious reason of the harm caused by jacketing to the aesthetic and architectural values of historical buildings (Fig. 6), there are further reasons that justify the exclusion of this intervention, namely, the increase of the mass of the building, the radical change of the movement of moisture and vapour within walls enclosed in concrete (leading with time to the disintegration of masonry), the limited efficiency of one-sided RC jackets, usually applied in the interior of the building, etc. The need of bridging the gap between the targeted and the available bearing capacity can be served by alternative techniques (e.g., transforming partition walls to bearing ones, providing a new internal bearing system, constructing external buttresses, etc.) to be selected on a case-by-case basis. Last but not least, the new use of a historical building should be compatible with the potential of the structural system to safely host it, after due rehabilitation, respecting the values to be preserved.

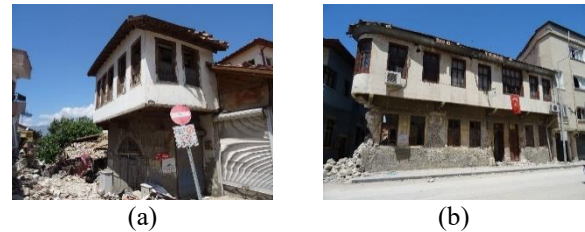
Figure 8. The historical structural system of Antakya

The historical system combining stone masonry at the lower story and timber-framed masonry at the upper story is found in a number of buildings in Antakya (Figure 8). This structural system is reported to behave reasonably well after several earthquakes. For example, Bal and Vatan [23] report on the survival of buildings made according to the historical structural system, in contrast to modern buildings in the same area. This is confirmed by Gülhan and Güney [24], who have report on their study in Kocaeli and Sakarya, after the 1999 Marmara earthquake.

However, in several cases, the damage typical to this building typology were observed, namely, severe cracking

or partial collapse of the stone masonry at the ground storey (Fig. 8b), loosening of connections between timber elements, damage to masonry filling the timber frames, etc. (see also [3]). It is admitted that the severity of damage depends on several parameters, such as the quality of stone masonry (quality of materials and construction typology), the level of elaboration of the timber-framed walls (in terms of arrangement of timber elements and their connections), as well as on the state of preservation (maintenance included).

As for the upper storeys, adequate interventions are to be chosen, depending on the state of timber-masonry. Thus, extensive biological attack of timber elements or large residual deformations may lead to the need of partial or complete reconstruction. If the state of preservation is, in general, good, local damages of filling masonry may be repaired, loose connections are to be improved (e.g., using metal plates nailed on joints), etc. In other cases, e.g., in buildings like the one shown in Figure 8b, interventions may need to be limited to the lower storey.
