## Historical Transformation of Cultural Heritage Conservation Policies in Turkey with Special Reference to Çemberlitaş Hamam (1951-2004)

### Abstract

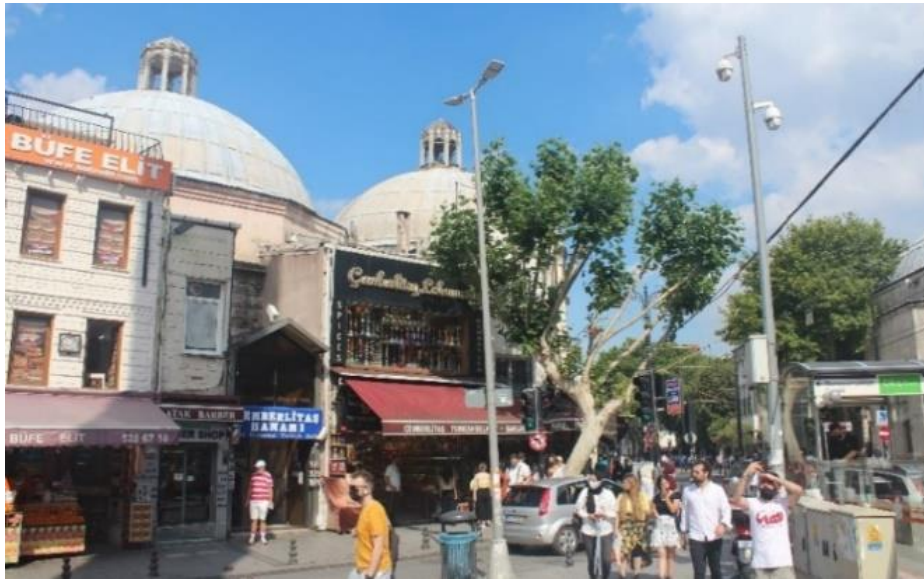
*Figure 2. Çemberlitaş Hamam entrance façade on Vezirhan Street (2021)*

Çemberlitaş Hamam is on Vezirhan Street, Molla Fenari Neighborhood, Fatih District, Istanbul Province (Figure 1). The bath, which is close to the square where the Roman Çemberlitaş Column is located, which gives its name to the bath and neighborhood, has a façade on Divanyolu Street, which has been the city's main street in every period [1]. The bath is surrounded by many cultural properties belonging to different periods. This has obscured other parts of the bath from the outside, except for the masses of the dressing room (Figure 2).

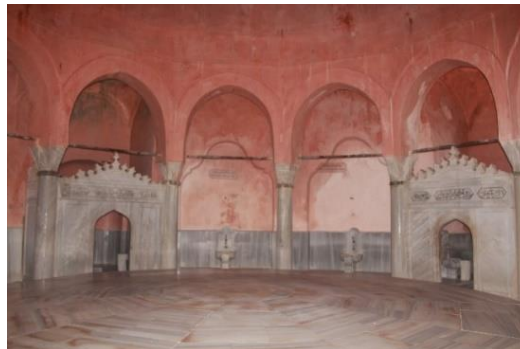
**Figure 5.** Men's bath sıcaklık (2022)

The square-planned dressing room (soyunmalık), which is entered through a crown door with a flat arched door and an inscription on it, is covered with a dome resting on trumpets. In the center of the dome is a circular skylight covered with a light lantern. The rectangular warm room (ılıkılık) is covered with two domes resting on pendentives. One of the narrow sides of the space leads to the shaving room (usturalık), which is covered with a dome resting on tromps, and the other leads to the latrine (hela) attached to the outside of the bath mass. The hot room (sıcaklık), which Cichocki describes as “the heart of the bath”, has a plan scheme that is not encountered in traditional Turkish baths [5]. The dome in the center of the externally square-planned space is carried by arches resting on twelve columns. Under this dome is a large, heated stone (göbektaşı) in the form of dodecagon. At the corners of the space, four private cells (halvet) are covered with a dome. The spaces between the columns in front of these halvets are covered with triangular pedimented marble walls with couplets carved on them (Figure 5). The creation of a large and spacious temperate space by leaving the upper part of these walls open is an innovation that Mimar Sinan brought to Turkish baths [6]. Except for the column intervals where the transition to this space is provided, bathing benches (seki) and water basins (kurna) are in the intervals.

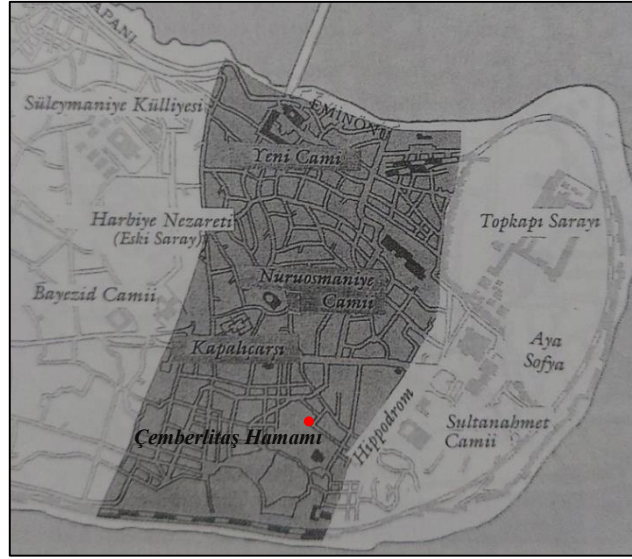
**Figure 6.** The location of Çemberlitaş Hamam in the area affected by the Hocapaşa fire of 1865 [14]

During the Ottoman period, many wooden residential buildings, mosques and madrasahs were around Çemberlitaş, but many fires in the region damaged these structures [13]. In 1865, the area was affected by the Hocapaşa fire (Figure 6), the biggest fire in the history of Istanbul, and was reorganized by the Islahat-ı Turuk Commission, which was established in 1869. With the idea of opening the area around the Çemberlitaş Column, houses and other structures left behind from the fire were demolished, and Divanyolu Street was widened by nineteen meters [14]. With this widening work, the corner of the square-planned women's soyunmalık mass of the Çemberlitaş Hamam and part of its dome were cut off and covered with a façade [1] (Figure 7), reflecting the architectural understanding of that period. It can be seen in the photographs of the period that two shops were added in front of the new façade facing Divanyolu Street (Figure 8). These additions made a recess in the women's bath's soyunmalık space up to the level of the beginning of the trumpet and this recess was organized as a resting area for distinguished visitors, accessed by a wooden staircase [3].

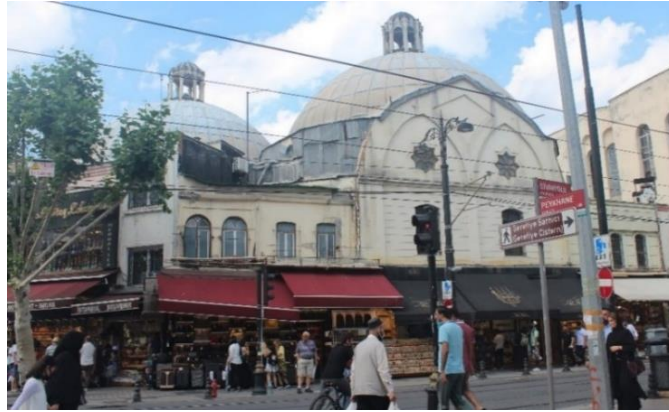
**Figure 7.** Çemberlitaş Hamam women's soyunmalık façade (2021)

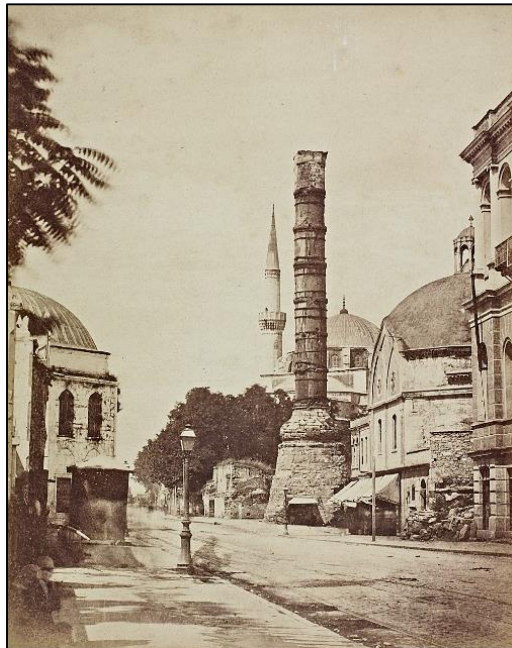
**Figure 8.** Women's soyunmalık façade of Çemberlitaş Hamam in 1894 [15]

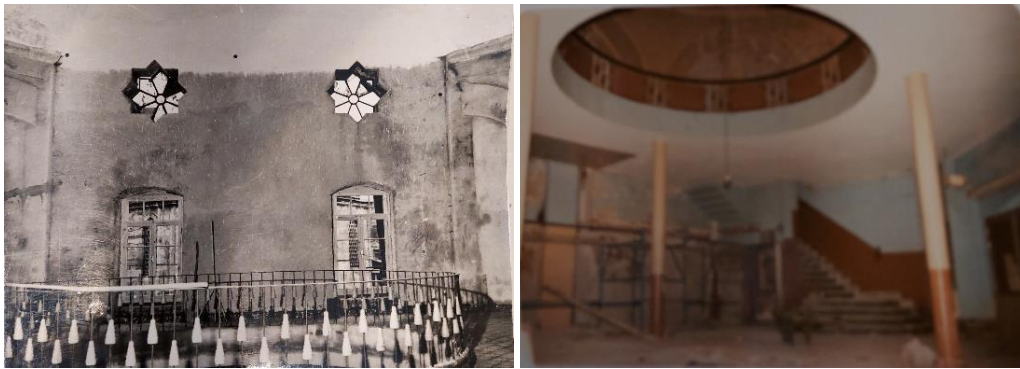
**Figure 9.** The women’s soyunmalık space mezzanine (1967) and ground floor (1986) [28]

With a petition sent to GEEAYK in 1965, it was reported that the women’s baths’ soyunmalık had been vandalized to convert it into a shop. After the on-site investigations made from this petition, it was determined the space’s original floor, which was previously used as a warehouse, would be removed and columns, two floors and stairs were added on reinforced concrete foundations. One of these floors was in the form of a mezzanine with a circular space in the middle, the other was arranged on the same level with the shops on Divanyolu Street (Figure 9) and a basement floor was created (Figure 10). With the removal of the walls between the shops and soyunmalık, a connection was established between these spaces. In GEEAYK decision no. 3156 dated June 4, 1966, it was decided that these interventions, which caused the destruction of the space’s original elements in question and permanent change, were not objectionable, but it was decided to stop them and submit their projects to the council. In GEEAYK decisions no. 3578 dated July 30, 1967 and no. 4410 January 12, 1969, it was decided that the reinforced concrete mezzanine added to this space could be used without any partition. Although the decision also stated the interventions in the space were by the project submitted to the council, the additional basement floor was not included. This situation showed that inspections were not carried out sufficiently or the issue was ignored. A newspaper article dated 1968 reported that, with these alterations carried out in the women’s soyunmalık space of Çemberlitaş Hamam, this section started to be used as a restaurant [27].

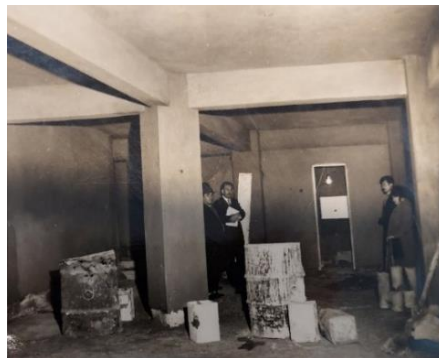
**Figure 10.** The basement floor added to the women’s soyunmalık (1967) [28]

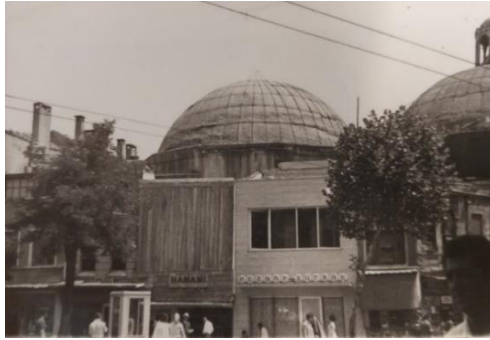
**Figure 11.** Reinforced concrete addition in front of the entrance of Çemberlitaş Hamam (1969) [28]

The project, report and photographs prepared by the owners of the men's section, which served as a single bath with its original function, were submitted to GEEAYK in 1968 as part of the restoration request. It was stated the interventions included arrangement of this section's entrance, removal of the dilapidated wooden cabinet (şirvan) in the soyunmalık and its replacement with a three-story building with a basement, renovation of the hela and tıraşlık to meet the requirements of modern life, repair of the dilapidated hypocaust brick piers of the sıcaklık, and renovation of parts of the surface coatings in need of repair. In GEEAYK decision no. 5383 dated 10.5.1970, the restoration proposal project was deemed inappropriate and a measured drawing of the section requiring intervention was requested. In the decision, it was stated that, of the interventions planned to be made, only the structure to be added to the men's soyunmalık was deemed appropriate, provided it did not exceed two storeys, and it was decided to send a new project in this direction. In GEEAYK decision no. 6449 dated May 13, 1972, regarding the restoration project prepared after this decision, the addition in question was deemed appropriate. In the decision, it was decided to preserve the original coatings and elements of the men's bath, complete the deficiencies, add a passage opening between the men's and women's sıcaklık due to the desire to use the women's sıcaklık space, and remove the two-story reinforced concrete annex (Figure 11) added in front of the men's bath entrance without council permission. Photographs from 1969 show the alterations planned for the men's soyunmalık were started before this council decision (Figure 12). In this decision, which does not cover the entire bath, the reinforced concrete construction of the two floors added to the soyunmalık and acceptance of opening a passage to allow the sıcaklıks to be used together was an intervention that damaged the bath structurally. Although it contained more information on preservation and repair than previous decisions, by specifying the surface coatings and architectural elements to be preserved and completed, it did not mention the practical details.

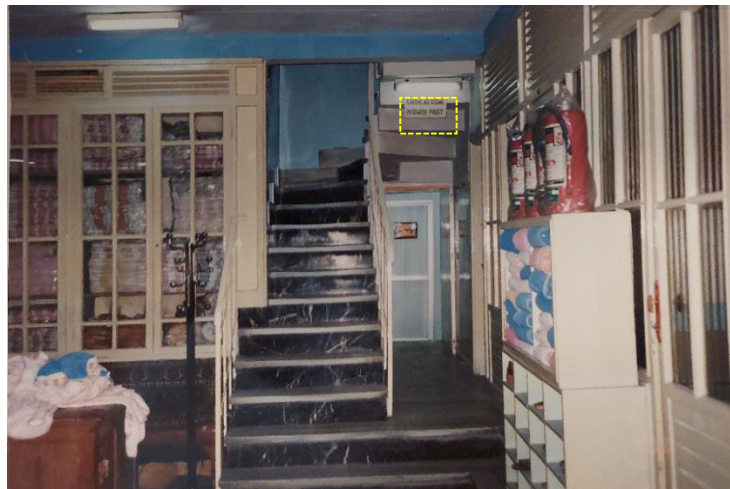
**Figure 13.** A signboard showing the transition to the women's bath (1993) [28]

Approximately four years after decision no. 1249, on June 7, 1993, the measured drawing of the bath, which was submitted to council, was accepted with decision no. 4661 dated June 11, 1993, by the Istanbul KTVKK No. I, it was decided to submit the application project of the bath to the council. From the photographs sent with these measured drawings, it is understood the women's section of the bath was opened for use (Figure 13).

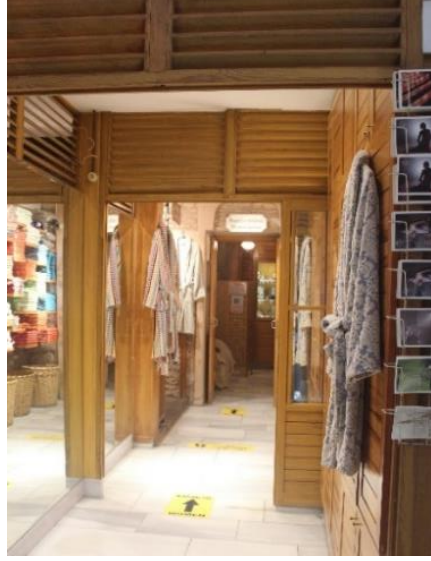
**Figure 16.** Transition from the men's soyunmalık to the women's bath (2021)

In line with decision no. 12065, the men's soyunmalık was rearranged and the transition to the women's bath was provided with a short passage (Figure 16), while the opening added to the corner of the men's soyunmalık in line with decision no. 4737 was closed. The reinforced concrete gallery floor with circular cavities was removed from the women's soyunmalık and a two-story reinforced concrete gallery floor similar to the men's soyunmalık was added, the floor level was rearranged, the floor was covered with marble, and an ornamental pool was added in the middle of the space (Figure 17). In Glück's plan (Figure 3), the original benches and wooden şirvan in this space [3] were not included in the restoration project and implementation. The transition from this space to the ılıklik was achieved by reopening the original passage that was previously closed. In the restoration project attached to decision no. 4737 (Figure 14) and in the photographs from 1993 (Figure 18), it was seen there are original latrines in the men's bath. Despite GEEAYK decision no. 6449 dated 1972, stipulating preservation of the originality of the existing latrines and that decisions no. 12065 and no. 13227 did not include any regulation on this section, the latrines were renovated and shower sections were added.

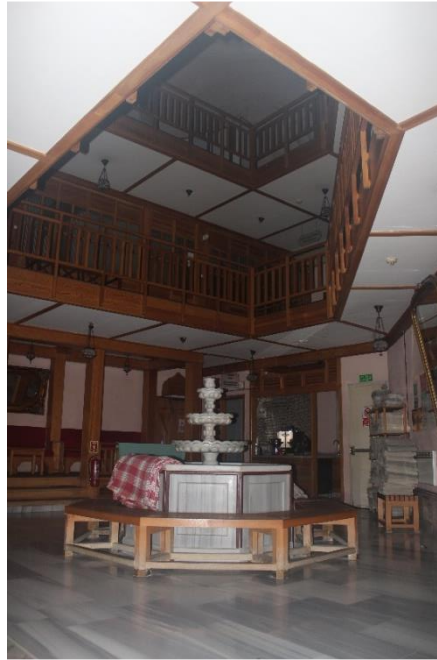
**Figure 17.** Women's soyunmalık space (2022)

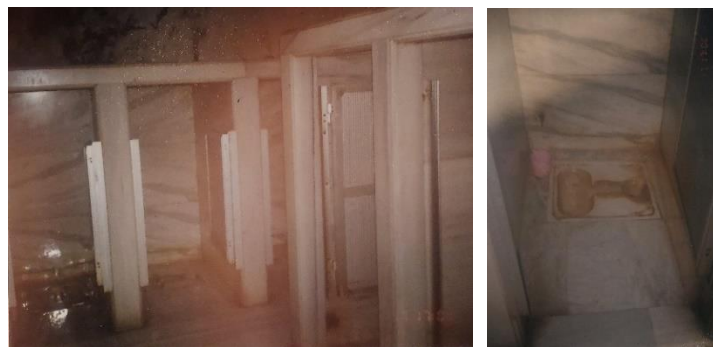
**Figure 18.** The original latrines of the men's hamam, which do not exist today (1993) [28]
