EVALUATION OF THE AUTHENTICITY OF THE HISTORICAL HOCA  
HASAN BATH IN HARPUT*Harput Tarihi Hoca Hasan Hamamının Özgünlüğünün Değerlendirilmesi*Murat Şahin<sup>1</sup>, Kadir Atıcı<sup>2</sup>

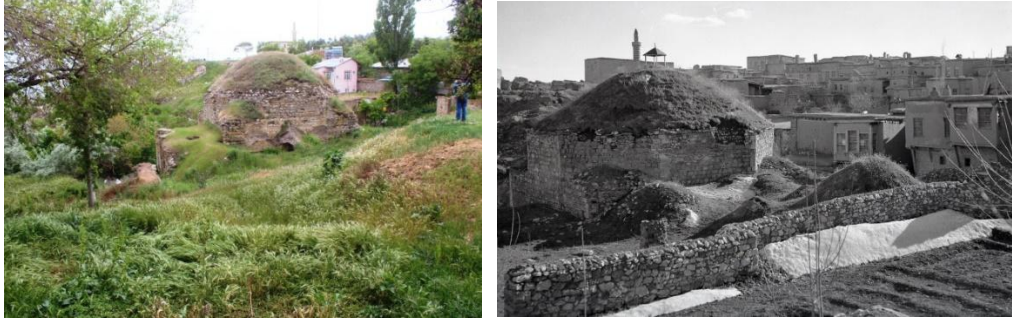
**Figure 3.** Northeastern facade views of the Hoca Hasan Bath in different periods  
Resource: (Archive photo MVGM, 2025)

Since the building has no inscription, there is no information about its construction date. The earliest historical document regarding the bath is in the Harput Sharia Registry numbered 386 and dated 1042/43-1632/33-1633/34 (Figure 3).

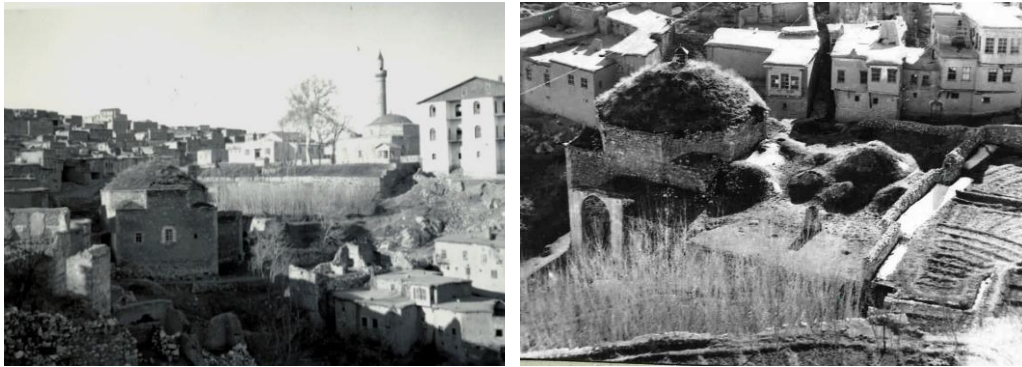
**Figure 4.** The view of the historical Hoca Hasan Bath in 1940 (Atıcı archive, 2025)  
Resource: (Atıcı archive, 2025)

Considering the fact that the bathhouse has a front area at the entrance to the changing room and that the cold section is covered with a dome and the historical information above, it is possible to say that this bathhouse was built in the late 16th century or early 17th century (Atıcı & Aytacı, 2020, p.106) (Figure 4)

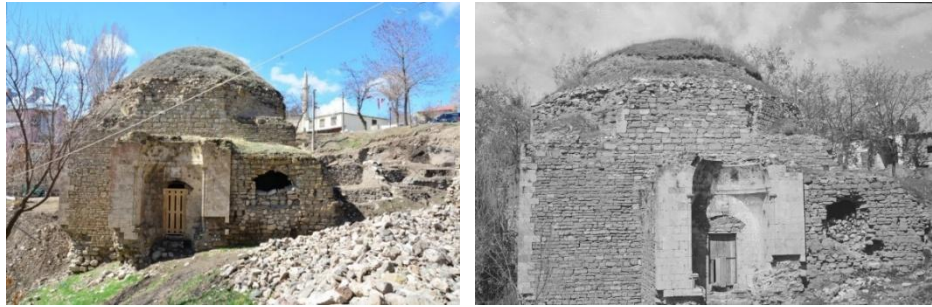
**Figure 6.** General views of the main gate from the east

Entrance Section; The changing room is entered from the east side of the bathhouse through a crown door. The changing room is entered from the area called the information/deposit or bath attendant's room, which is divided by a partition wall at the entrance to the east. Today, the door and upper part of this front area have partially collapsed. The main entrance door on the east side is a crown door as understood from the traces and has survived to the present day as a partial ruin (Figure 6).

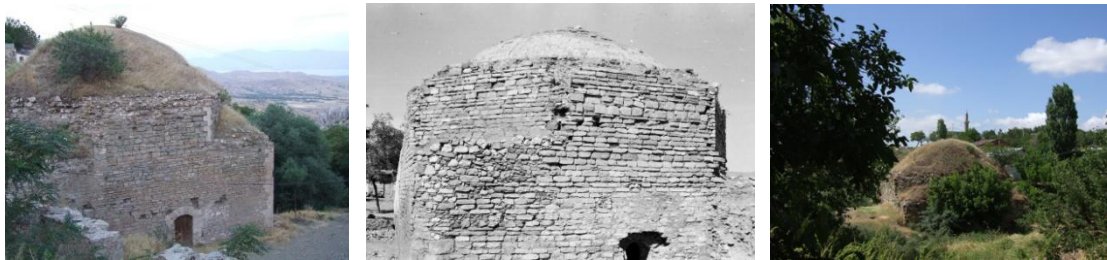
**Figure 7.** External views of the dome of the dressing room

Changing Room; The changing room has a plan close to a square (10.25x10.40 m) and is covered by a single dome. The square plan is passed to the octagonal drum with squinches at the corners and from there to the dome. The height of the dome is approximately 10.70 m from the ground. There is a hexagonal lantern in the middle of the dome (Figure 7).

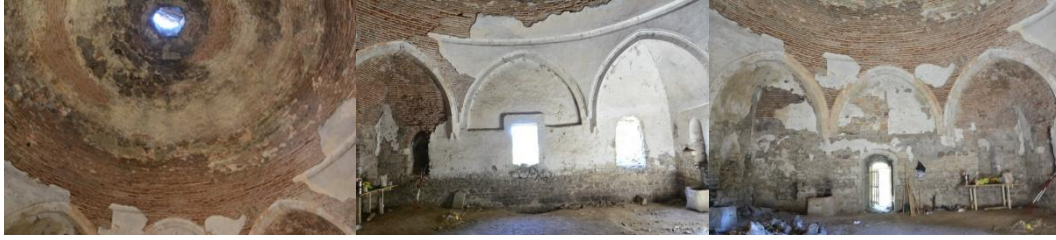
**Figure 8.** Interior view of the dome of the dressing room section, interior south wall of the dressing room section, interior west facade of the dressing room section

The plaster has fallen off most of the dome, exposing the regular brickwork that forms the dome. There are surface losses due to the damage that has occurred to the bricks over time (Figure 8).

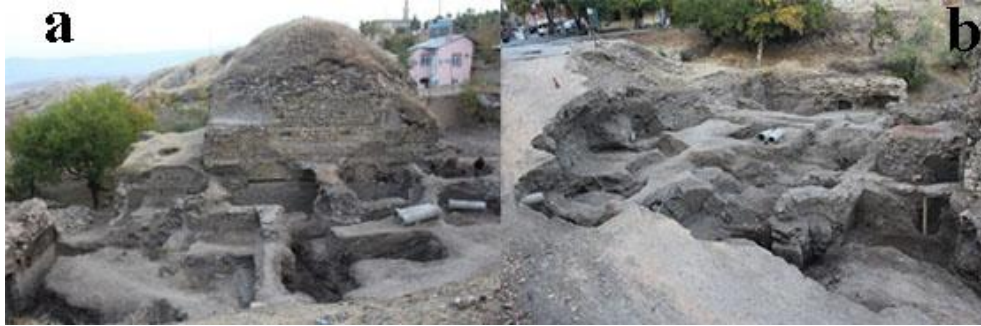
**Figure 9a.** Warm and Halvet Rooms after excavation

Warm room section: The majority of the upper part of the building, starting from the warm room section, has collapsed. It is understood from the archive photographs that the warm room was covered with a dome and vault. In the survey plans drawn according to the wall traces unearthed as a result of the excavations carried out in 2016, it was possible to reveal the authentic plan scheme of the building (Figure 9a-9b).

**Figure 9b.** Warm Room and Halvet Rooms after excavation

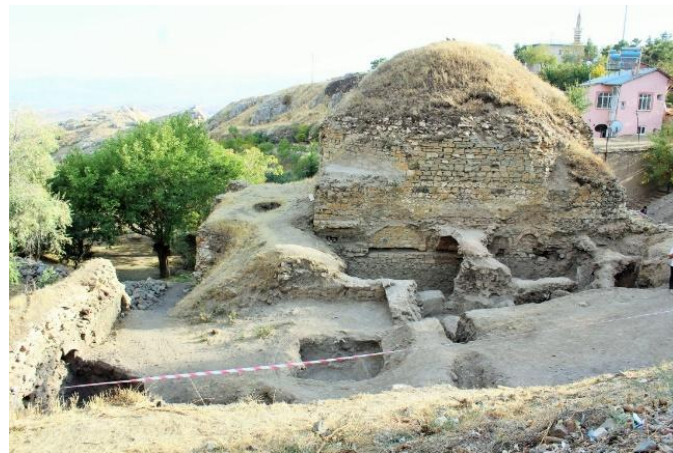
**Figure 10.** Temperature section after excavation.

Hot Room: The hot room located to the north of the changing room has a completely collapsed top cover and its walls were revealed after excavation. The hot room was built according to the bathhouse typology with 4 iwans and corner halvets. It is understood from archive photographs that the iwans were covered with vaults and the halvet rooms were covered with domes. It is also noteworthy that the halvet rooms were built with an octagonal plan, which is not very common in bathhouse architecture (Figure 10).

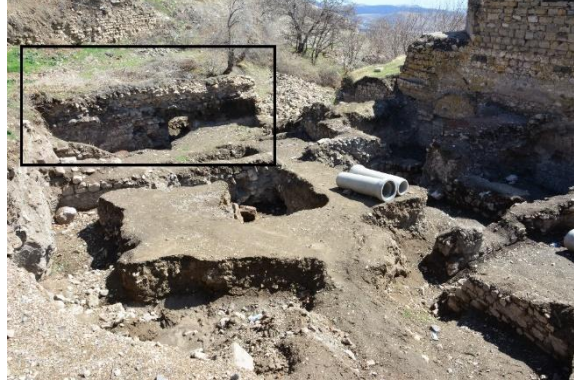
**Figure 11.** Eastern facade furnace section after excavation

**Furnace Section:** The furnace and woodshed sections are located on the eastern facade. While the eastern body wall of the furnace (hellhole) section covered with a vault is standing and the body walls on the other facades have been demolished, these parts were completely unearthed after the excavation (Atıcı & Aytaç, 2020, p.106) (Figure 11).

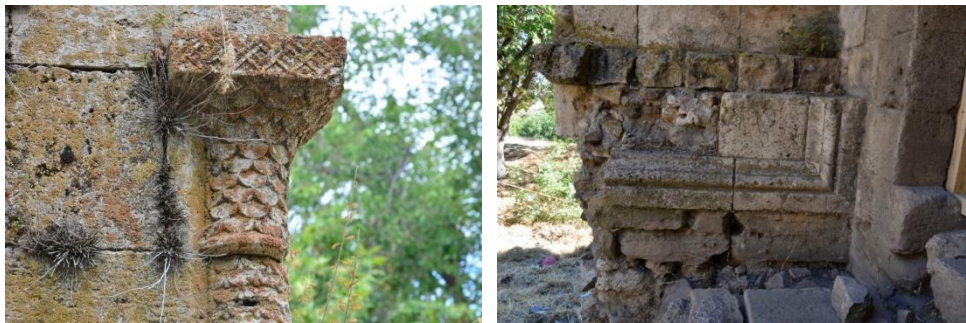
**Figure 13.** Shows the inlaid stone on the Crown Gate and details of the main gate.

**Decoration:** The decoration in the bathhouse consists only of the fish scale motif on the columns of the crown door on the east facade and the square zincerek motif on the column capital. Transitional elements, the fusion of architectural elements can be seen as a part of the decoration (Figure 13). The proportions of the architectural elements add aesthetic value to the structure from the inside and outside. In addition, the use of stone and brick arches has added aesthetic richness.

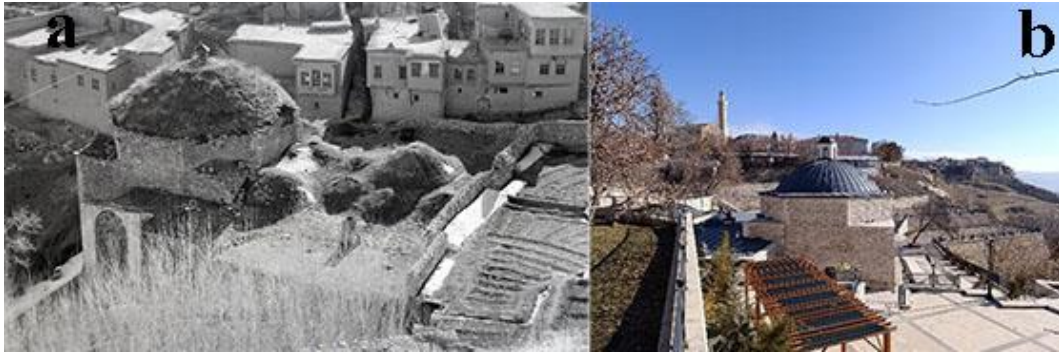
**Urban Environment and Location Authenticity:** The buildings and groups of buildings that make up a region reflect the style and characteristics of the period in which they were built. As the level of preservation of the building and its surroundings increases, more comprehensive information can be provided about the architecture, social life, traditions and customs of the relevant period. Therefore, it is of great importance to preserve not only individual buildings but also the environmental fabric and pass it on to the future (Figures 17a-17b).

**Figure 17a.** The appearance of the building in 1940

**Figure 17b.** Shows the current surroundings of the building.

When the urban environment and location authenticity of the bath structure is examined; the historical Harput region is an important settlement area in terms of the historical and cultural heritage values of the region. However, it has lost most of its historical and cultural texture in the process. Especially a large part of the civil architecture examples have disappeared. In this context, the surroundings of the Historical Hoca Hasan Bath structure have also changed significantly. When the authenticity of the structure in terms of urban environment and location is examined, it is understood that it has lost most of the civil architecture structures around it. Only the monumental structures around it appear to remain. In this respect, the urban environment and location authenticity is thought to be around 45-50%.
