Ecological Approaches in Historical Public Buildings; Talas Old American College

Z. Özlem Parlak Biçer¹, Fazıl Akdağ*² and Esra Ateşoğlu³

Keywords: Ecology, Ecological architecture, Talas American College facilities, Traditional buildings

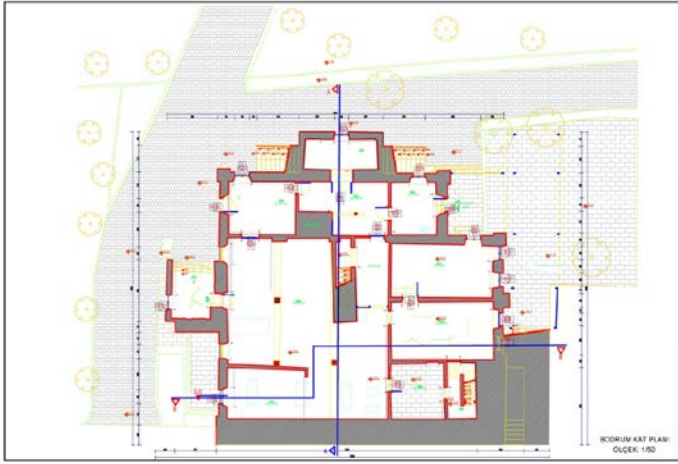
Figure 3 (a). Basement floor plan (ERÜ general directorate of construction, 2017)

The examined building is the largest building on the campus which consisted of, a basement floor, first floor and the second floor that is used together with the roof. The building is settled in the area by arranging different levels on the ground. This allows the basement and ground floor to be accessible from different levels. While the basement is used as an annex, it has begun to be used as a kitchen for the restaurant which is held in the garden in hot seasons. In addition, the boiler room is also located on this floor (Figure 3 a). The ground floor which was transported by monumental staircases from the west side, adapted to the current living conditions by the addition of bathrooms. In addition, wet spaces that can be used without entering the building from the garden are added later. In addition to the four bathrooms, there is also a room used for management functions (Figure 3 b). There is a one-armed staircase leading to the upper floors,

the selected building but it can be said that the basement provides the physical and mechanical conditions as in the rock carved spaces that betting. The basement floor, which is already used as an annex, is also available as a cold store for food regarding the daylight intake, the presence of levels in the landscape and the orientation of the building can provide the appropriate conditions. Hence, energy consumption can be saved. Daylight can be taken inside the building in every turn of the year which provides energy conservation. Window openings in the south and west directions of the building are particularly suitable to the climate conditions.

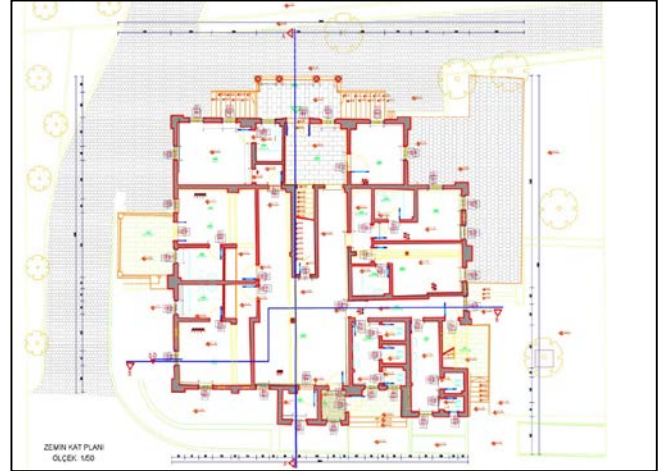
Figure 3 (b). Ground floor plan (ERÜ general directorate of construction, 2017)

opposite off the main entrance. On the ground floor there are rooms set around a central stair and a space for common use.

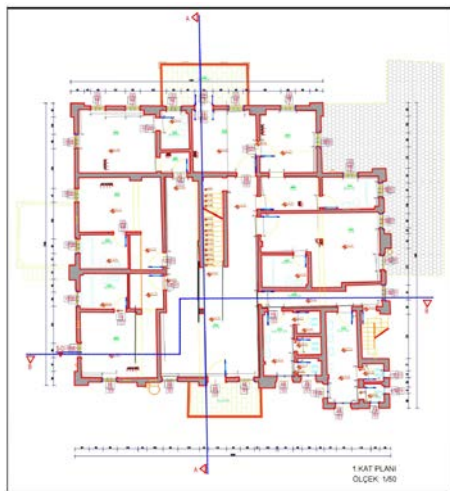
Figure 4 (a). 1st floor plan (ERÜ general directorate of construction, 2017)

Figure 4 (b). 2nd floor plan (ERÜ general directorate of construction, 2017)

The first floor, which is reached by the one-armed central staircase, is also consisted of bedrooms. The balcony overlooking to the west is accessed from a bedroom and it covers the entrance. Another communal balcony is reached from the common usage area which is overlooking to the east side. Wet volume solutions have been made on the same area as in the ground floor. Wet volumes are located to the north-east of the structure (Fig. 4 a, b). The second floor of the building is located inside the attic. Roof height is kept higher than required and inter-roof spaces are created by the volume this height granted. This floor, where the central plan scheme is seen, also has wet spaces as later additions to the bedrooms. Wet spaces do not exist in the initial planning but the wet volumes in the north east, which all units use together, were thought to be in the initial planning.

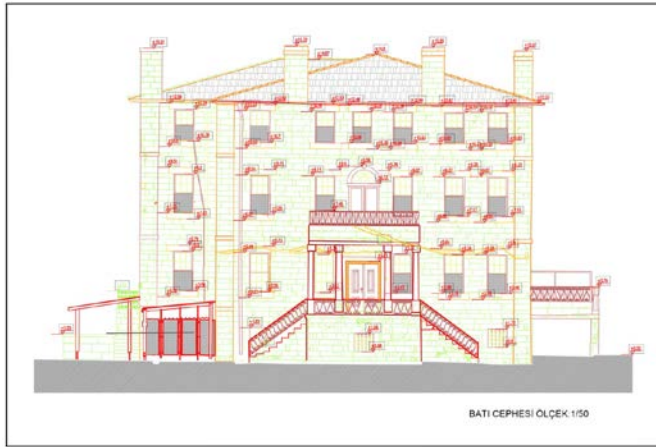
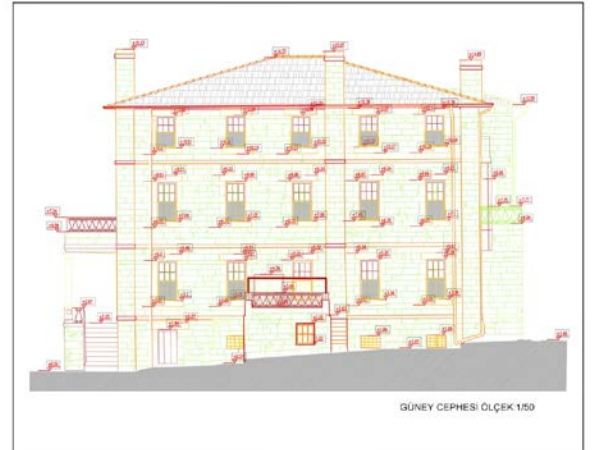
Figure 5 (a). West facade (ERÜ general directorate of construction, 2017)

Figure 5 (b). South facade (ERÜ general directorate of construction, 2017)

The balcony, that is located on the west side of the building which emphasizes the entrance, is carried with one piece of cylindrical stone pieces. The western side of the building, where

scenery of Kayseri and Ali Dağı can be seen has large window openings that makes possible to take enough amount of sunlight to the inside. This is an important feature for the buildings located in the areas where winter climate conditions are harsh. Although the structures on the south side are additions that made depending on the requirements, it seems that the basic planning approach has not deteriorated. Depending on the usage in the interior, the need to utilize heat and natural light has been decisive in the general character of the interior and window openings. In the building constructed with the masonry system, the window openings have been tried to be kept as large as possible in accordance with the possibilities of the construction system (Figures 5 a and b).

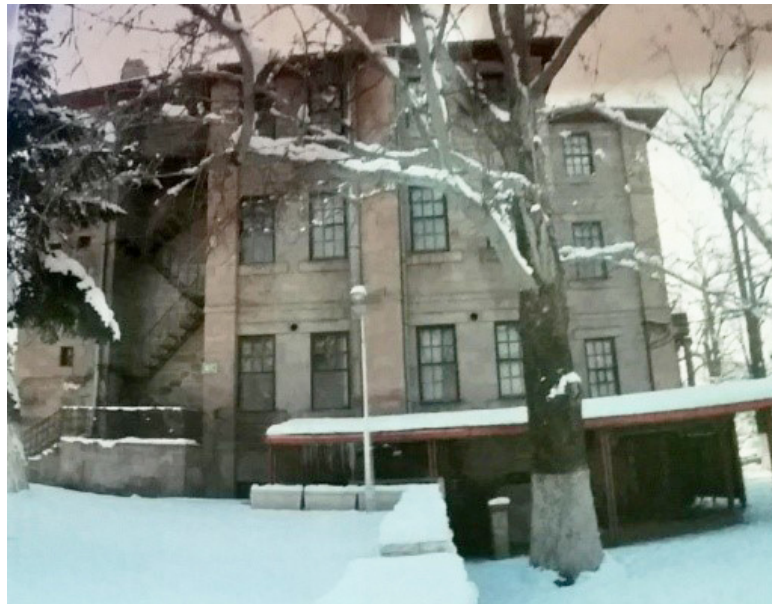
Figure 6. North Facade (Kayseri Directorate of Landscape and Monuments archives-2011)

The eastern and northern facades have less window openings due to the presence of wet spaces on these two facades, although they are similar to other facades in terms of material, architectural language and construction system (Figure 6). This indicates that insulation is considered especially in colder directions for cold winters (Figure 7 a, b).

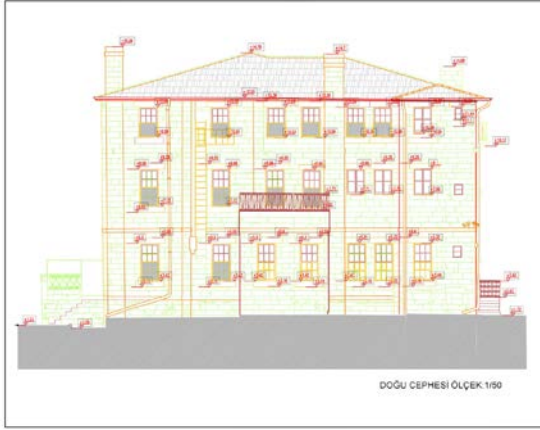
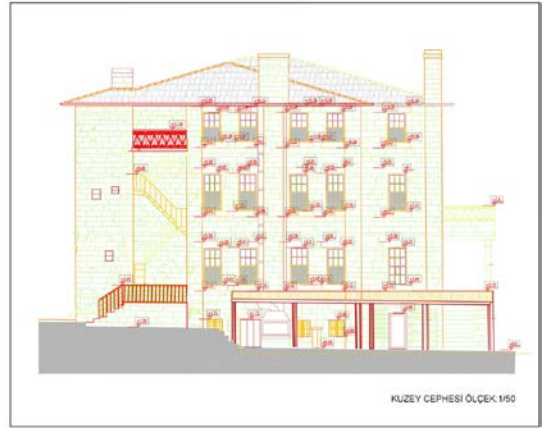
Figure 7 (a). East Facade (ERÜ general directorate of construction , 2017)

Figure 7 (b). North Facade (ERÜ general directorate of construction, 2017)

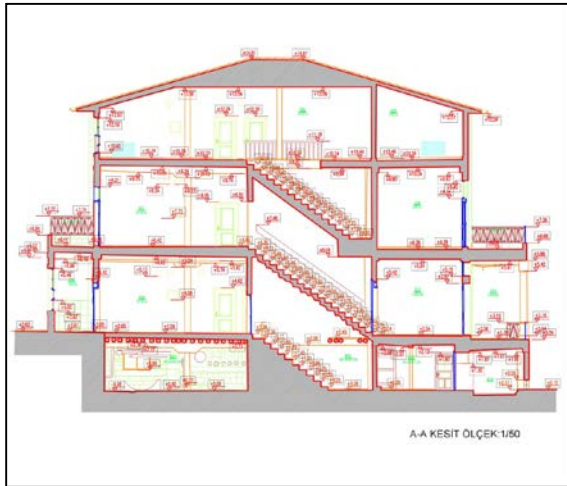
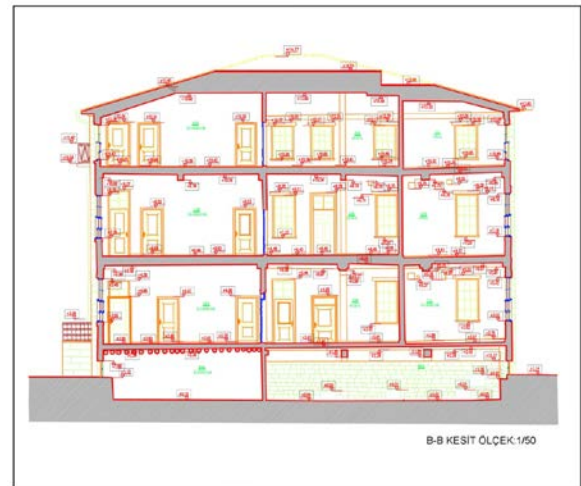
Figure 8 (a). A-A section (ERÜ general directorate of construction, 2017)

Figure 8 (b). B-B section (ERÜ general directorate of construction, 2017)

The bearing walls of the structure which built in the masonry carrier system are consisted of local cutting stones. It is estimated that stone used as building material is brought from local stone quarries considering its characteristics. In addition to this, it is observed that wood is used intensively especially in floors and door and window frames. It is also remarkable that the building is placed compatible to the natural elevations of the topography. There are differences in the number of floors between the facades of the building due to decreasing ridges of the landscape from east to west. Depending on the ridges of the landscape, the building can be perceived as it have three floors or four floors regarding to the observation point. The basement can be accessed directly from the garden, especially in summer by the level differences on the site. The components of carrier system on the roof which is thought to have been built by local masters, is also made of wood (Fig 8 a, b).

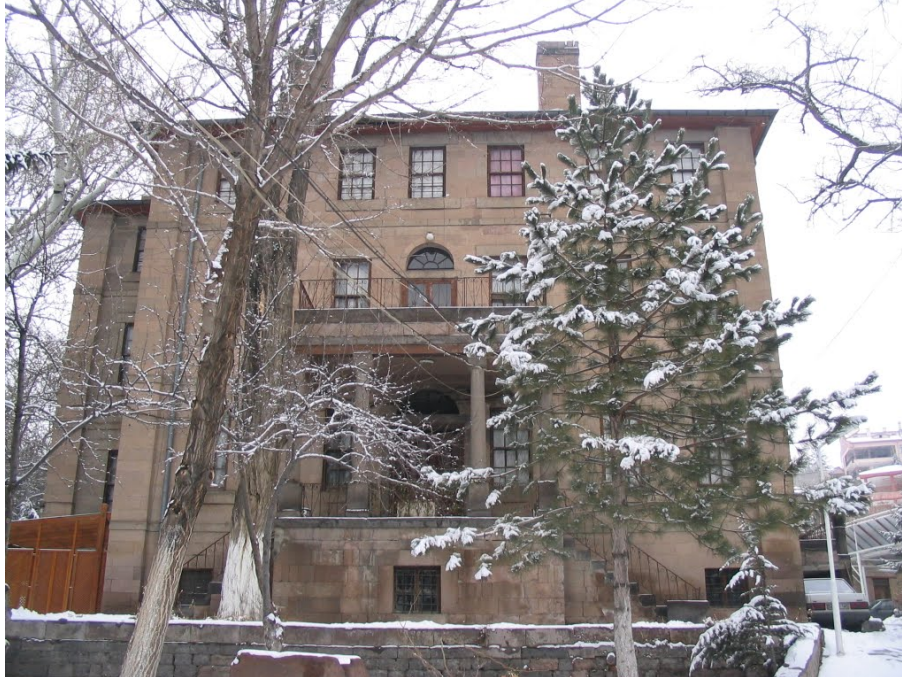
Figure 9. West facade, main entrance (<http://mapio.net/pic/p-34376969>)

The criteria set out by the CIB has been decisive in ecological evaluation of the building known as the number one building within the Talas American College campus area (Figure 9). Depending on the energy usage and material selection and the use of selected materials, the

locally produced stone was found to be in accordance with the ecological criteria with the use of local craftsmanship through local construction systems. Also, there is no extra energy and human power consumption to transport the stone, the main material of the structure. In addition, since the stone is heat-retaining, it is suitable for balancing the temperature differences between summer and winter and day to night.

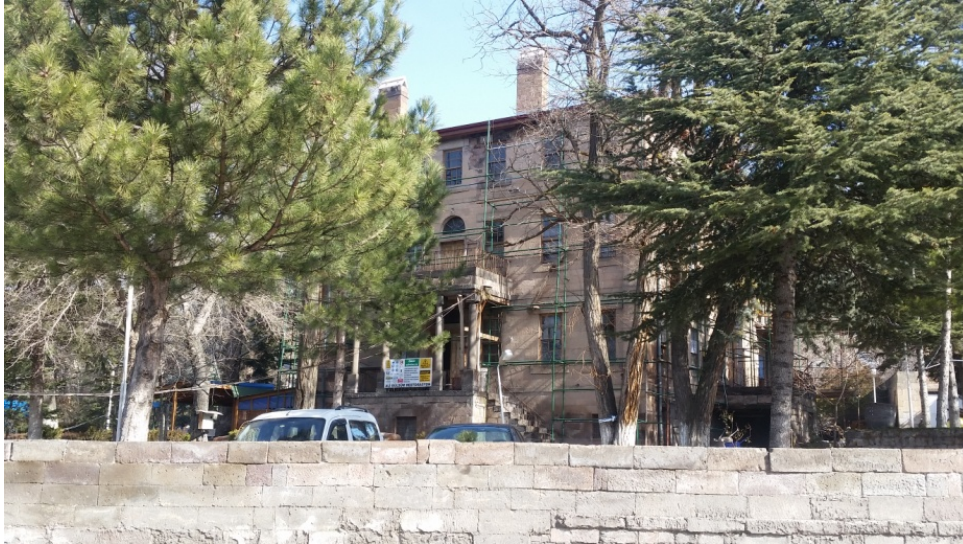
Figure 10. Use of natural materials in and around the structure (Z.Ö. Parlak Biçer, 2018)

When the building is evaluated in the context of relationship between human health and material choice; it is seen that the architectural and technical elements that make up the building are produced from natural and unprocessed materials (stone, wood etc.) which is harmless to the human health (Figure 10). Ecological approaches can be observed especially in materials used for decoration and fine structure. The use of natural wood in roofs, upholstery, ceiling tiles and doors and windows is seen as an appropriate choice in terms of both air quality and thermal conditions within the scope of ecological criteria. However, some later interventions distorted the originality of the work. An example of this is the painting of interior walls with oil paint, which is a material that prevents breathing. Although the later unattended interventions do not overlap with the original character, the construction techniques and materials used in the initial production of the structure show that the original state of the structure provides many of the currently accepted ecology and sustainability criteria.
