A Chronological Research of Samsun City Floods

Neslihan BEDEN^{a*}, Hesham ALRAYESS^b, Asli ULKE^c

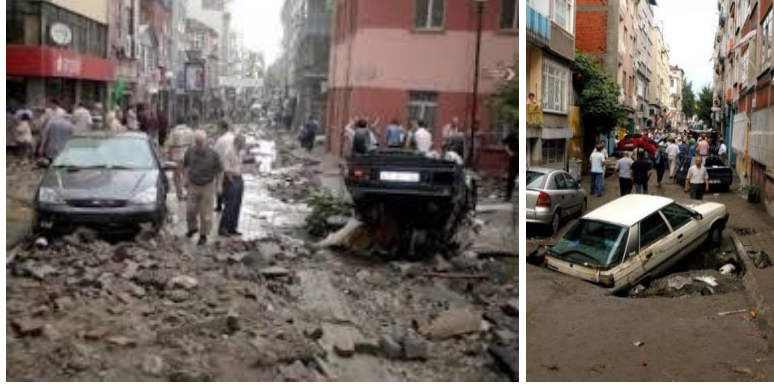
Figure 8. Damages of Flood in Derekoy and Samsun City

On 24.08.2007 Friday, extreme precipitation started from 03:40 and continued till 05:18 which caused floods in Samsun city center and Derekoy area (Figure 8). Floods occurred at Karasamsun stream, Military Branch stream, Agabali, Kelin, Stream No. 1, Sitmapinari, Gulistan, Ortadag and Fideli streams which located in Samsun city center and Derekoy area. Flooded area was about to 25 km².

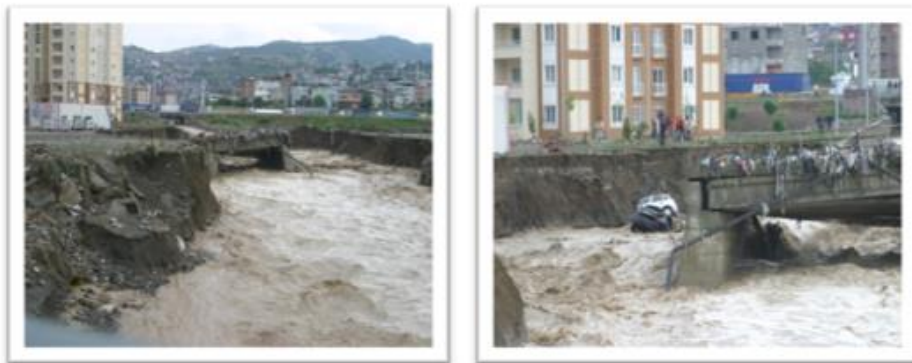
Figure 10. Damages of Yilanli Stream Flood in Canik District

The 1000-year frequency flood peak of the dam was $Q=217 \text{ m}^3/\text{s}$. Flow rates during flood calculated as $710 \text{ m}^3/\text{s}$. The important thing that the incoming flood was 2.37 times bigger than the catastrophic peak and that indicates us that was a disaster dimension. As a result of this flood, 7 people lost their lives in Yesilova Street and the shopping center, many houses, old industry and stadium of the city were damaged by the flood (Figure 10).

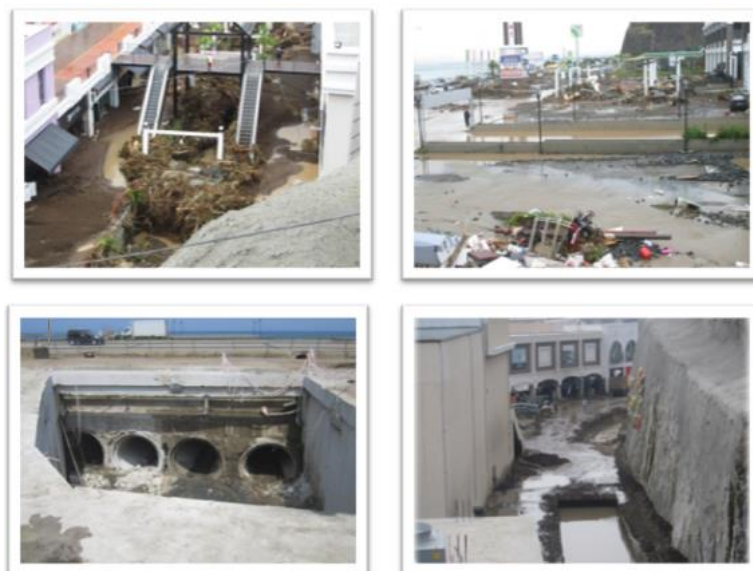
Figure 11. The Damage Caused by Incirli Stream Flood to the Shopping Mall

The 1000-year frequency flood peak of the stream was $Q=121.3 \text{ m}^3/\text{s}$. The flow rate during the flood was calculated $172.7 \text{ m}^3/\text{s}$. It is also seen that the incident was in disaster dimension. The shopping centre which located in the Haskoy surrounding has also suffered from big financial damage (Figure 11).

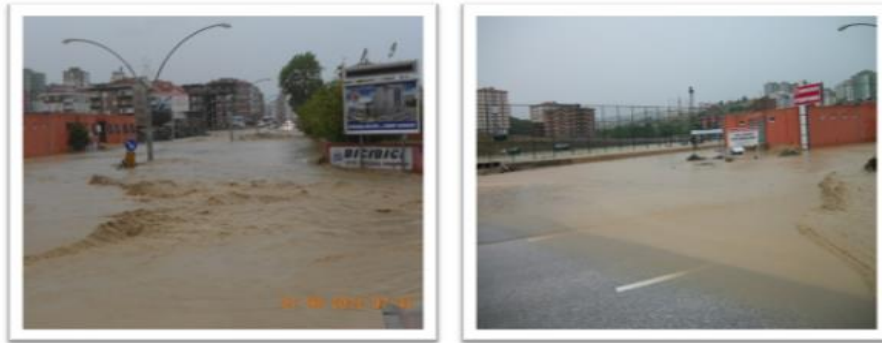
Figure 12. The Damages Caused by the Kuruzeytin (Cobanli) Stream Flood

The 1000-year frequency flood peak was $Q=160.7 \text{ m}^3/\text{s}$. Flow rate during flood calculated as $55 \text{ m}^3/\text{s}$. This flow rate is even smaller than the calculated $Q_{100}=100.3 \text{ m}^3/\text{s}$. Since the downstream part of Kuruzeytin (Cobanli) was used as a road after the flood, flood waters caused material damage in many buildings and workplaces around the access road (Figure 12).

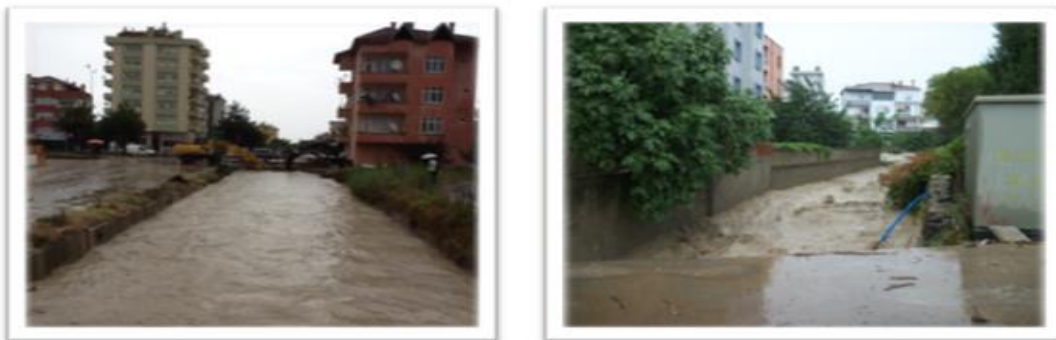
Figure 13. The Damages Caused by the Afanlı Stream Flood

The 1000-year frequency flood peak was $Q=254.1 \text{ m}^3/\text{s}$. The flow rate during flood calculated as $75 \text{ m}^3/\text{s}$. This flow is calculated as the flood gauge $Q_{100}=157.1 \text{ m}^3/\text{s}$. It shows that flood disaster occurs because of interfering in the stream beds. After the flooding, material damage has occurred in vehicles and workplaces due to the inadequacy of the culvert on the stream passing over the Samsun-Sinop Highway.

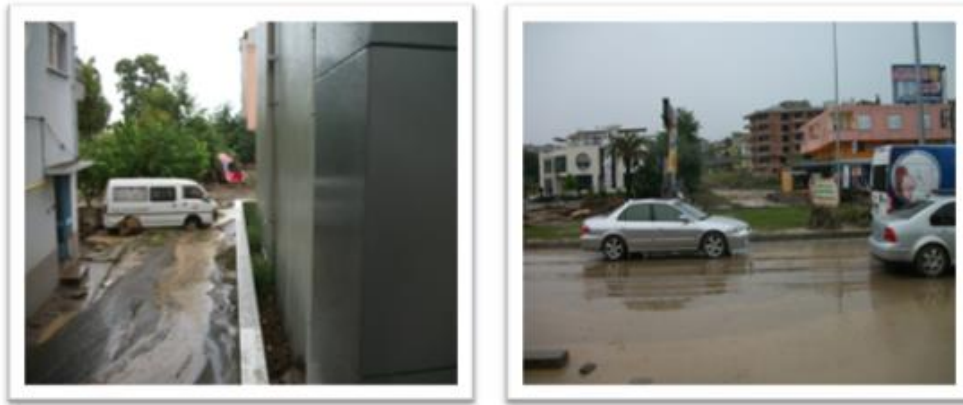
Figure 14. The Damages Caused by the Flood of Degirmen Stream

The 1000-year frequency flood peak of the stream was $Q = 192.4 \text{ m}^3/\text{s}$. Flow rate during flood calculated as $35 \text{ m}^3/\text{s}$. This flow is even smaller than the calculated $Q_{100} = 117.5 \text{ m}^3/\text{s}$. This also shows that flood disaster occurs because of interfering in the stream beds.

After the flood, property damage has occurred in the vehicles and in the workplaces due to the inadequacy of the culvert on the Samsun-Sinop Highway (Figure 14) (Ulke et al. 2013; DSİ, 2012).

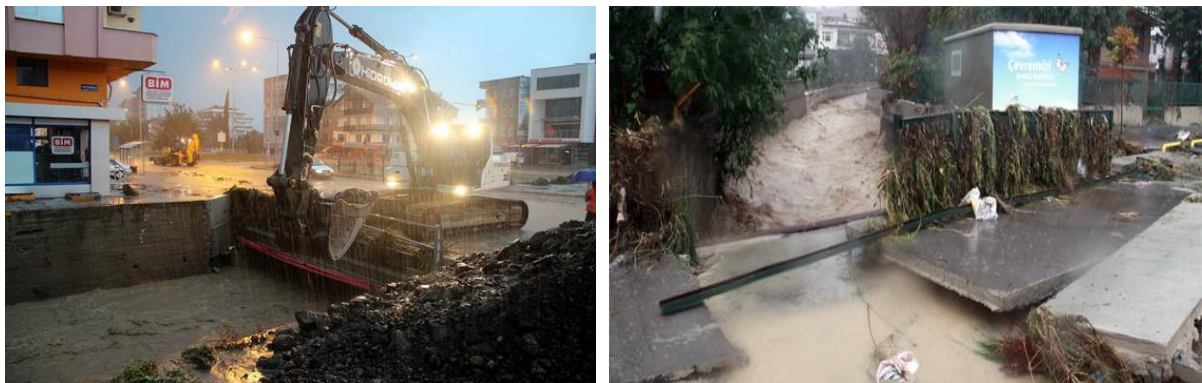
Figure 15. Flood Damage (Highway Bridge) and in Atakum Coastal Road Bridge

Precipitation started at 01:00 am at night and continued until 04:00 in the morning and the heavy precipitation has left 250 kg rainfall per square meter in Atakum district in 07.08.2013. Alanli and Degirmen stream overflowed, especially the result of the overflow of Degirmen stream was tied traffic up and Sinop-Samsun highway traffic was provided after several hours with control (Figure 15).
