The Eurasia Proceedings of Science, Technology, Engineering and Mathematics (EPSTEM), 2025

**ICBASET 2025: International Conference on Basic Sciences, Engineering and Technology**

## **Comparative Analysis of Measures to Reduce Wear on Ship Hull Structures in Areas Around Ballast System Suction Pipes**

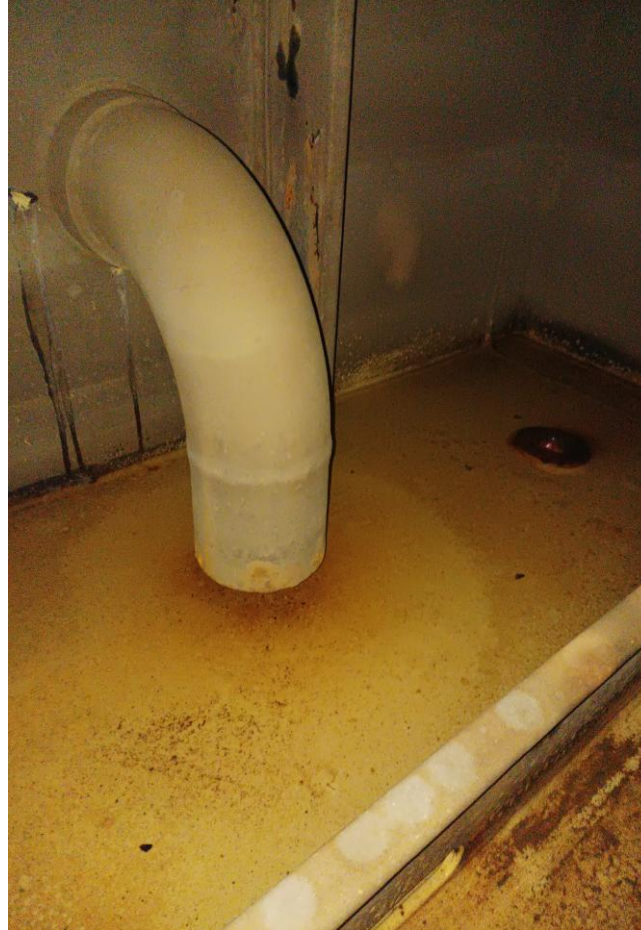
Figure 1. Option one without installed plate

The surface preparation for repair in option one consists of burning off the paint around and under the suction pipe, welding, grinding the welded areas, installing, and welding the anti-erosion plate. The peculiarity here is that all these activities cannot be performed by two people simultaneously. This is precisely why the repair takes a longer time to complete.
