## Behaviour the Concrete Structures Under the Several Conditions

**Abstract** The damaging impact of various chemicals and exposure conditions on concrete materials was investigated, especially in concrete facilities in long time of exploration. This study includes a preliminary analysis of chemically treated water in existing concrete structures, and another after the application of the method and using materials for the structures in future. For repair of existing reinforced structure, new technologies of polymer carbonated materials are used. One of the priorities was to examine the existing concrete structures by using non destructive and destructive methods. After that, based on the results of the analysis, adequate new materials are proposed for the repairs, most commonly new technology polymer carbonated materials, in order to achieve durability of structure elements in using technological processes. Behaviour of the repairing structures was tested using the in situ methods, and especially pull-of test, to verify the adhesion force between the old concrete structures and new applied layer. After the repairing, the concrete structures will be monitored to record the behavio

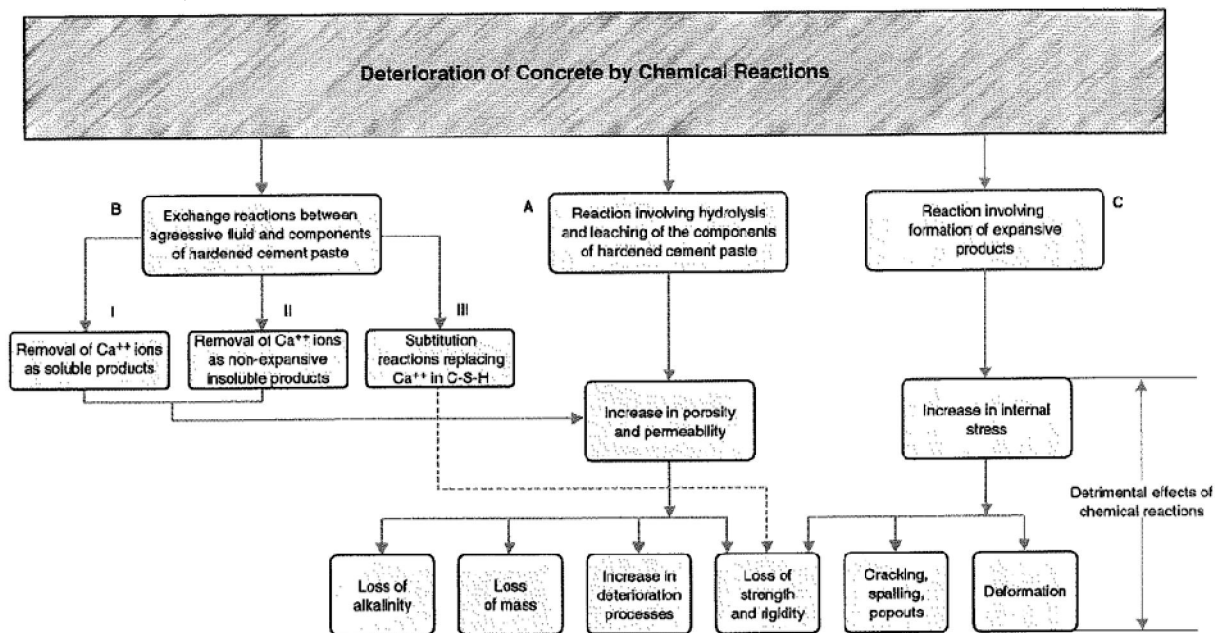
**Figure 2.** Types of chemical reactions responsible for concrete deterioration. *A: Soft water attack on calcium hydroxide and C-S-H present in hydrated Portland cements; B(I): acidic solution forming soluble calcium compounds such as calcium chloride, calcium sulphate, calcium acetate, or calcium bicarbonate; B(II): solution of oxalic acid and its salts, forming calciumoxalate; B(III): long-term seawater attack weakening the C-S-H by substitution of  $\text{Mg}^{2+}$  for  $\text{Ca}^{2+}$ ; C: sulphate attack forming ettringite and gypsum, alkali-aggregate attack, of steel in concrete, hydration of crystalline MgO and CaO (Mehta & Monteiro, 2006).*

It should be noted that chemical attacks on concrete manifest themselves into detrimental physical effects, such as increase in the porosity and permeability, decrease in the strength and cracking. The chemical processes can be divided in three subgroups as shown in Figure 2 (Mehta, & Monteiro, 2006).

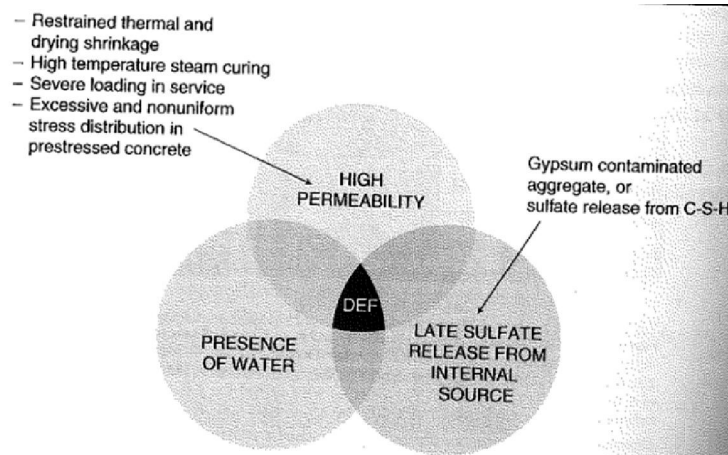
**Figure 3.** A diagrammatic presentation of holistic approach to DEF related to cracking and expansion (Mehta & Monteiro, 2006)

new. It is known to occur when either a gypsum-contaminated aggregate or a cement containing unusually high sulphate content has been used on the concrete production. Ettringite is not a stable phase above 65 °C, it decomposes to form the monosulphate hydrate if steam-curing temperatures higher than 65 °C are used in manufacturing process. The sulphate ions released by decomposition of ettringite are absorbed by calcium-silicate hydrate. Later, during the service, when sulphate ions are desorbed, the reformation of ettringite causes expansion and cracking. A diagrammatic representation of holistic approach to DEF related expansion and cracking is shown in Figure 3 (Mehta & Monteiro, 2006).

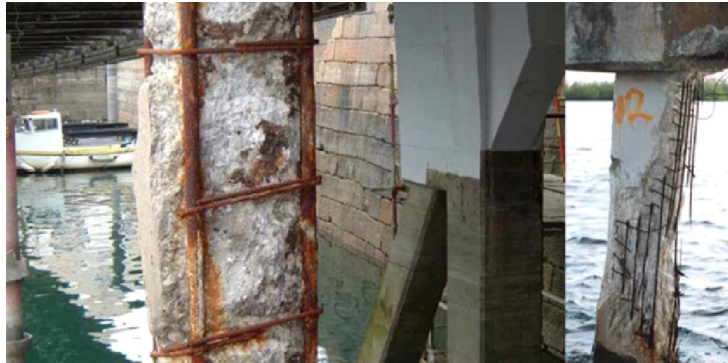
**Figure 4** Concrete permanently located underwater, i.e. marine piles (Concrete Institute of Australia)

- Atmospheric zone. This is reinforced concrete located in the vicinity of the marine environment, but not in direct contact with water; i.e. bridge decks, soffits and beams. These elements often display moderate corrosion rates due to the presence of airborne moisture and chloride.
- Splash and tidal zone. This is the area located on and around the water line and is often classed as semi-submerged; i.e. concrete piles and piers. These elements generally experience the most severe corrosion due to the high moisture, oxygen availability and wet/dry cycling.
- Submerged zone. This is reinforced concrete permanently located underwater, i.e. marine piles. These areas can experience lower levels of corrosion due to reduced oxygen levels. However, while corrosion here is less aggressive, submerged areas are at risk from another problem

known as black rust and low water corrosion (Concrete Institute of Australia; Elsner, 2000; Emmons, 1993).

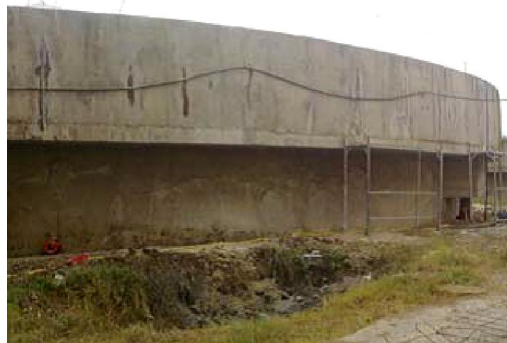
**Figure 6.** The concrete structure during the visual inspection: outside and inside.

The visual inspection resulted in the need to remove the existing additional materials, because the process of damage of concrete surface is ongoing and also leaking water is also visible outside (Kabashi, at al, 2014)

The concrete facilities stage during the inspections is on the conditions presented in Figure 6. The following steps are applied in this analysing and solving the actual protection and repairing the typical concrete structures (Kabashi *at al*, 2014).

The surface before cleaning, during the cleaning and after cleaning is presented in Fig. 6

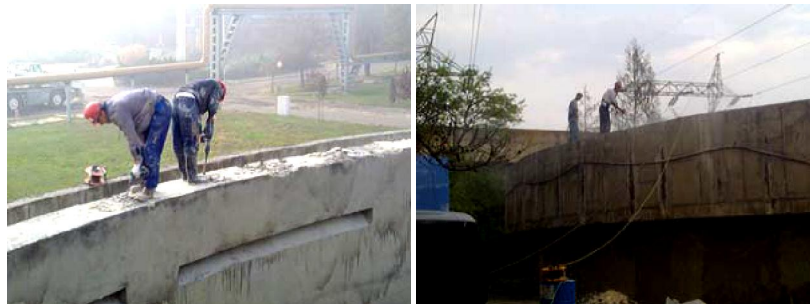
The internal surface of concrete was damaged during as a result of 30 years of use and the sedimentation of the lime from treated water. The lime and sulphates are connected fast to the existing concrete and as a result both cleaning methods had to be applied:

**Figure 7.** Removal of the damaged parts and the cleaned concrete surface inside.

- High pressure water for removing the damaged parts;
- Mechanical removal of the damaged part.

The surface after the cleaning is treated with primer layer before applying the repairing mortar or layer of mortar (Kabashi *at al*, 2014).

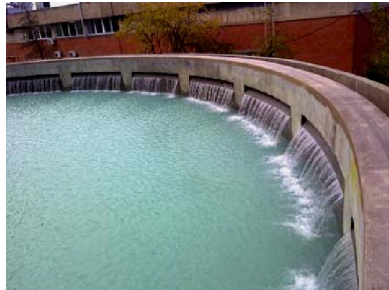
**Figure 9.** Water treatment facilities after repairing (Kabashi at.al, 2014)

All activities will be under the EN Standard 1542, and must improve the durability of new repaired structures. One of the requirements in this case is the bond strength between the old concrete and new layer. To verify the bond strength, the authors used the “Pull-of Test Method-EN 1542” and the methodology of examinations and results are presented in Figure 8.b which situation before and after are presented in Figure 9.
