## Flashfloods and Floods in Istanbul

Hüseyin TUROĞLU\*

*Istanbul University, Faculty of Letters, Department of Geography, Istanbul*

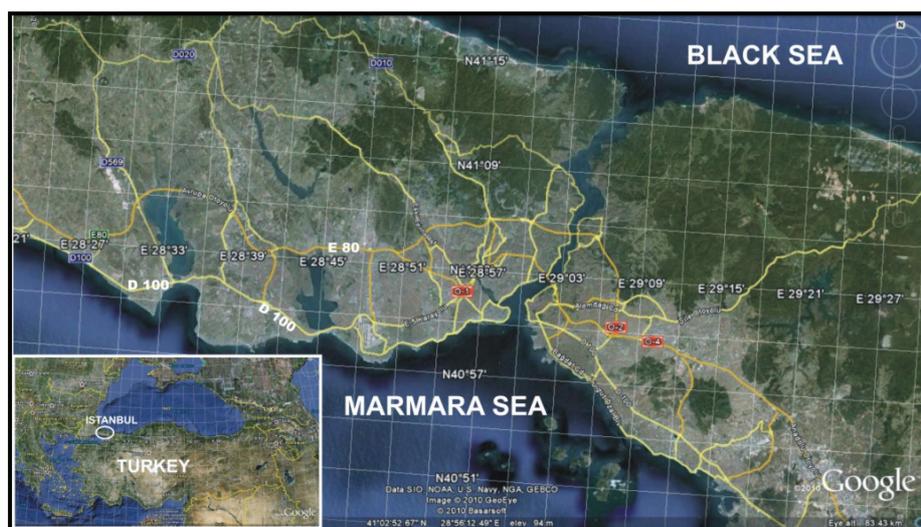
Figure 1. Location and landcover features of Istanbul city and close vicinity.

Due to its historical, geographical, social, and economic characteristics, Istanbul is one of the most important cities not only in Turkey but also the world (Figure 1). Flashfloods and floods cause serious damage to this city. Between the years of 1989-2009, flashflood and flood disasters causing

Istanbul's urban development has always been under the limiting and guiding influence of the city's geographical features, namely, the land and seas surrounding it. This effect still continues. The Istanbul Strait, running in a roughly north-south direction, is a natural waterway. The first center of the city was founded on a location called the “historical peninsula” at the southern end of the Istanbul Bosphorus Strait. The city then widened to encompass not only both sides of the Bosphorus Strait but also areas to the east and west of the Bosphorus. The urban area, which is shown in rectangular form, is limited to the north and south by the Black Sea and Marmara Sea acting as natural barriers (Figure 1). Taking place on link roads between Asia and Europe has played important role on urban development of the Istanbul city. Due to these features, the general direction of all constructions which are the natural result of urban development in Istanbul have been planned and applied in an east-west direction (Anonymous 2009) (Figure 1).

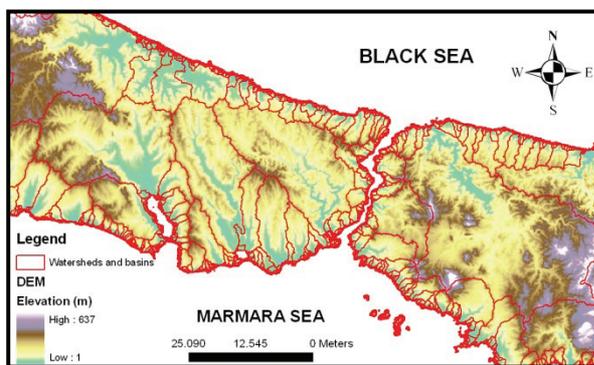
Figure 2. Watershed and river basin features of study area.

GIS technologies provide important advantages for hydrologic analysis (Jenson and Domingue, 1988; Maathuis and Wang, 2006; Schäuble et al. 2006; Li et al. 2008; Turoğlu, 2008; Orlandini and Moretti, 2009). Accordingly, GIS was used for determining natural flow direction, calculating natural flow accumulation, and delineating natural watersheds of the İstanbul region and close vicinity. GIS data were analyzed to create layouts for a Digital Elevation Model (DEM), Flow Direction, and Flow Accumulation graphics (Figure 2 and 3).

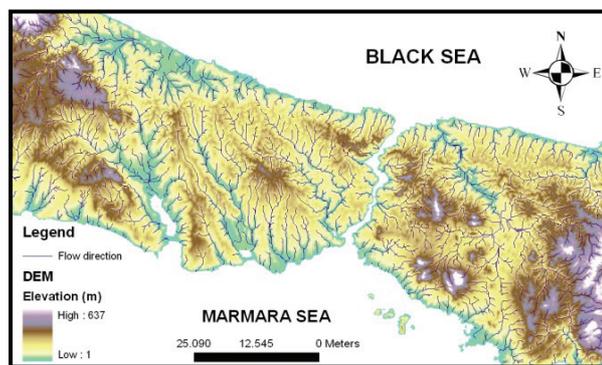
Figure 3. Natural flow direction features in study area.

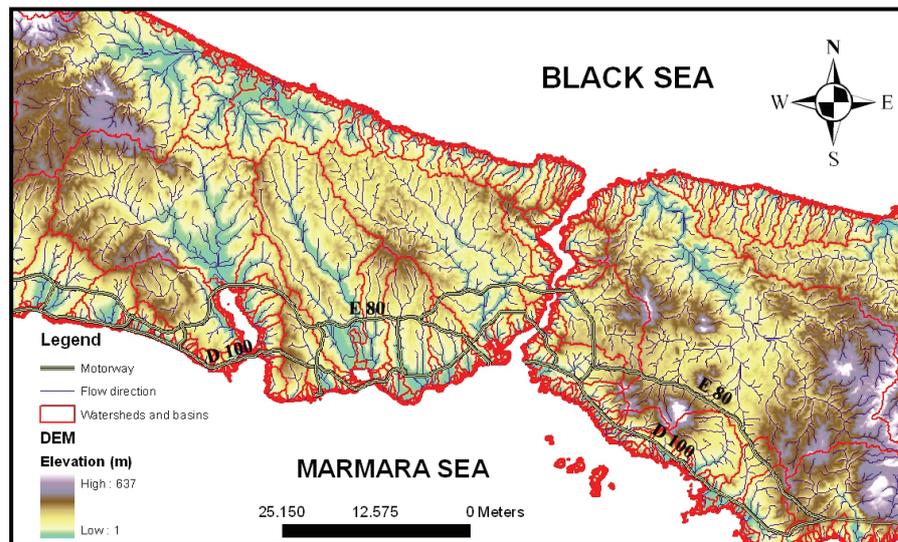
Istanbul's highway transportation network lies in an east-west direction (Figure 4). All sorts of construction projects have been implemented in accordance with this east-west approach. However, the natural flow accumulation and flow direction in the İstanbul region lie roughly in a north-south direction. The natural flow direction in the north part of İstanbul is towards the north, and rivers in the northern part of İstanbul flow and discharge into the Black Sea. Flow direction in the southern part of İstanbul is towards the south, and rivers in this region flow and discharge into the Marmara Sea (Figure 2, 3 and 4). Constructions in İstanbul constitute vertical barriers against the surface flow for natural flow accumulation and flow directions by cutting across them longitudinally. Thus, constructions in İstanbul have prevented the natural surface flow and/or changed the natural flow direction.

Figure 4. Surface runoff features and D100 and E 80 motorway routes in Istanbul region.

The main arterial motorways D100 and E80 were planned and built to cut vertically into the natural flow direction. Link roads between the E80 and D100 motorways were constructed on both the valley floor and following the lowest lineaments of the valley floor. In this case, the main arterial highways hinder surface flow, and the link roads act as natural flow channels. The rain water coming with exceptional rainfall, reaching huge volumes, does not flow into the present artificial drainage systems but prefers to flow according to existing slope conditions and on roads (Figure 4, 5 and 6).

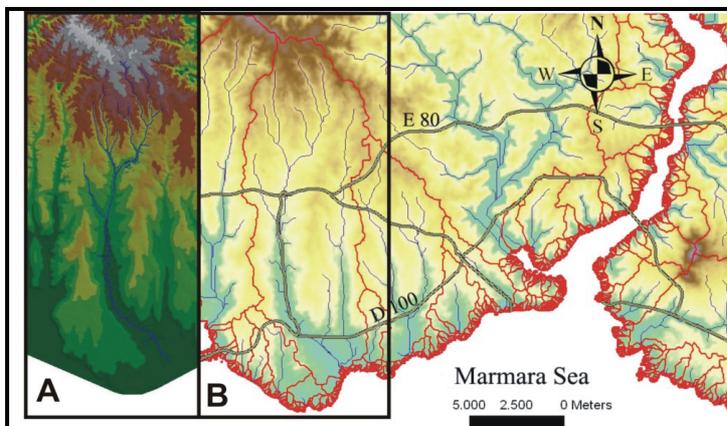
Figure 5. Drainage system of Ayamama River (picture A and B) and link road between E80 and D100 motorways. In Picture A, the main channel of Ayamama River was moved westward and artificially closed the western slopes of the valley. Picture B represents an overlay of the natural flow accumulation and flow direction with the link road between the E80 and D100 motorways in the Ayamama River basin.

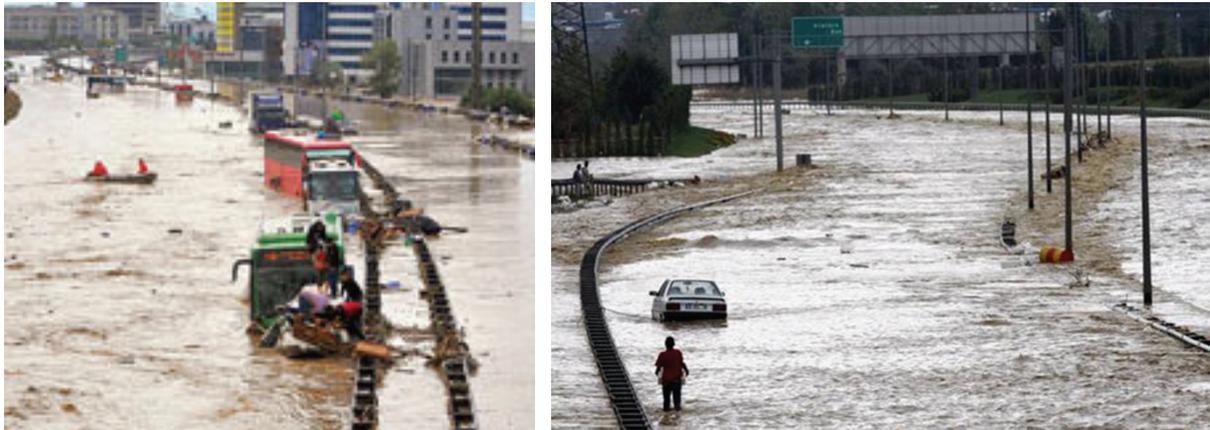
Changes to the natural slope conditions that have arisen from urban development in Istanbul have caused puddles of rain water to reach huge volumes and turn into urban floods. The pipes and box culverts, bridges and underground drainage, constructed for water runoff in Istanbul, are either inadequate to discharge the collected water or do not work because they are clogged or defective (Figure 6, 7, 8, 9).

**Figure 6.** Main roads served as drainage channels (Ayamama River basin, “Basin Express” link road, September 9, 2009).

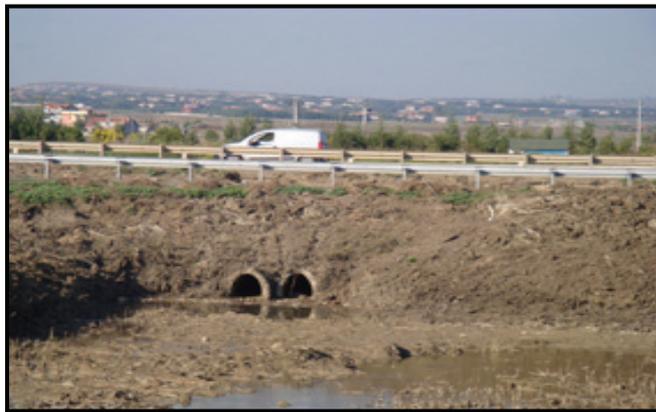
**Figure 7.** Filling under D 100 Motorway in Tuzla valley bottom and pipe culverts.

- Restoration projects must be carried out on all constructions blocking natural surface flow.
  - Culverts on motorways and constructions hindering natural surface flow must be renovated.

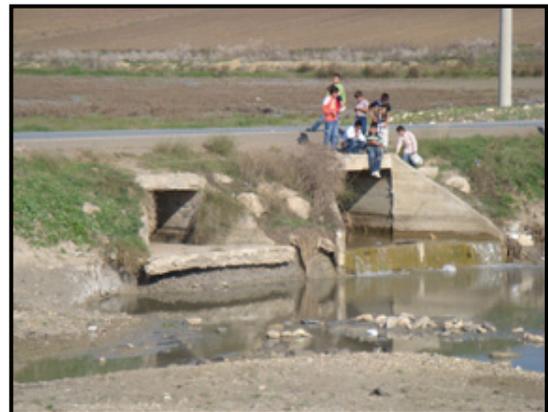
**Figure 8.** Both pipes and box culverts are insufficient to handle the surface flow.

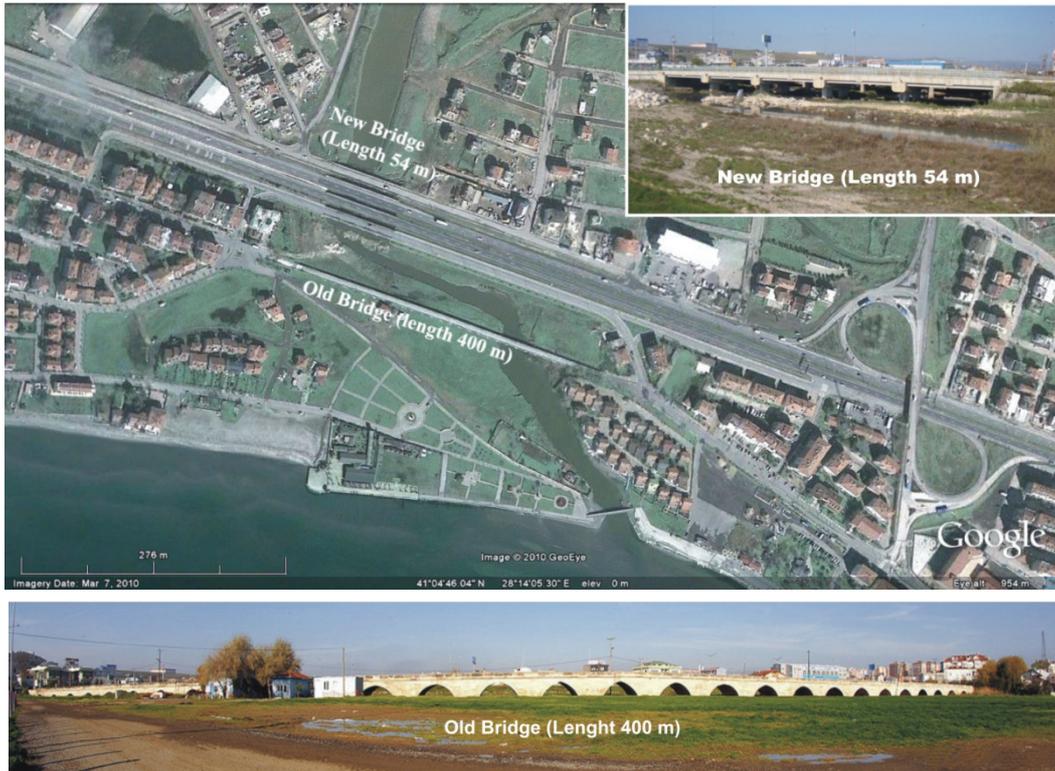
**Figure 9.** There are two bridges in the same location on the D100 motorway. The older one was built by Mimar Sinan c. 1560. The second bridge was constructed in the last decade.

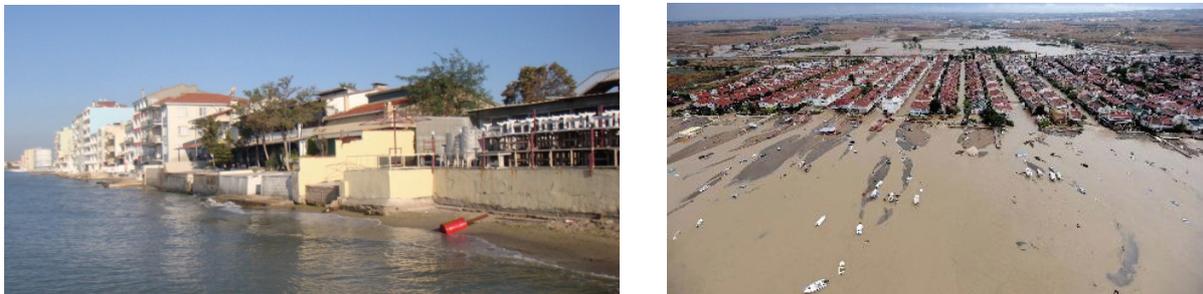
Hastily-erected constructions are the other important reason for the occurrence of flashfloods and floods in İstanbul. During extraordinary precipitation, these constructions, which completely block the coast and do not allow runoff to discharge into the Marmara Sea, have been a significant triggering factor for urban flashfloods and floods in İstanbul (Figure 10). These constructions, between the D100 motorway and Marmara Sea, have not only created an artificial barrier and modified natural slope features, but also created a small artificial basin within each site (Figure 4, 5 and 10). Because of the slope and elevation characteristics, roads between the constructions have acted as natural stream channels for surface runoff during extraordinary precipitation (Figure 10).

**Figure 10.** Buildings on the shoreline prevent surface runoff from the catchment area into the Marmara Sea (Marmara Sea coast of Istanbul, September 9, 2009).

- Infrastructure drainage systems in İstanbul need to re-examined and renovated if necessary. They must also be kept in full working order.
- Longshore land-use planning of the İstanbul-Tekirdağ and İstanbul-Tuzla coastline should be revised taking into consideration hydrologic analysis data.
