Crack Analysis in the Sae 1117 Steel Shafts for Inclusion and Heat Treatment Combination Effect

^{1,2,3,4}Totomak Machinery and Spare Parts Co., Turkey

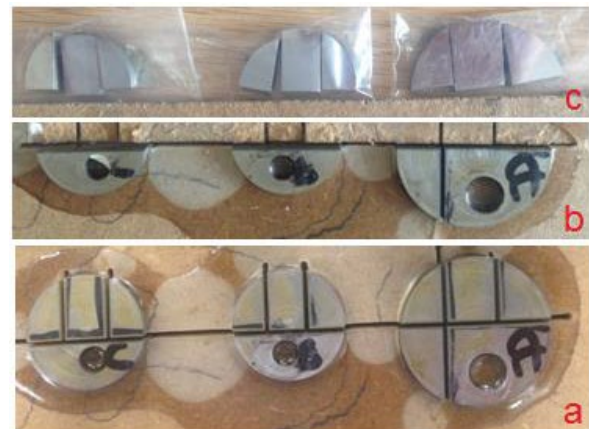
Then, the samples were re-cut with the help of water jet and the surface was polished for microstructure studies. Representative samples obtained after first cutting with water jet has been shown in Figure 2. Parts are polished after being cut with water jet. Figure 3 shows the dimensioning of the samples after the second cut (a), unpolished parts (b), and photos after polishing (c). The images of this experiment, which are examined by camera system. As experimental method, two types of methods can be used for inclusions. The first of these is microscopic test methods and the polished surface is examined by a light microscope and several representative photographs are made by reporting the inclusion types encountered in the sample. Surface polishing is carried out for a satisfactory and more consistent result. The experiment is carried out with samples from three different positions of the part. In order to determine the microscopic image, the polished surface area should be minimum 160

Figure 3. a) Dimensioning of the samples after the second cut. b) Unpolished parts, c) Polished parts

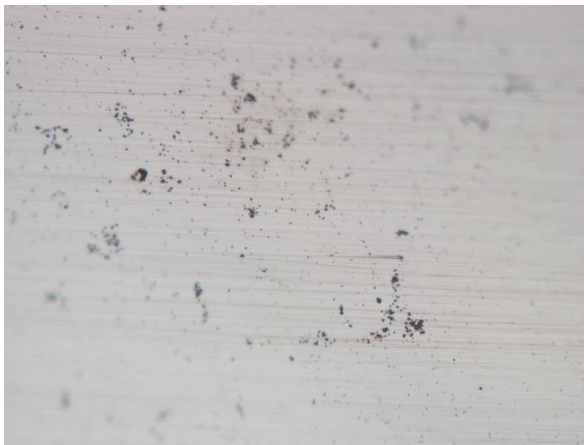
Figure 7 shows the image taken at 20 magnifications from sample B1. Figure 8 shows the image taken at 20 magnifications from sample B2. Figure 9 shows the image taken at 20 magnifications from sample B3.

Figure 7. Sample B1 (20X)

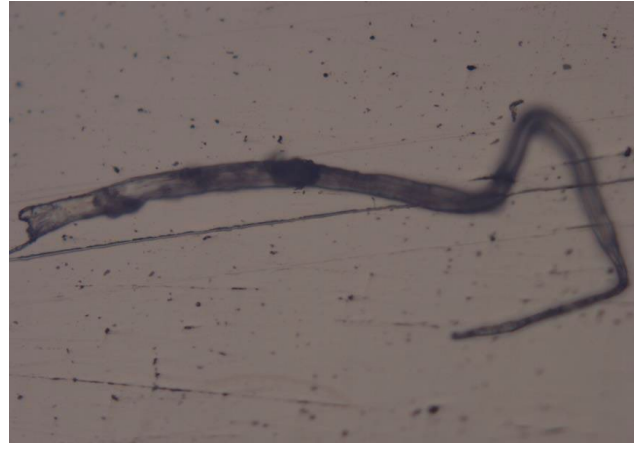
Figure 8. Sample B2 (20X)

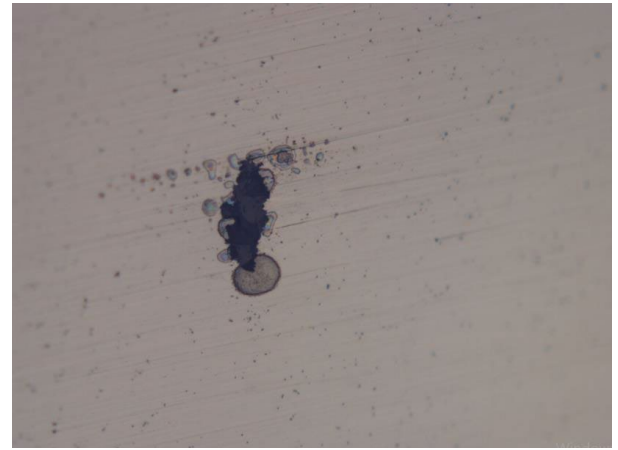
Figure 9. Sample B3 (20X)

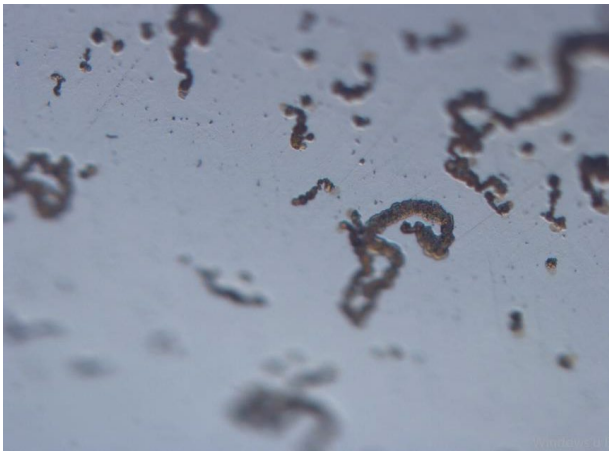
Figure 10 shows the image taken at 20 magnifications from sample C1. Figure 11 shows the image taken at 20 magnifications from sample C2. Figure 12 shows the image taken at 20 magnifications from sample C3.

Figure 12. Sample C3 (20X)

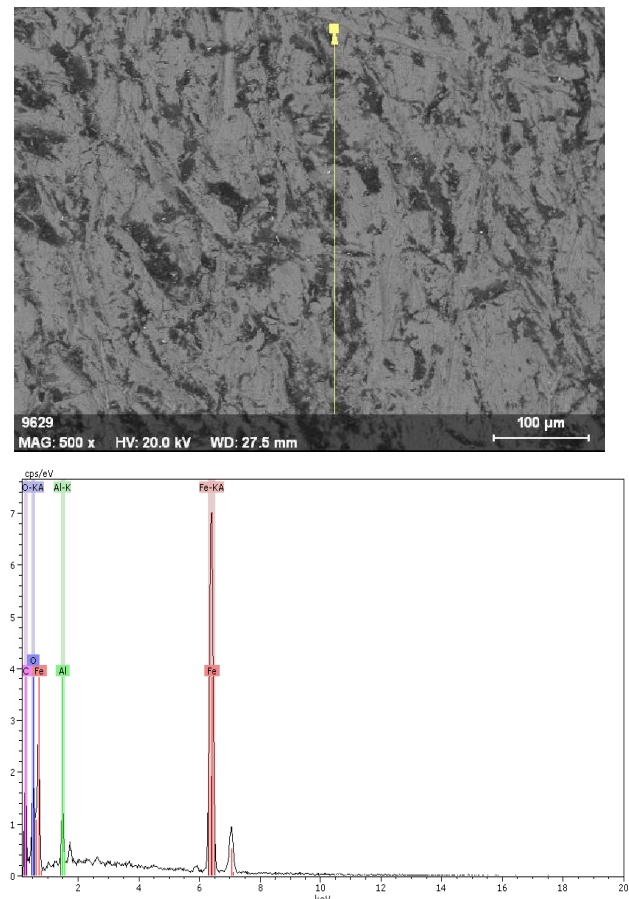
Figure 19 show the vertical section microstructure image and chemical analysis of sample A. Figure 20 show the vertical section microstructure image and chemical analysis of sample B. Figure 21 show the vertical section microstructure image and chemical analysis of sample C.

Figure 20. Vertical section microstructure image and chemical analysis of sample B
