## Use of Dental Implantation in a Dog With Hypodontia in Permanent Dentition

**Abstract:** The purpose of this article is to evaluate clinical properties of a rare hypodontia case in the permanent dentition in a dog, and its treatment by dental implantation. A 1.5-year-old male Canary dog was referred to the surgery department for missing of a tooth. All primary teeth were present except for the right mandibular fourth premolar (P4) at the time of the first dental examination. Mandibular oblique radiographs confirmed the finding of P4 hypodontia. The implant system consisted of an endosseous component, a transgingival collar, a collar-retaining screw, a coping, and a coping-retaining screw. Ceramic implant tooth was placed and fixed by dental acrylic. There was no any implant stability after 3 month the surgery. In conclusion, hypodontia is a rare abnormality that we now know can be seen in dogs. It can reconstructed by implant system and the owner's dissatisfaction can be fulfilled.

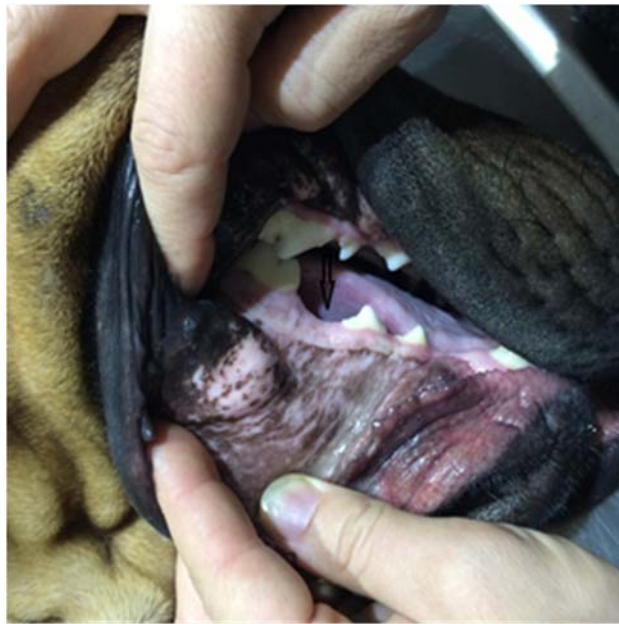
**Figure-1.** View of missing tooth on the right mandible (arrow).

A 1.5-year-old male Canary dog was referred to the surgery department for missing of a tooth (Figure 1). His owner was discontented to this esthetic problem. His body weight was 43 kg. All primary teeth were present except for the right mandibular fourth premolar (P4) at the time of the first dental examination. Mandibular oblique radiographs confirmed the finding of P4 hypodontia. The implant system take placed an endosseous component, hereafter referred to as the implant, a coping, a coping-retaining screw, a transgingival collar, and a collar-retaining screw (Niko Dental, Bad Elstam, Germany).

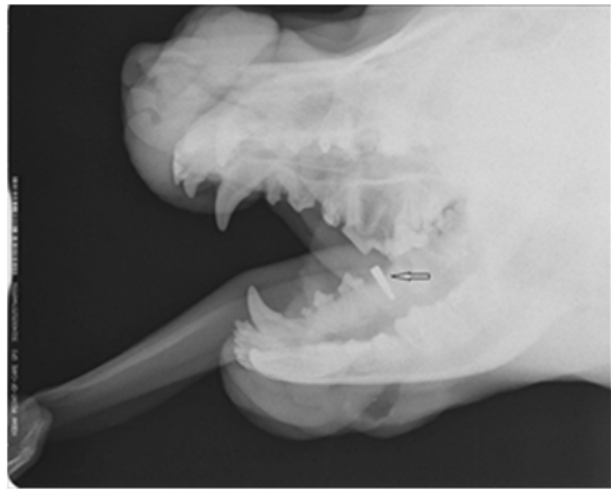
**Figure-2.** The radiographic appearance of the implant (arrow)in the bone level.

Dog was premedicated with xylazine 2 mg/kg IM and atropine 0.04 mg/kg SC, and general anesthesia was induced with ketamine 10 mg/kg IM. Directly on the ridge crest, a crestal incision was made in the linea alba. A hole (4.0 × 11.5 mm) was made by drill. This hole dilated by 4.2 × 11.5. For implant, the insertion torque, which demonstrates the cutting resistance of bone when its spin is stopped, was patented in Ncm (Saeshin, Korea). The implant was established at the bone level (Figure2). After stable installation of implant, cover screw was bonded to it (Figure3). The dog was then discharged and permitted only pureed food for the

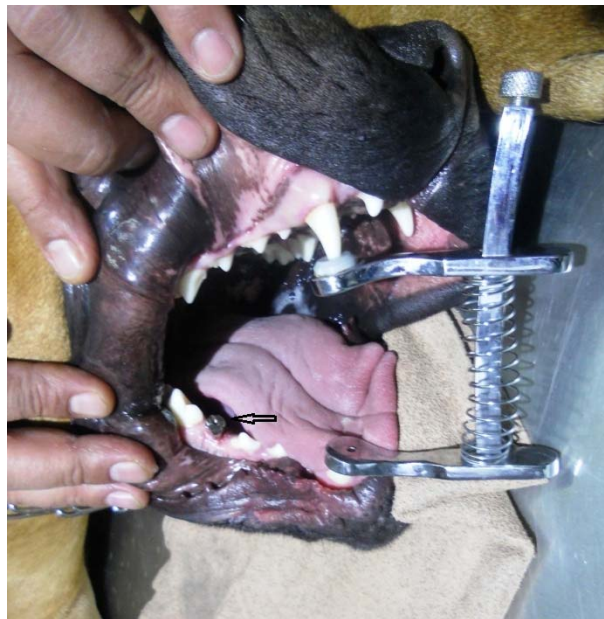
**Figure-3.** View of implant and cover screw (arrow) on the right mandible.

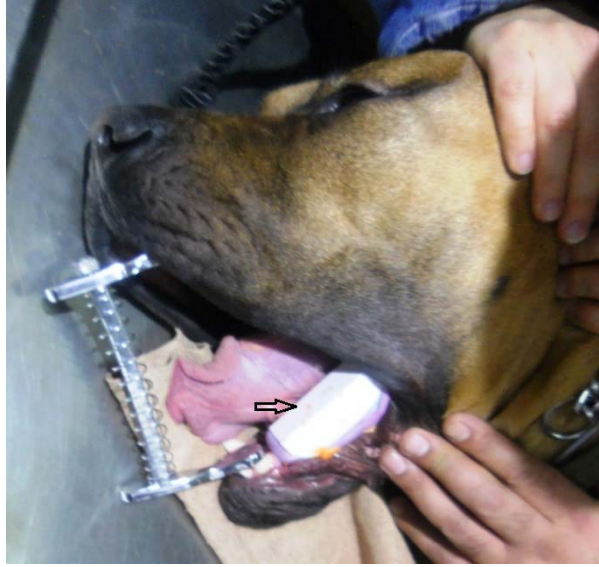
**Figure-4.** View of tooth mold (arrow) on the left mandible.

Transfer was placed right mandible. Two stage tooth mold was done by silicone gel (zeta plus, Italy) with 2 spatula. Mold of missing tooth was taken. Additionally, contrary P4 mold was also done (Figure 4). During a second procedure, the cover screw was lifted from implant, and the collar-retaining screw and collar were enclosed and squizzed with a small screwdriver and the anti-torque wrench. Next, the coping-retaining screw and coping were attached, the latter being squizzed minimally. Abudment was added on implant. After abudment was covering by teflon tape and tempit item. Abudment was applied by anticeptic and saliva was cleaned from area. Ceramic implant tooth was placed and fixed by dental acrylic (Aifix) (Figure 5). Radiographs were taken pre-operatively and immediately postoperatively (Figure 6). Thereafter, radiographic follow-up was planned at the scheduled monthly examination.

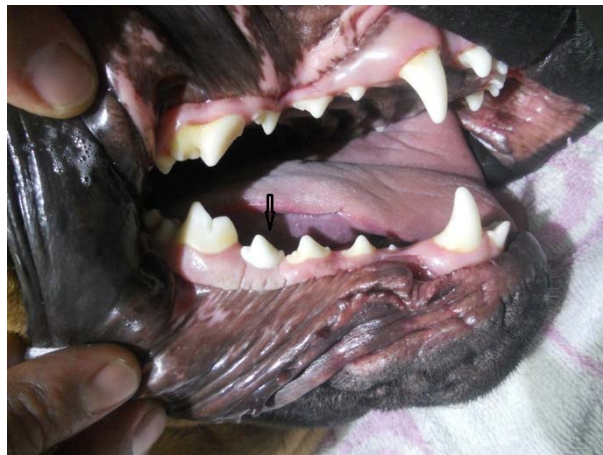
**Figure-5.** View of ceramic implant tooth(arrow) on right mandible.

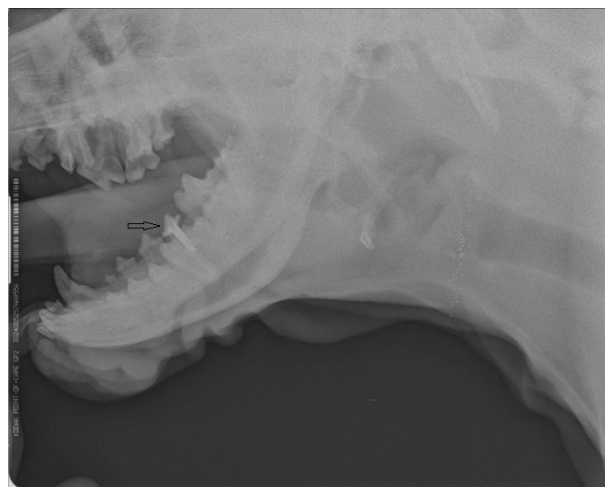
**Figure-6.** The radiographic appearance of ceramic implant tooth (arrow).

It was noted that the bone implant score obtained from radiographic analysis was an accurate means of assessing peri-implant bone height is confirmed by the good correlation between bone implant score values and data on peri-implant attachment levels and pocket depths (8). By the radiographs bone implant score determined type II in implantation site on mandible. In conclusion, hypodontia is a rare abnormality that we now know can be seen in dogs. It can reconstructed by implant system and the owner's dissatisfaction can be fulfilled.
