Structural Performance Assessment of Historical Dilovasi Sultan Suleyman (Diliskelesi) Bridge in Turkey

Ferit ÇAKIR

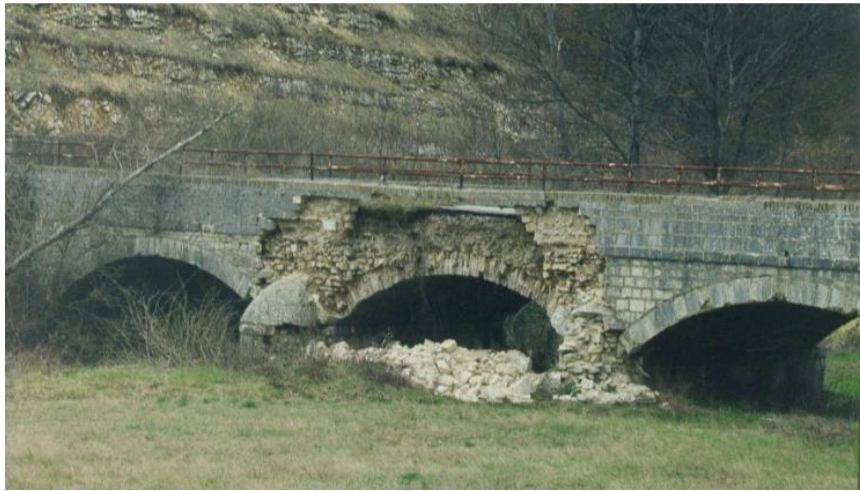
Figure 2: Collapse of spandrel of a masonry bridge during the 1997 Umbria-Marche earthquake

Masonry arch bridges are exposed to many different external and internal effects throughout their lives. An understanding of the load carrying capabilities of these bridges and an estimation of the type and intensity of load on them would be beneficial in order to better understand the performance of these bridges and how they have been able to survive the changes in the loading regime. The fact that many masonry bridges have been able to keep up with these loads and changes is a testimony to the complexity of their structural behaviors. Major loads on masonry bridges are dead loads, live loads, lateral loads, and water and earth forces. Lateral loads are horizontal loads acting on the structures and might be the most dangerous loads for masonry bridges. The most common lateral load is due to earthquake which has a dynamic nature. An earthquake load is a function of the mass of the structure and the intensity of the ground acceleration. Since the nature of earthquakes is random, the timing of the occurrence and the magnitude of the corresponding loads due to earthquake is uncertain. Therefore, the potential damaging effects of earthquakes may become more severe than those of the wind loads. Masonry bridges have large masses due to heavy construction materials such as stones, bricks and mortars. Thus, earthquake load significantly affects masonry bridges. The heavy mass increases the intensity of the force on the bridge. At the same time, the ancient masonry structures lack the structural ductility that is needed to perform well during earthquakes. As a result, the masonry bridges are vulnerable to earthquakes and seismic effects have been among the most important reasons for collapse among masonry bridges. Earthquake loads originate from ground shaking and formation of seismic waves which usually have two major components -- horizontal and vertical. Recent research shows that the horizontal waves are more dangerous than the vertical waves on masonry structures; and many ancient and newer masonry structures have been destroyed due to horizontal waves (Meyer, 2006). According to the reports on earthquake damages on masonry bridges, earthquake damages are observed in the spandrels (Figure 2) or the superstructures (Figure 3) (Cakir and Seker, 2015; Cakir, 2011).

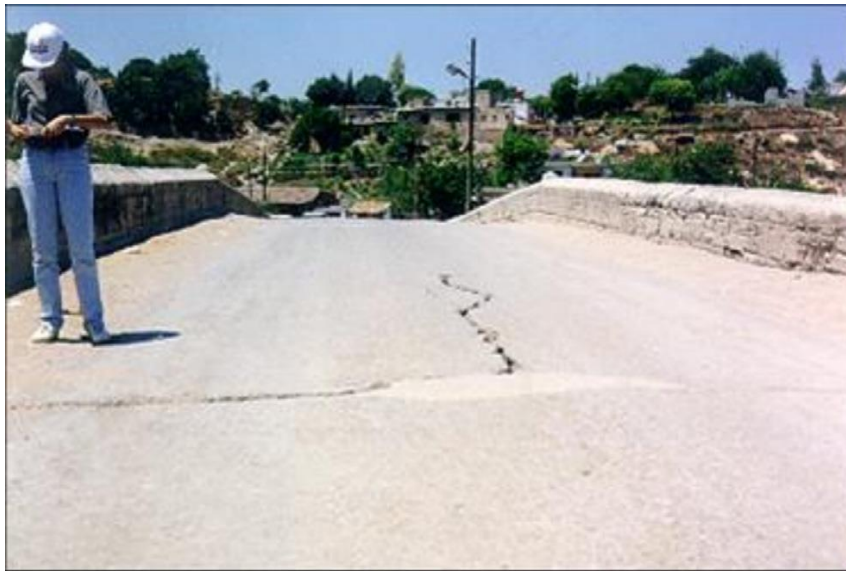
Figure 3: Damages occurred in superstructure of the Misis Bridge during the 1998 Adana-Ceyhan earthquake (Ural et al. 2008)
