Research Article

Color Differentiation of Wall Stones: Historic Karatay College Building

Abstract

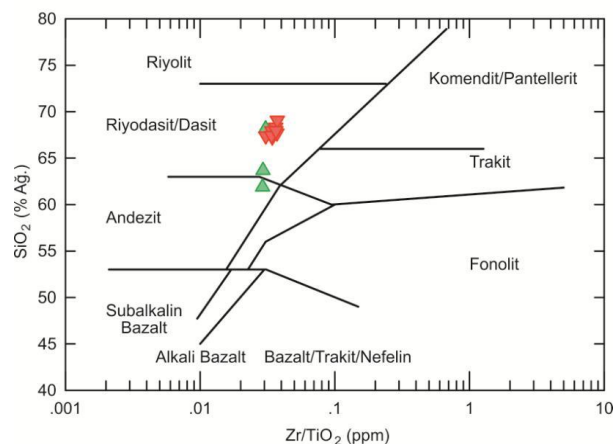
Figure 2. Classification of rocks according to SiO_2 - Zr/TiO_2 composition on Winchester & Floyd [12] diagram; Green triangles: Tuff samples from KMuhsine formation, Red triangles: Lava rocks from Sulutas volcanites, [2].

Saydam defined his samples obtained from *Sulutas formation (lava rocks)* as *rhyodacite-dacite* by using the graph given in Fig. 2. Besides geological background of Sille stones (mainly Sulutas volcanics), certain mechanical properties of this rock have also been studied by other researchers [13, 14, 15] to understand Sulutas volcanites' building stone behaviors and characteristics. Fener & Ince [15] named their test samples obtained from Sulutas volcanites (Sille stone quarry) as *quartz-andesite*. They tested these building stones for freeze-thaw characteristics. They wrote that freeze-thaw cycles influenced *quartz-andesite* stone samples' physico-mechanical properties. Kansun [16] worked also on Sille stones and he noted that, quartz-andesitic and rhyodacitic-dacitic rocks are very similar to each others and they can transitionally be observed in Sulutas rock formation at Sille quarry. Andesitic rocks especially andesitic tuffs as a member of KMuhsine formation give outcrops widely enough around Kucuk Muhsine village near Konya. As Ozkan [17], wrote that, KMuhsine rock formation consist of beige, creamy and pink colored volcanic breccias, tuffitic rocks, tuffs and agglomerates. Ince [18] pointed that andesitic tuffs around Konya have also been used for building purposes together with Sille stones throughout the historical times.

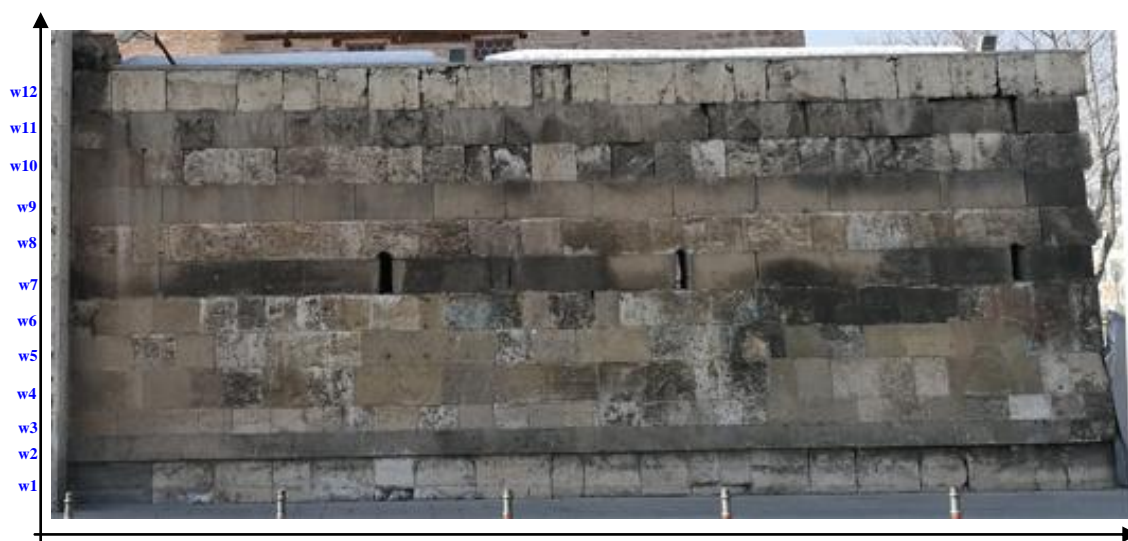
Figure 5. Digitized photograph of Karatay College frontal wall [3]. Dimension stones were numbered according to their positions over the main road (pedestrian, pavement) level.

Surface colors (RGB values) of dimensioned building stone used for Karatay College building frontier wall's outer face had been determined one by one through the digitized photograph shown in Fig. 5. The differences in RGB colors among face stones of the wall and other rhyodacitic-dacitic and andesitic tuff stones surfaces photographed for this research can easily be detectable in Fig. 6 and 7. Karatay College wall stones have been influenced by weather conditions similar to Konya city centre. These face stones were situated in vertical plane and thin concrete protection (8 cm thick) layer at the top of the wall was molded at earlier repair works. Therefore, building stones of this wall have rarely been affected by direct snowing and raining. However, indirect influences on the wall have possibly been occurred for years. In addition, foundation of this wall might have been bothered by groundwater (capillary effects). Beside of these features, the wall stones have been dreadfully influenced by heavy city traffic vibrations, exhaust fumes and particles. One of the busy city roads in Konya is just located after 3 meters of pavement (Fig. 1a). This fact has been one of the main disturbing factors on surface colors of the wall. In addition, Karatay College rooms at the back of the analyzed frontier wall were diminished in history [4]. Therefore, any permanent/temporary room

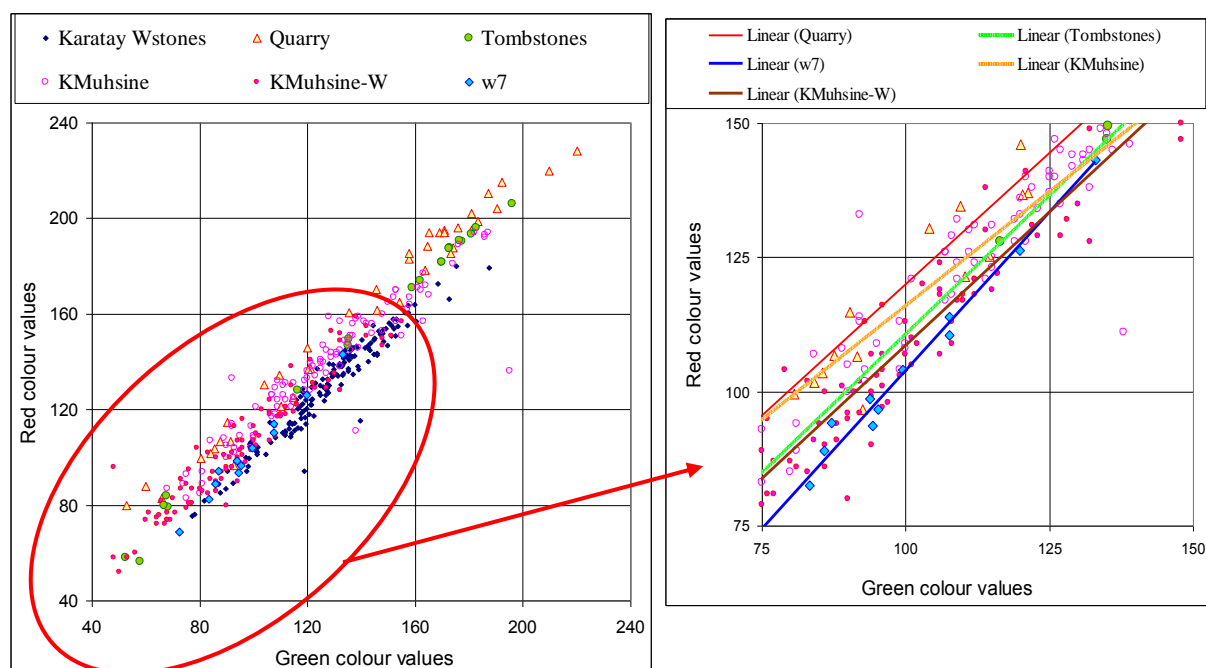
Figure 6. Green-Red digital color codes of selected Sille stones' and KMuhisine tuffs' surfaces colors (together with representative linear lines to compare their positions); **Karatay Wstones:** Karatay wallstone surface colors, **Quarry:** Sille stone surface colors at the quarry (fresh rock surfaces), **Tombstones:** Rhyodacitic-dacitic tombstones in Sille cemetery (200-400 years of weathering), **w7:** Rhyodacitic-dacitic stones used at Karatay College frontal wall's 7th layers (more than 128 years of weathering). **KMuhisine:** Surface colors of andesitic tuffs in KMuhisine formation, **KMuhisine-W:** Surface colors of weathered andesitic tuffs around Kucuk Muhisine village.

decisions if the stones should be replaced or not. In this research Sille stones, (rhyodacitic-dacitic lava rocks in Sulutas formation) and andesitic tuffs (KMuhisine formation) were analyzed for their surface color changes. After obtaining each building stone's surface colors, their differences were evaluated through Green-Red and Blue-Red color band graphics (Fig. 6 and 7) as it was performed for weathered rocks before (Fig. 4). In addition, recognized rhyodacitic-dacitic stones used as tombstones in Sille-Konya were then photographed together with these rocks' mining sites at Sille stone quarry. Thus, the data sets for rhyodacitic-dacitic lava rocks' surface colors were formed for further color analyses to recognize their color differences. Surface colors of weathered rhyodacitic-dacitic rocks in this data set were obtained from; Karatay College frontal wall, historic Sille cemetery tombstones. Fresh rhyodacitic-dacitic rock surface colors were also digitized through the photographs of related locations at Sille stone quarry site. Similar data set were prepared for andesitic tuffs and weathered surface of them. Surface colors obtained from rhyodacitic-dacitic Sille stones and andesitic tuffs were plotted in Fig. 6 and 7 to understand if there is any pattern for logical reasoning and conclusions. In these graphs, colors of Karatay College frontier wall's face stones can be differentiated without difficulty from the other test samples. They have in general lower Red color values and higher Green and Blue color values. Especially face stones of 7th layers of this wall have illustrated more darkened colors (Fig. 5) which were distinguished through the color graphics given in Fig.6 and 7. Curves defining color data obtained from face stones of Karatay College frontier wall's 7th layers stones have:

$$y=(1.1776)x+13.859 \quad (R^2=0.9835), \quad y=(1.4127)z+29.595 \quad (R^2=0.9516) \text{ linear relation.}$$

Similar color relations for rhyodacitic-dacitic quarry stone surfaces have:

$$y=(0.9788)x+22.118 \quad (R^2=0.9796), \quad y=(0.9293)z+47.295 \quad (R^2=0.8566)$$

similar linear color relation of rhyodacitic-dacitic tombstone surfaces at Sille cemetery have:

$$y=(1.0366)x+6.7428 \quad (R^2=0.9956), \quad y=(1.0758)z+17.388 \quad (R^2=0.9835)$$

similar linear color relation of andesitic tuffs and weathered andesitic tuffs surfaces observed around Kucuk Muhsine village simultaneously have:

$$y=(0.8541)x+30.332 \quad (R^2=0.8656), \quad y=(0.7148)z+63.564 \quad (R^2=0.7519)$$

$$y=(0.992)x+9.3924 \quad (R^2=0.9405), \quad y=(0.8642)z+31.099 \quad (R^2=0.7857)$$

In these equalities, y , x and z variables are representing x : Red, y : Green and z : Blue color codes in RGB color system.

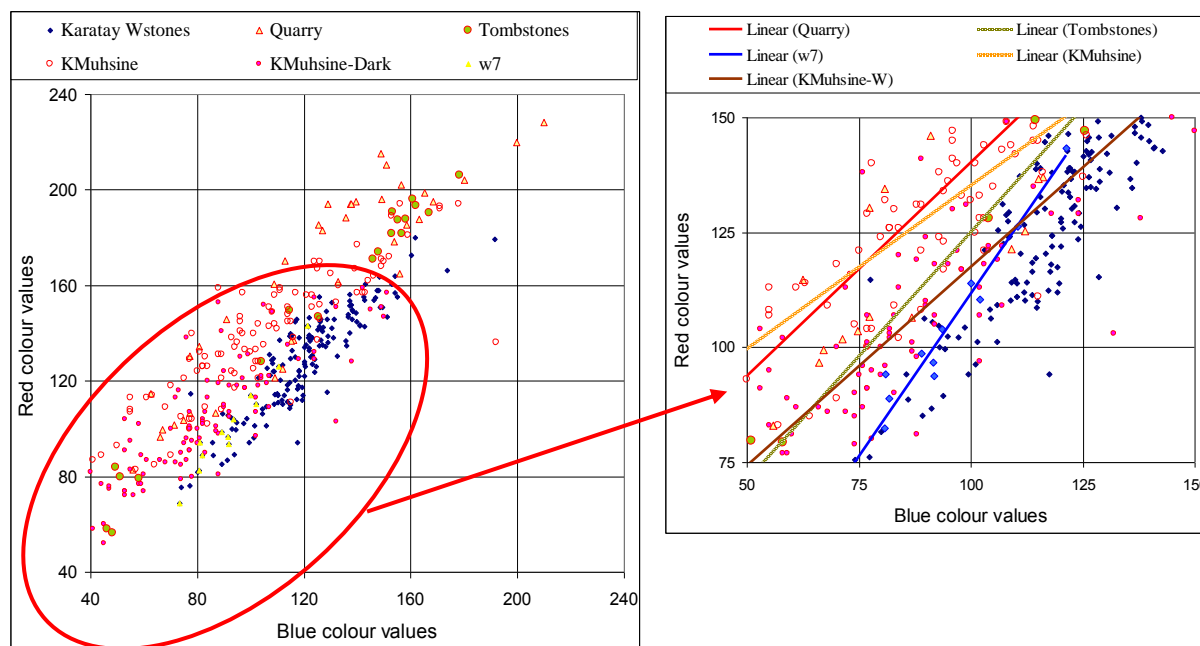
Figure 7. Blue–Red digital color codes of selected Sille stones' and KMuh sine tuffs' surfaces colors (together with representative linear lines); **Karatay Wstones:** Karatay wallstone surface colors, **Quarry:** Sille stone surface colors at the quarry (fresh rock surfaces), **Tombstones:** Rhyodacitic-dacitic tombstones in Sille cemetery, **Sille-Wstones:** rhyodacitic-dacitic Sille stones used at the walls of Sille village historical houses, **w7:** rhyodacitic dacitic stones used at Karatay College frontal wall's 7th layers. **KMuh sine:** Surface colors of andesitic tuffs in KMuh sine formation, **KMuh sine-W:** Surface colors of weathered andesitic tuffs around Kucuk Muhsine village.
