## Case report

# One-year follow-up of immediately-placed implants with early radiographic signs of failure: report of two cases

**CITATION:** Sağırkaya E, Bekçioğlu B, Çehreli MC. One-year follow-up of immediately-placed implants with early radiographic signs of failure: report of two cases. *Acta Odontol Turc* 2015;32(3):144-8.

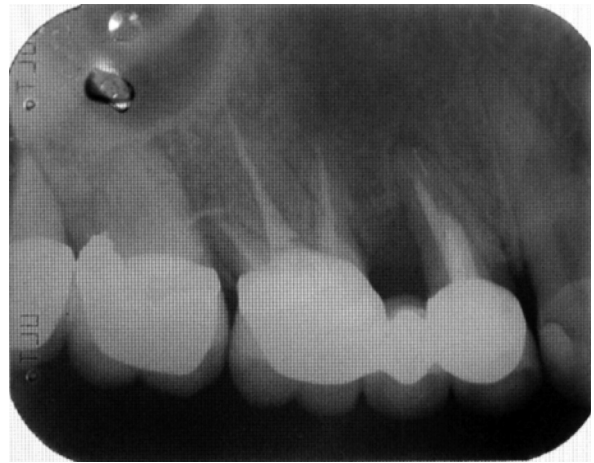
**Figure 1.** Preoperative periapical view of the site. The chronic periapical radiolucency and bone loss around the premolar and the excessive loss of bone around the distobuccal root of the molar

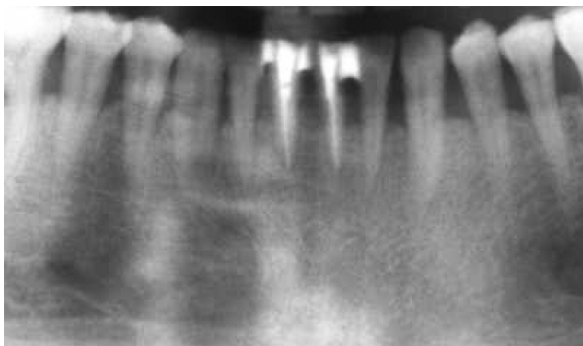
**Figure 4.** Preoperative sectional view of the site in a panoramic radiograph

tic therapy and the teeth had 40-50% horizontal bone loss (Figure 4). The incisors were extracted, two implants ( $\text{AE } 3.75 \times 15 \text{ mm}$ ; MKIII TiUnite) were immediately placed in sites of lateral incisors, and an immediate removable denture was delivered to the patient. Likewise, primary closure of the surgical site was provided by full-thickness flaps sutured and kept in place for 1 wk. This patient was also prescribed antibiotics, analgesics, and 0.2% chlorhexidine gluconate postoperatively for 1 wk. At three months of healing, the cover screws of the implants were exposed allowing direct examination of the implants, which were stable. In addition, both sites did not show any signs of pocket formation and peri-implantitis. Radiographic examination, however, showed wide radiolucent areas around both implants, which exceeded the previously-existing roots (Figure 5). As the implants were asymptomatic, a cement-retained 4-unit fixed partial prosthesis was delivered to the patient. The patient did not feel pain during torque-tightening of the abutments. The implants were stable in place and the peri-implant soft tissue health
