## **CONCOMITANT OPEN INTRACARDIAC REMOVAL OF GIANT VEGETATION LOCATED ON ENDOCAVITARY PACEMAKER LEAD AND BEATING HEART CORONARY BYPASS SURGERY**

#### **ABSTRACT**

The prevalence of infection of permanent pacing material ranges from 0.13 to 19.9% of patients according to published series. In this study, we report a case retrospectively that is lead endocarditis complicated with giant vegetation in a patient with pacemaker and successful surgical removal of this infected device with concomitant beating heart coronary bypass procedure.

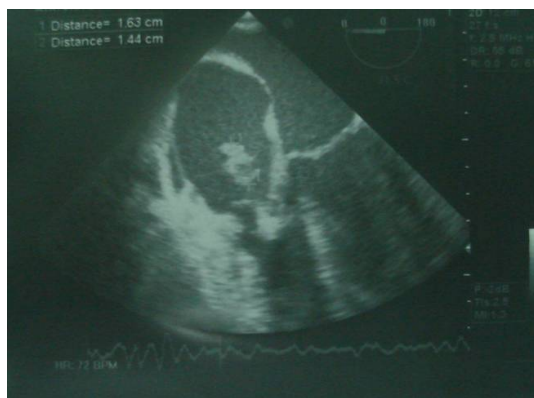
**Figure 1.** Transthoracic echocardiographic view of the vegetative mass on the lead at the time of admission.

showed a mobile hyperechoic mass on the right atrial and ventricular leads, consistent with vegetation. Transesophageal echocardiography confirmed that there was a mobile mass of 16x14 mm within the right atrium, entering into and exiting from the ventricle, consistent with vegetation (Figure1). A triple antibiotic regimen consisting of ceftriaxone+vancomycin+rifampicin was initiated after consultation with Department of Infectious Diseases since the most probable etiological agent in PM endocarditis was coagulase (-) staphylococcus species. Emergency surgical

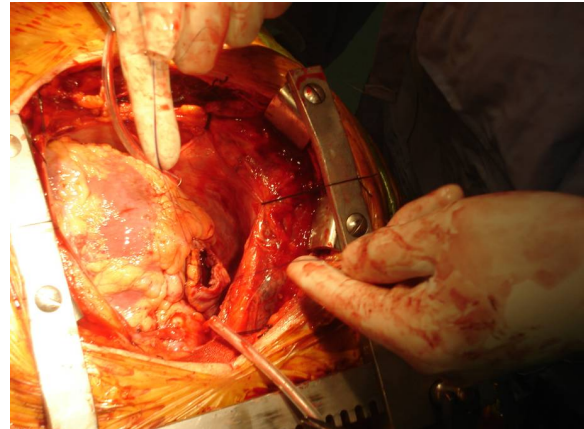
**Figure 2.** Perioperative view of the excessive adhesions within right atrium.

But, it failed due to excessive adhesion to the right atrial wall and subtotal occlusion of the superior vena cava (Figure 2). Upon this, aorta and inferior vena cava were cannulated establishing partial cardiopulmonary bypass. Right atriotomy was safely extended and adhesive tissues were dissected. The PM lead was explored and extracted with two large vegetative masses on (Figures 3&4). In the last stage, a pocket for the generator was prepared beneath the left

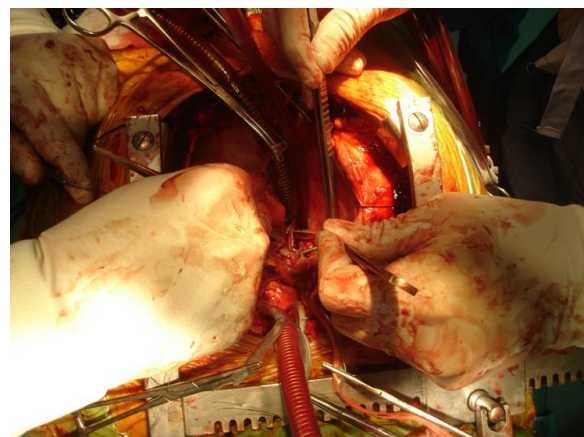
**Figure 3.** Perioperative view of the infected PM lead end showing two different vegetations.

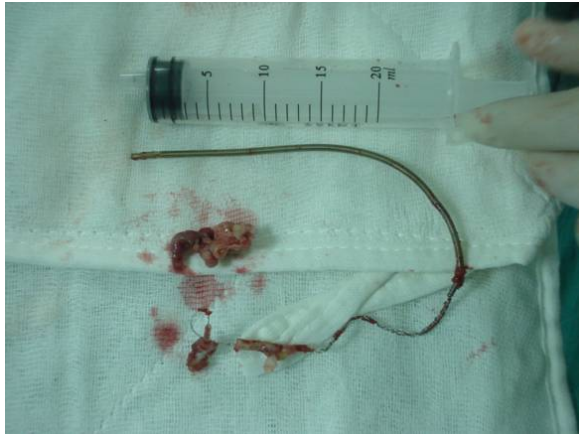
**Figure 4.** Extracted PM lead end and giant vegetation.

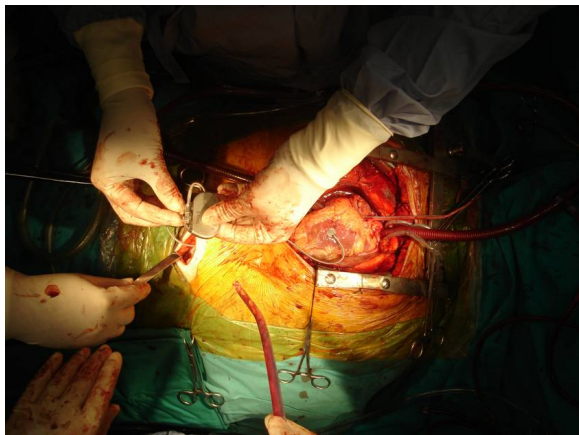
**Figure 5.** New permanent epicardial PM implantation during last period of operation.

rectus sheath and a new permanent epicardial pacemaker was implanted (Figure 5). Microbiologic investigation revealed no growth in culture of vegetations as it was for the postoperative blood cultures. By reconsulting the case with Department of Infectious Diseases, antibiotherapy was continued for 6 more weeks postoperatively and he was discharged afterwards with complete recovery. Outpatient follow-up was carried out by Cardiology department without any problem.
