HERITAGE RECORDING WITH 3D LASER TECHNOLOGY: THE CASE OF LORD' S BATH (BEY HAMAMI) IN MUĞLA, MİLAS

3D Laser Scanning,
Architectural Survey,
Heritage Recording,
Medieval Bath

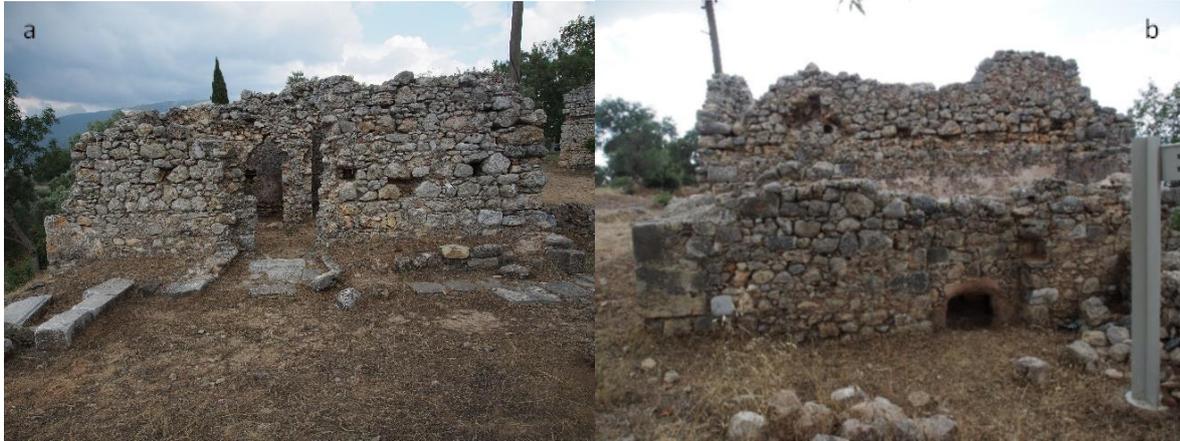
Fig.3 Entrance of Hot Room (a) and Furnace (b), Gökçe Altay's Archive, 2018

The Bath (Fig.3-a and b) is one of the 6 baths in the City of Beçin and was named as the Lord's Bath (Bey Hamamı) by one of the site directors, Prof. Dr. Hüseyin Rahmi Ünal. Unfortunately, the inscription tablet of the bath was lost and since the archives of Mentеше is lost [8], it is not possible to determine the exact date of construction. The bath is dated to 15th century by Prof. Dr. Hüseyin Rahmi Ünal but a more comprehensive study can be done after the detailed documentation. According to excavation reports, only the northern seclusion of the hot room excavated in the structure. The movable cultural heritage assets can be dated back to the 15th century according to the excavation reports [9,10].

The reason of the selection of this bath for this study and makes it distinctive amongst the other structures in Beçin is its unique and rare moulded stucco decorations. These rare decorations attributes historic and aesthetic values to the bath. Due to the absence of roofing these decorations are in danger of destruction and immediate conservation interventions are needed.

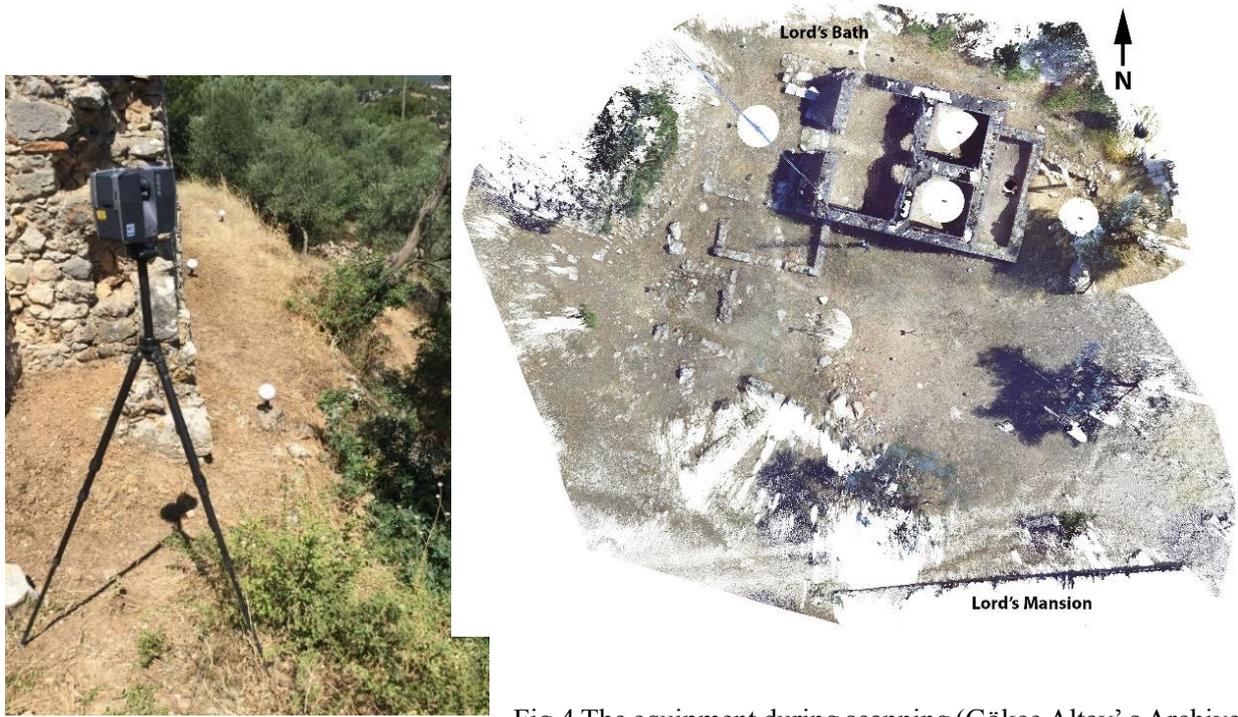
Fig.4 The equipment during scanning (Gökçe Altay' s Archive, 2019) (a) and scanned area (b)

The architectural survey was conducted in 16 sessions for adequate resolution by FARO Focus 3D laser scanning equipment in 2 hours. The equipment can be seen in fig.4-a with the spheres used as reference points for less margin of error. In order to place the building on the Beçin city map properly, a small part of a nearby building (Lord's Mansion) were also scanned as a reference. Considering top view, an area of approximate 830 m² was scanned (fig.4-b). At the end of this process, raw scan data were obtained in 16 different files.

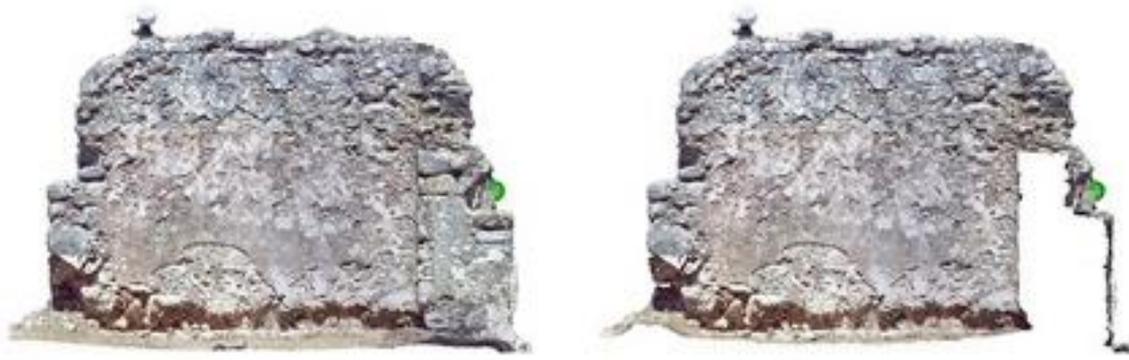
Fig.9 Understanding the irregular material loss on walls via two different sections

6- Practical for application projects: Since the application of conservation projects are rather costly due to the fact that construction materials are expensive and in most of the cases are produced specifically for the structure, quantity surveys should be done properly. A proper quantity survey cannot be done without adequate and accurate drawings. If the structure is partly demolished and there is material loss on different levels, more elaborate and unusual sections are needed in order to understand the material loss and problems as shown in fig. 9.

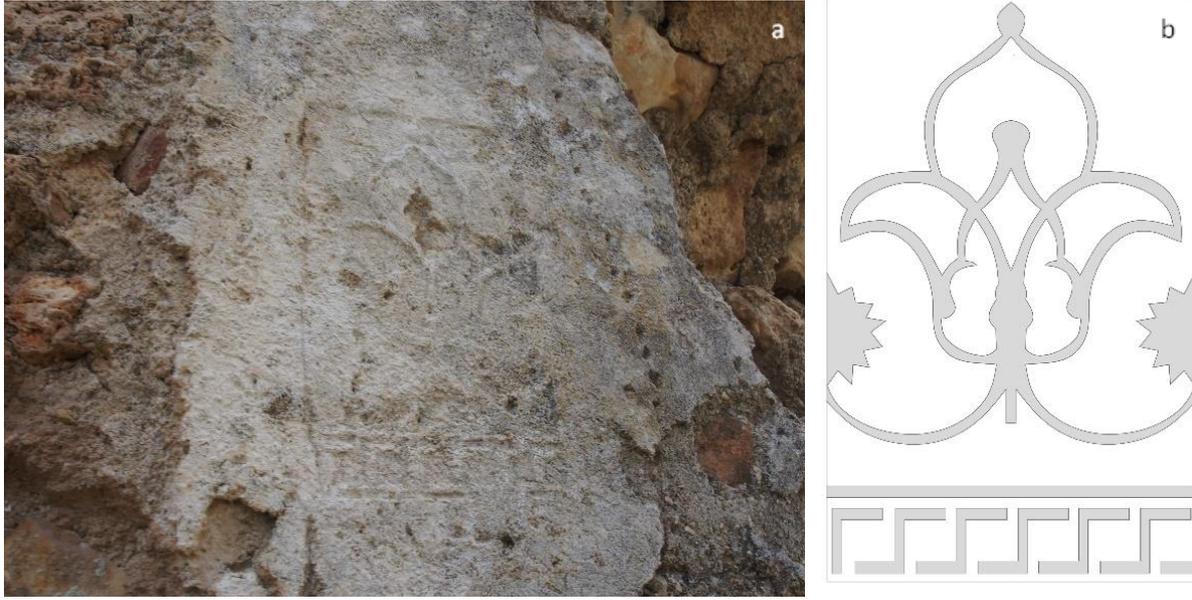
Fig.10 Moulded stucco decoration (Gökçe Altay' s Archive, 2018)(a) and drawing (Gökçe Altay, 2019)(b)

- For this study, 3 plans, 4 facade drawings and 12 sections are produced.
- Moulded stucco decorations are documented separately, because laser scanner's precision was not enough (fig.10-a/b)
