## A Cultural Heritage in the Walled City of Nicosia: "Dervish Pasha Street" from the Past to the Present

Dervish Pasha Street is in the Arabahmet Quarter within the walled city of Nicosia, which has a rich historical texture of architectural works of various historical periods of Cyprus. It presents an important example of historical street texture of the neighborhood with its cultural heritage buildings. The creation of the historical texture of the street began with a two-floor house of Traditional Turkish House, built there during the Ottoman Period (1571-1878). The development of the street texture was completed to a great extent during the British Period (1878-1960) with the building of single and two-floor houses, first with the characteristics of Turkish Architecture, and later with the architectural influences of the period. During the Republic of Cyprus period and the years following that, during which intercommunal political problems and migrations occurred, no change or development was observed in the street texture; however, the demographic structure of the street changed. Works for the preservation of the historical texture of Dervish Pasha Street began in the period

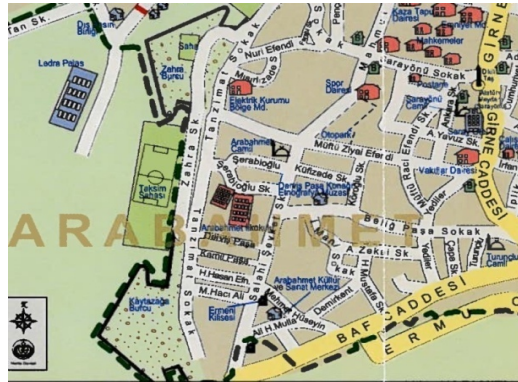
**Figure 1-** Arabahmet District Plan (Map Office of TRNC-2014)

Being close to the governor's mansion in the Sarayönü Square, the area became the district of residence of high-ranking state officials, pashas (Beliğ Pasha, Dervish Pasha, Kamil Pasha), and the Turkish Muslim elite during the Ottoman Period. Evening breezes prevailing in this district during the hot Nicosia summers, also contributed to people preferring this district (Figure 1).

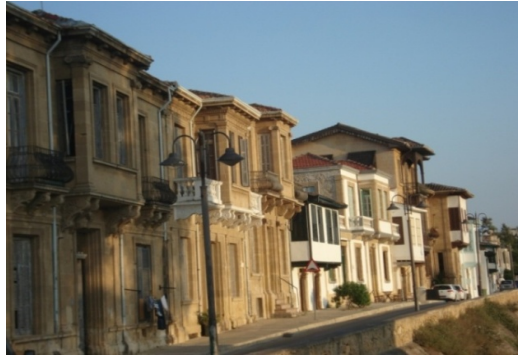
Narrow streets with one or two floor houses, with or without oriel windows, lined up in the Arabahmet District form silhouettes reflecting the history of Cyprus. The yards of houses provided privacy, being placed either in the opposite direction from the street, or separated from the street by high walls (Figure 2).

**Figure 2-** Historical Texture of Arabahmet District (Author-2018)

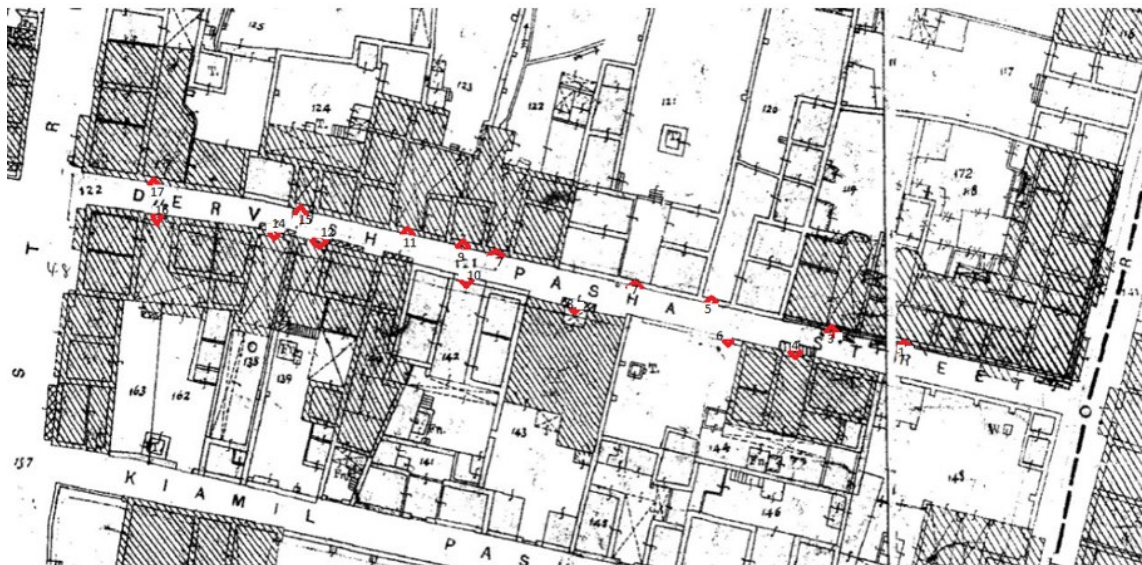
According to research there are no structures in the historical texture of Dervish Pasha Street dating before the Ottoman Period of Cyprus. The texture formation of the street began with the Ottoman Period (Figure 5).

**Figure 5-** Historical Texture of Dervish Pasha Street (Buildings' Plans) (Town Planning Office of T.R.N.C. - 2018)

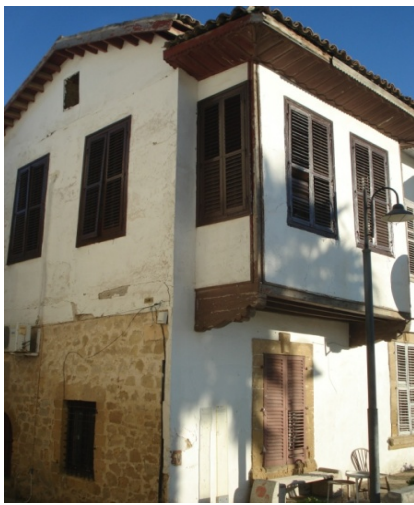
**Figure 6-** Dervish Pasha Street. No: 16 (Author-2018)

Based on the dates 1791 and 1801-1802, and the Nicosia city plan of 1881 (Kitchener Map), the first structure of the historical texture is the house placed on the corner parcel on the south side of the west end of the street, addressed as number 16. This two-floor house with wooden blinds is of the Traditional Turkish House character, over brimming to Tanzimat Street in the west, with a wide eave projection, supported with C-S curved wooden cantilevers. It is assumed that the clock face figure showing 12:30 on the north face of the house is related to the former name of the street "Saatçi Street" (Figure 5, 6, 7).

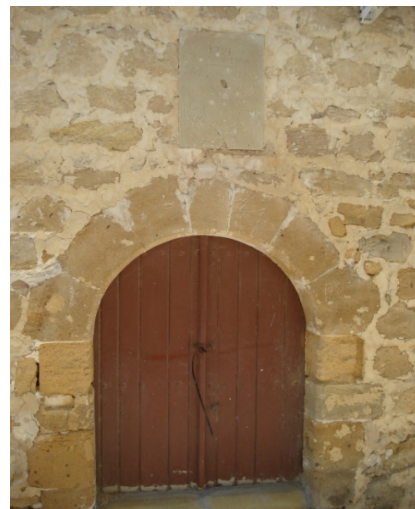
**Figure 7-** Arched door and Clock figure of No: 16 (Author-2018)

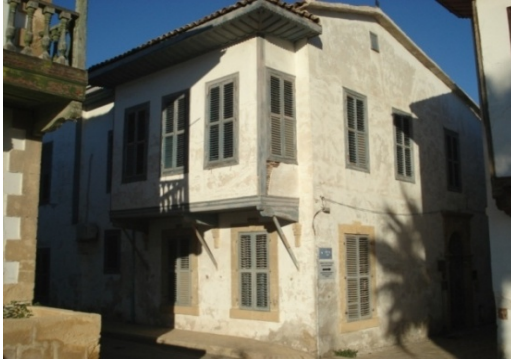
**Figure 8-** Dervish Pasha Street. No: 17 (Author-2018)

During this period, the formation and development of the texture of Dervish Pasha Street continued with the construction of the two-floor house at number 17, placed on the north-west corner of the street. The house, dated to 1884, found above the door arch, is assumed to have undergone alterations in 1904, as shown on the iron lattice of the door. Built in the early years of the British Period, the house is of the Ottoman Period Traditional Turkish House character, with the outer hall type. The bay window of the house, supported by three wooden consoled with buttresses, and surrounded by wide eaves, and having an asymmetrical front on Dervish Pasha Street, makes a projection to Tanzimat Street in the west (Figure 5, 8, 9).

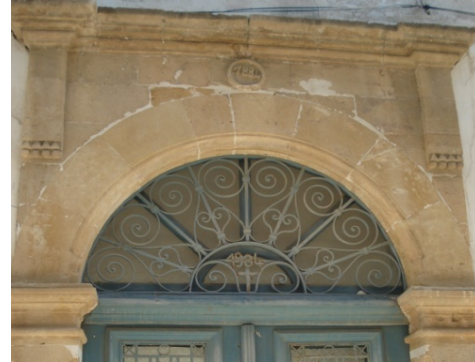
**Figure 9-** Arch of door (Cons. Date) of No:17 (Author-2018)

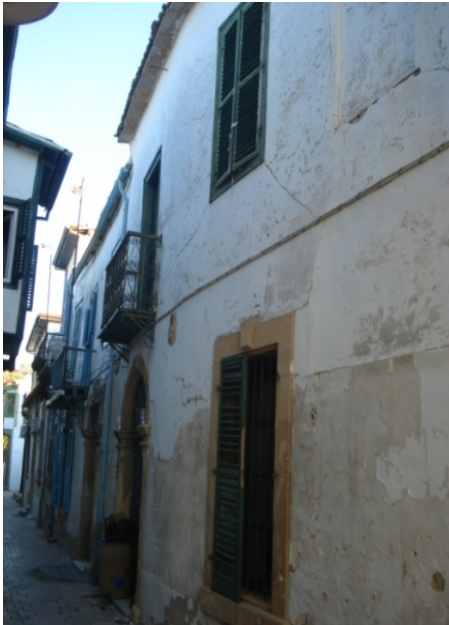
**Figure 10-** Dervish Pasha Street No:14 (Author-2018)

The second building in the street, belonging to the British Period, is the two-floor house at No. 14, placed in the south-west side of the street. The date 1893, on the door of the house is assumed to be the year of construction of the building. The semi-circle arched door and the ground floor window of the asymmetric front building have stone door posts. The windows of the building have wooden blinds, and a balcony with iron railings, and a wooden base carried by iron cantilevers at the upper level of its door (Figure 5, 10, 11).

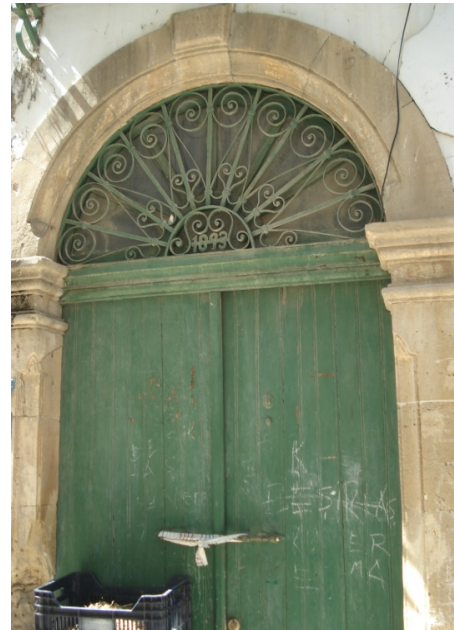
**Figure 11-** Door of Dervish Pasha St. No: 14 (Author-2018)

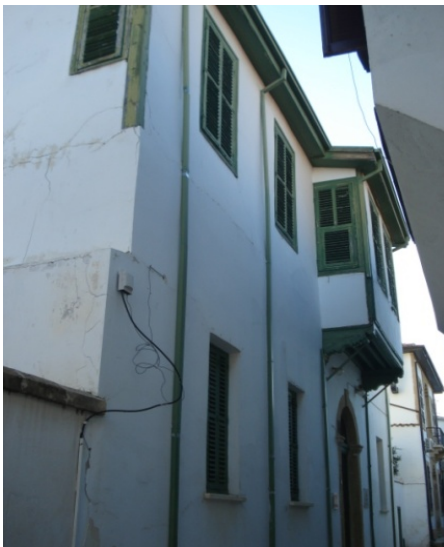
**Figure 12-** Dervish Pasha St. No:4 (Author-2018)

Another late XIX. Century building of the period is the two-floor house on the south of the eastern end of the street, numbered 4 and 6. Known to be constructed in 1896, is an example of the middle hall plan type of the Traditional Turkish House, with its arched door, windows with two wooden sashes, and its bay window, carried on C-S curved wooden cantilevers, projecting into the street. The yard is accessed from the street through a large iron double door. The building is used by the Cyprus Turkish French Cultural Association (Figure 5, 12, 13).

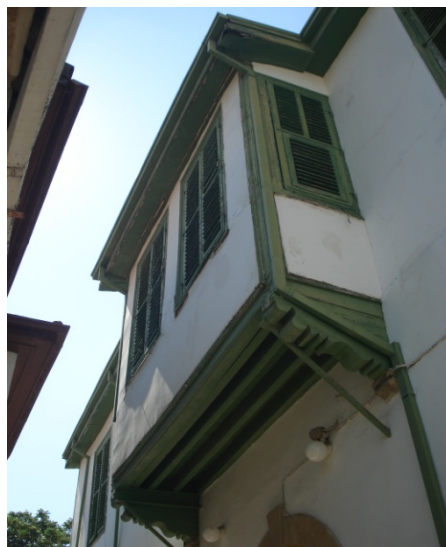
**Figure 13-** Corbel of Dervish Pasha St. No: 4 (Author-2018)

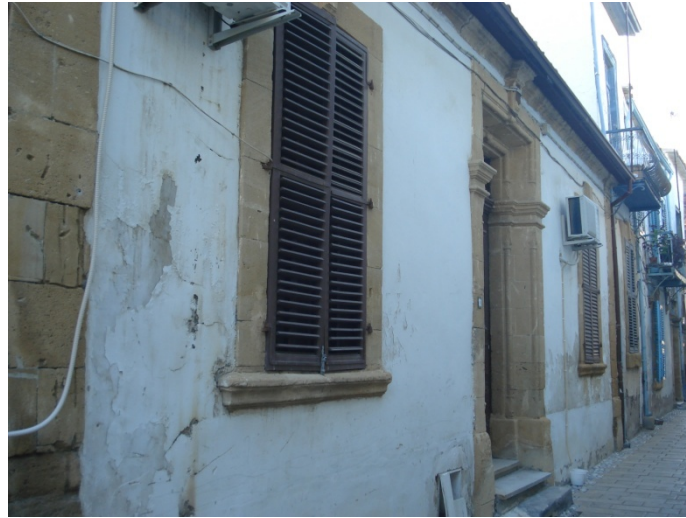
**Figure 14-** Dervish Pasha Street No: 10 (Author-2018)

The house at number 10, on the west of the south side of the street is another building added to the texture of the street during this period. Estimated to be built in 1914, from the date on its door, this building is a ground floor house with a symmetrical façade. On the front façade there is a door in the middle, and a window on each side of it. The door and the windows with wooden blinds with two sashes have stone posts, and border stones on the level of the eave (Figure 5, 14).

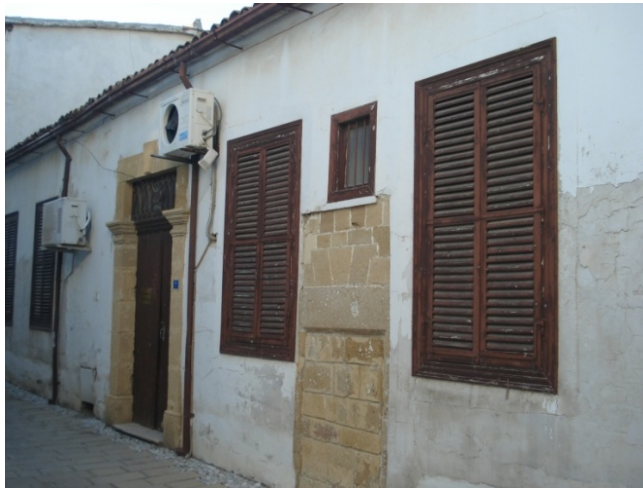
**Figure 15-** Dervish Pasha Street No: 7 (Author-2018)

The single floor building at number 7 takes place on the west part of the north of the street and is a British Period building. The construction date is 1913 (H. 1331), placed on its door. From the information obtained from the Nicosia Turkish Municipality, which carried out the renovation in 1998, reveals that the authentic ground level was 30 cms lower than the present one and that it was built on top of the remains of Lusignan Period (1191-1489), when it was laid with tacked pebble stones. The building with a middle hall plan, has a yard and a symmetrical façade. Its door on the front axle has stone posts, and the windows have two sashed, wooden blinds. Built as a house, the building is used as an art atelier at present (Figure 5, 15, 16).

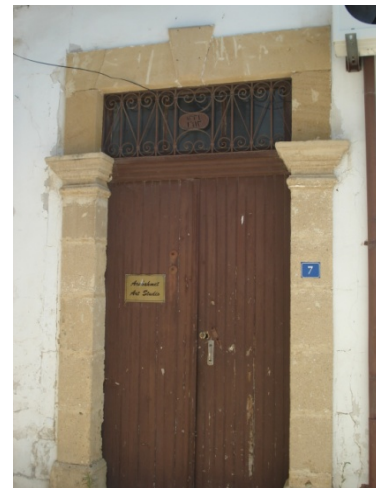
**Figure 16-** Door of No: 7 (Author-2018)

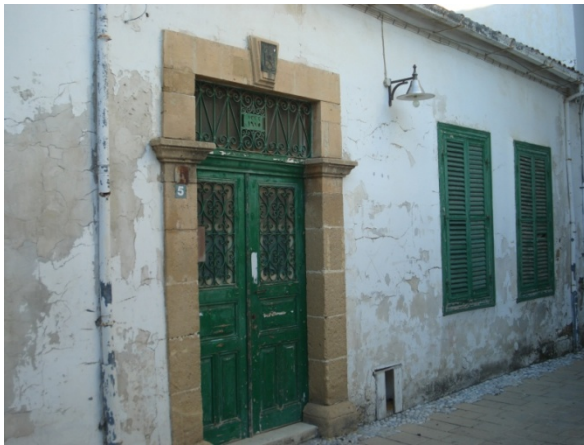
**Figure 17-** Dervish Pasha Street No: 5 (Author-2018)

Another building of this period is at number 5. The construction date of this building, placed on the east side of the north face of the street is assumed to be 1915 (H. 1333), as the date is placed on its door. On the west side of the plastered asymmetrical front of the house is a wooden double door with cut stone posts, and on the east side two windows with double sashed wooden blinds (Figure 5, 17).

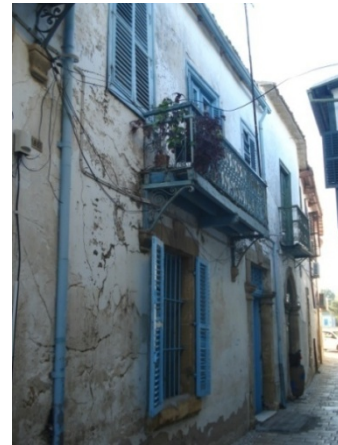
**Figure 18-** Dervish Pasha Street No: 12 (Author-2018)

The house in the east of the south side of the street, numbered 12, was added to the street texture in 1924, as is shown on the iron grid above the lintel level of its door. This two-floor house has an asymmetrical façade. Its double wooden door, and the window on the ground floor are framed with overflowing superficial stone posts. The windows are oblong shaped, with two wooden sashes. On the west side of the upper floor there is a narrow balcony carried on two iron consoles on each side and a wooden one in the middle, stretching east-west, with the base made of wooden planks placed on a rectangular wooden beam. The balcony is surrounded by iron railings. A wooden, double sash door opens to the balcony (Figure 5, 18).

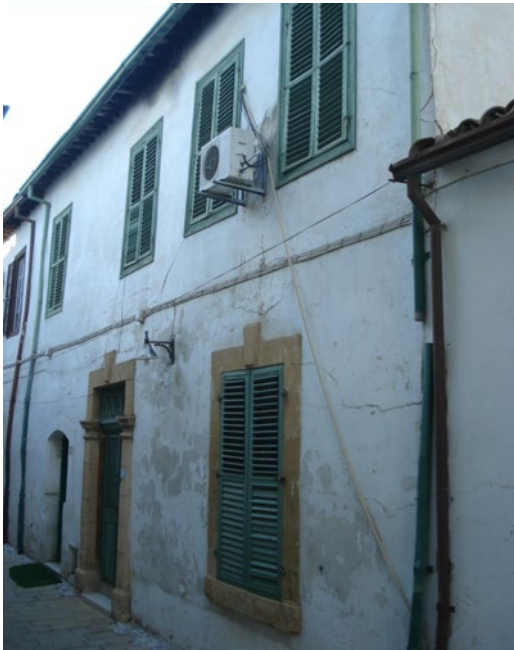
**Figure 19-** Dervish Pasha Street No: 9, 11  
(Author-2018)

The ground floor of the two-floor house on the west side of the north face of the street is addressed as number 9, and the upper floor as number 11. The number 9 house has an asymmetrical front, and its wooden double door and window are framed with stones. The house numbered 11 has a single sash wooden door on the ground floor, and its windows on the upper floor have wooden double blinds (Figure 5, 19). The two-floor house addressed as number 13 at present, on the west of the north side of the street, has an asymmetrical plastered front. All the windows of this house, with stone framed double wooden door and ground floor window, are oblong with two sashes, and wooden blinds (Figure 5, 20). The two-floored house with a bay window, at number 15 is on the west of the north side of the street. Its plastered front axle is symmetrical, with a wooden double door, and single sashed windows on each side, framed with stones. On the upper floor, there is bay window in the center with a double sash window on each side of it with wooden blinds. There is a double sash window with wooden blinds on each side bay window (on the east and west sides only) (Figure 5, 21, 22). The two-floor house at number 8, on the east of the south side of the street can be seen on the historical city plan of 1934. From the front character of the house it is estimated that it was built towards the end of the British Period. The house with a symmetrical front, has a double sash window on both sides of the door. On the upper floor, there is a balcony accessed through a wooden, double door in the middle. The balcony has a

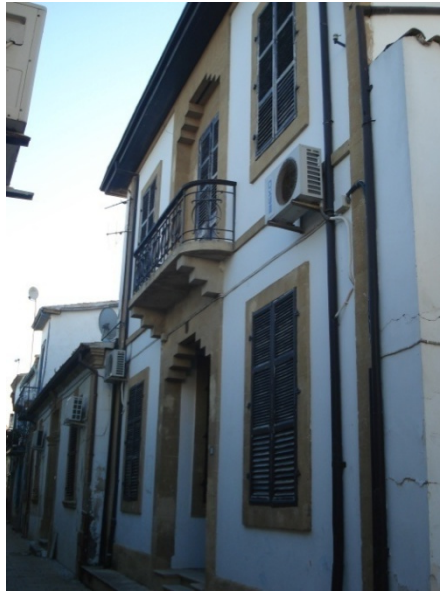
**Figure 23-** Dervish Pasha Street No: 8 (Author-2018)

concrete base carried by cascaded stone posts, and surrounded by iron railings. There are two windows with two sashes, one on each side of the balcony. The rectangular shaped windows have cascaded, superficial stone posts, and are with wooden blinds (Figure 5, 23).

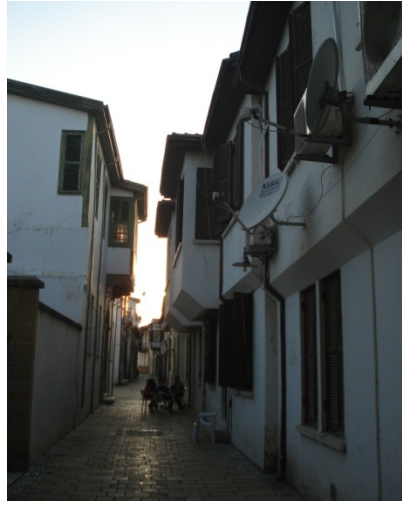
**Figure 24-** Dervish Pasha Street No: 1, 3 (Author-2018)

During this period a house structure, numbered 1 and 3, was built on the corner plot on the east end of the north side of the street, facing Dervish Pasha Street and Şehit Salahi Şevket Street, belonging to a demolished building. There are four houses at number 1, and two houses at number 3. The façade character of the two-floor concrete building, which was started in 1986 and completed in 1989, was built with a slanted tile roof with wooden eaves, rectangular shaped windows with wooden blinds, bay windows on each side, and their façades plastered white, in accordance with the historical texture of the district (Figure 5, 24).
