Evaluating Repairs and Interventions of the Fethiye Camii through the Perspective of Contemporary Conservation Ethics and Principles

Mine ESMER*

Fethiye Camii is located in Istanbul in the Fatih district amidst the historic neighborhood of Çarşamba. The current structure is comprised of the churches of the Monastery of Pammakaristos in the XIV. Regio built during the Byzantine period. From the monastery, nothing but two churches, four cisterns and a burial chamber survive. In the Ottoman rule, Pammakaristos was first in use as a monastery for nuns and a little later it was put in use as the Greek Patriarchate. At the end of the 16th century, the churches of the monastery were converted to a mosque called Fethiye to commemorate the conquest of Azerbaijan and Georgia. The monument has come to our day under this name. In 1963, a section of the monument was inaugurated as the Fethiye Museum. Fethiye Camii has possessed various identities and has served many functions and communities over time. Currently the monument presents complex problems of architectural history and conservation. Multiple repairs throughout its long history have resulted in various transformations in its physical

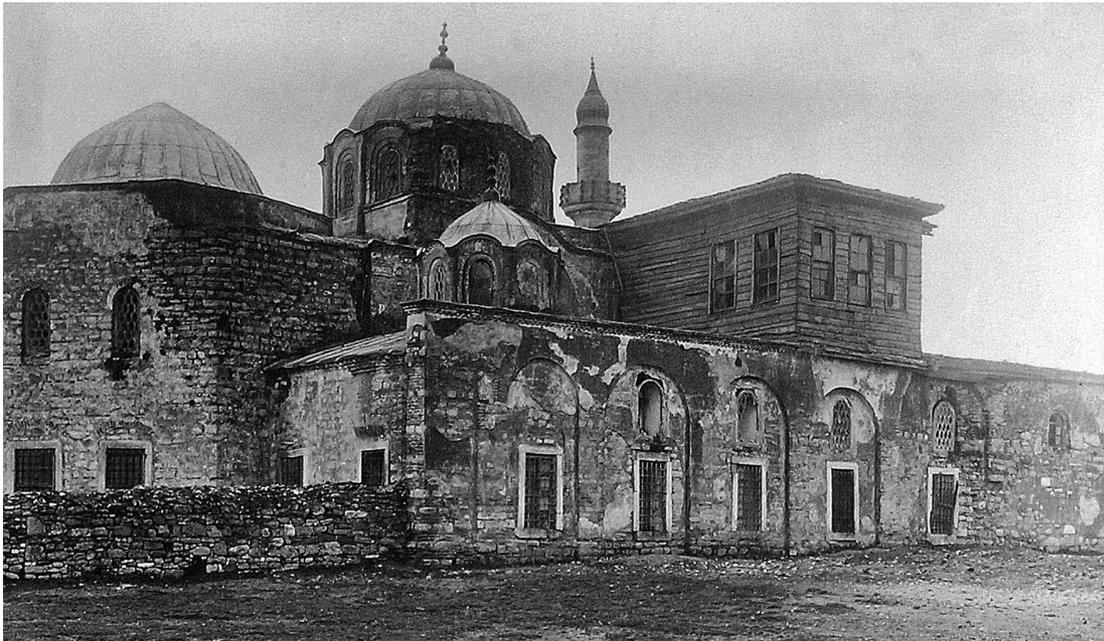
Fig. 9 Fethiye Camii, North Façade, Sender, 1925 (DAI, neg. no. 31897).

The sultan's lodge was reached by stone stairs on the southern facade. The building was located on the southern arm of the exonarthex and also covered its front (south) façade. It stretched above the narthex hall until the northern facade, appearing as a thin, long compartment (fig. 9). The connection of the lodge with the interior of the mosque was from the western arch of the main dome by a royal tribune (*bünkar mahfili*) that opened to the worship space from above (fig. 11). Photos of this wooden addition, dating back to 1925, show that it was in moderately good condition (fig. 9). Now we can obviously observe that it has evolved into a low-quality, single-storey structure prior to the repair in 1937 (fig. 10).

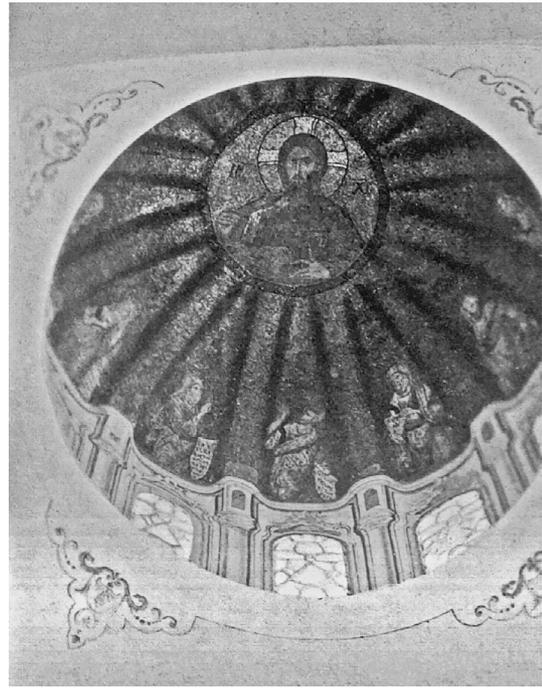
Fig. 12 Parekklesion, main dome, Byzantine mosaics with the Ottoman engravings (van Millingen 1912, 155).

The second major change within the context of this restoration has been determined by comparing photos published in “Arkitekt” journal and in other archives – the filling of 13 ground-level, rectangular windows at the narthex, exonarthex, northern annex facades, and eastern facade of the prothesis. The arched openings above the filled rectangular windows were double (exterior+interior) windows before the intervention and were replaced by single windows with a square network. Altan also states that the dogtooth cornice of the roof and wall surfaces were repointed.⁷² After the repointing, we observe that traces of the large-span arch on the north facade of the inner narthex vanished. Cleaning all the south church mosaics and frescoes – until then only the dome mosaics were able to be seen (fig. 12) – and renewal of lead coverings of the dome were the main items of the restoration work.⁷³

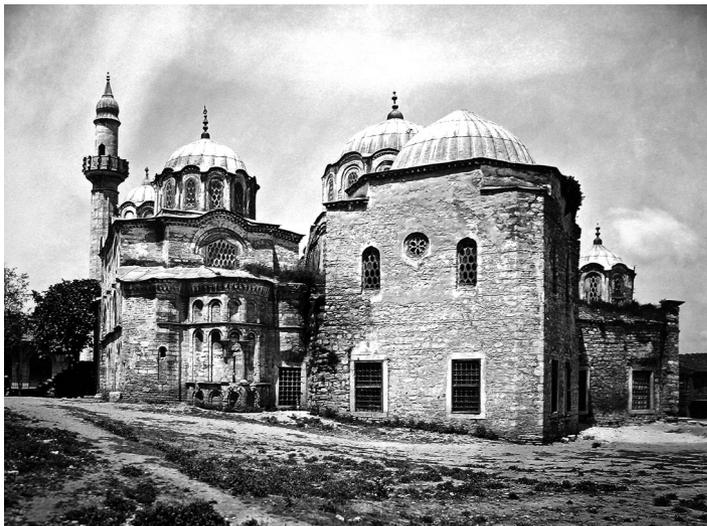
Fig. 15
Fethiye Camii, east façade (DAI, neg. no. 6481, beginning of 20th century).

- 1) removing the Ottoman-period pointed arch in the naos and replacing it with concrete columns that mimic marble columns in appearance,
- 2) disguising the pointed arch on the north wall of the naos from the museum side (inside the mosque the arch is still visible) (fig. 14),
- 3) reconverting the rectangular apse window of the prothesis to a tripartite opening (fig. 15), and
- 4) reconverting the rectangular windows of the south and east facades to tripartite openings (fig. 15).
