Metallosis following to neglected failed total knee replacement

Patient suffering from pain and color change in her knee 10 years after a total knee replacement diagnosed as metallosis due to failed total knee replacement (TKR).
Beginning: prosthesis fail and implant wearing is a well known and good identified subjects in arthroplasty surgeries. Polyethylene wearing is a common issue but metal wearing and metallosis are rare cases.

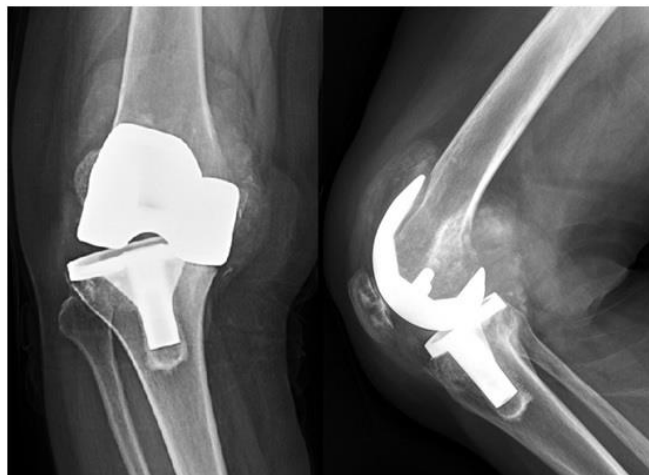
Picture 1: Radiological metallosis sign around the knee

A 77 years old lady appeared in the outpatient clinics due the right knee pain following to right (RT) TKR 10 years ago without patellar implant. This was the first clinical visit except the first months of postoperative examinations. The pain was increasing with instability and loss function through the last four years. In the clinical examination there was severe instability and pain and pigmentosis around the distal and of the surgical scar. Blood tests resulted insignificant with normal levels of crp esr and wbc. Direct x-rays acquired at the day of examination and severe wearing of the tibial component and proximal tibia is displayed. Also surrounding radiodensity outlining the suprapatellar and posterior recess of the joint capsule come to attention (picture 1). This radiodensity is the characteristic radiographic finding of metallosis after TKR caused by the presence of embedded metal particles¹.

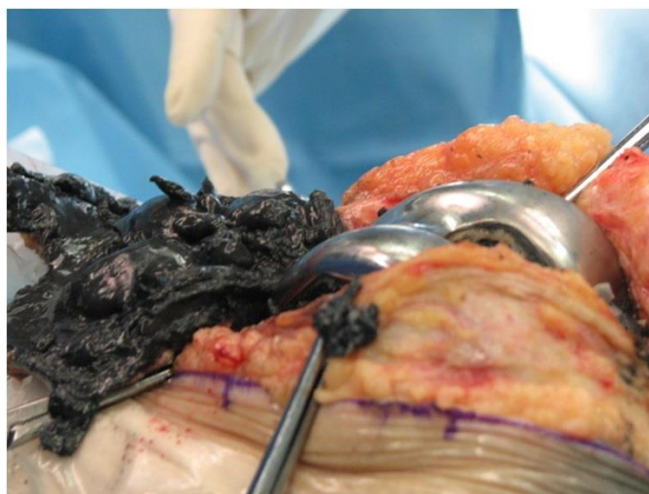
At surgery, starting from the dermal tissue all layers was covered with metallic debris. Joint fluid and synovium was black and surrounding tissue was hypertrophic (picture 2). The tibial polyethylene was worn on the medial side but still attached to the tibial component. The tibial component was made of titanium and severely aroused against chrome-cobalt femoral component. Also wearing was continuing through the medial proximal tibia. Highly dense bone formation on the medial side inspected. Pathological reported as fibrotic and synovial tissues rich in jet-black histiocytes.

Picture 2: Intraoperative synovial appearance
