Mitral Annulus Caseous Calcification: Not A Conundrum with Cardiac Computerized Tomography

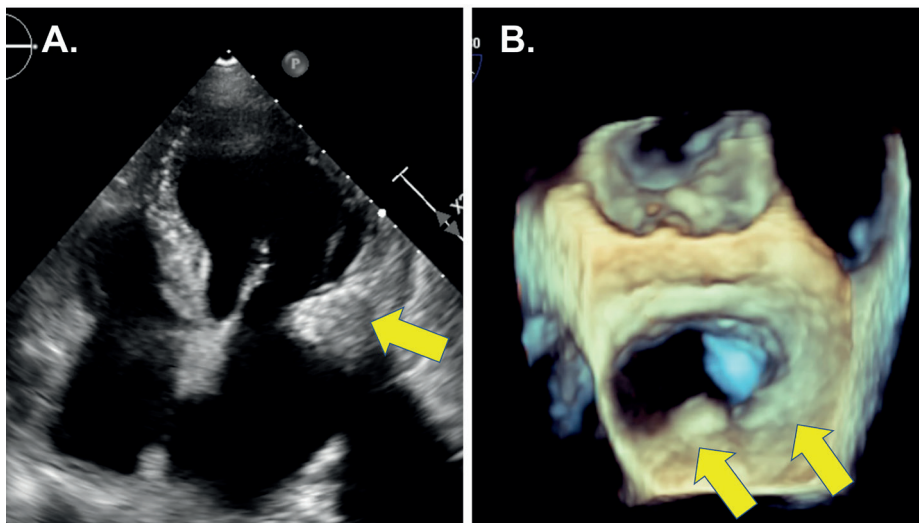
Figure 1. 4 chamber TTE (A) and 3D-TEE (B) images show a hyperechoic lesion with (arrow) acoustic shadowing protruding towards the posterior mitral valve.

A 58-year-old woman with atrial fibrillation was referred for mitral valve replacement due to mitral valve mass on echocardiography. Transesophageal and transthoracic echocardiography showed an echogenic, round mass attached to the basal portion of the posterior mitral valve, mild degeneration of both mitral leaflets and moderate mitral regurgitation. Cardiac computerized tomography (CT) was planned to further assess the mass and its relationship with the mitral apparatus. Cardiac CT showed densely calcified caseous thickening of the mitral annulus that was measured 32 x 13 mm and encircling the posterior mitral annulus which protruded towards the posterior leaflet without disruption of the mitral apparatus. The heart team assessed the patient with integrated findings of transesophageal echocardiography and cardiac CT and decided to manage conservatively.

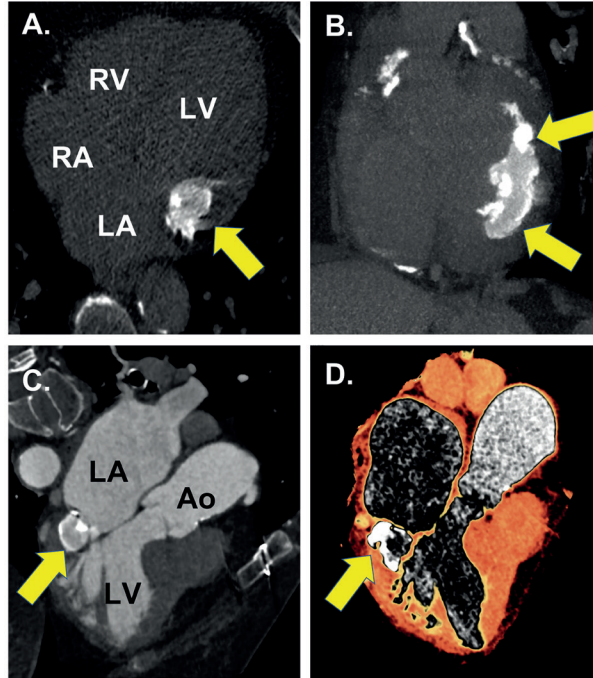
Figure 2. 4 chamber (A) and short axis (B) nonenhanced cardiac computerized tomography images show a densely calcified lesion (arrows) in the mitral annulus. 3 chamber image of contrast enhanced computerized tomography (C) and volume rendered reformatted (D) images demonstrate that the lesion protrudes towards posterior mitral valve.
