# CULTURAL HERITAGE AND SCIENCE

*Cultural Heritage and Science (CUHES)*

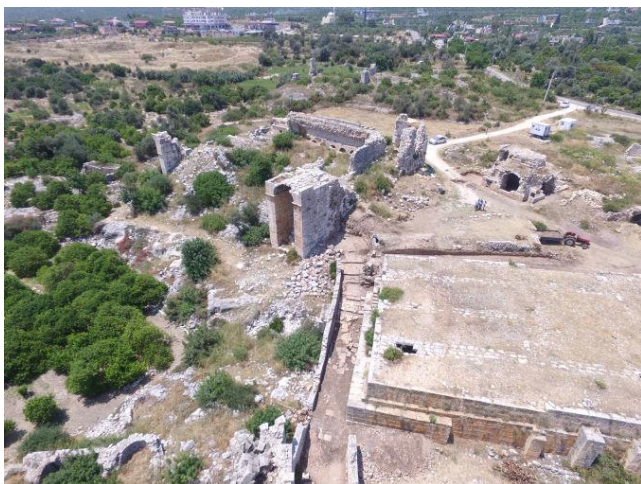
**Figure 2.** Akkale Cistern and buildings in Akkale

There were harbour bath, accommodation facility (inn), public cistern, monumental tomb and remains of religious buildings (Aydınoğlu & Mörel, 2017). Archaeological surveys have also revealed remains of water channels leading from Elauissa-Sebaste Korykos water work towards Akkale. Moreover, there are remains of additional water structures excavated nearby Akkale cistern indicating that there was an integrated water distribution network through the settlement (Figures 2 and 3).

Akkale cistern is one of the remarkable and well preserved buildings of the whole site. It has a rectangular size with 21.53 m × 36.40 m dimensions and 9.80 m interior height. The main construction technique of the cistern is cut-stone masonry walls, with two rows of arcades supporting the vaulted superstructure. The cistern finishes with flat roof located onto the three rows of barrel vaults. There are top windows and remains of cut-stone roof claddings on the cistern roof. The roof top might have been utilized for additional rainwater harvesting into to the cistern, since there is remarkable catchment capacity with its roof size. Each arcade has 7 arches supported on stone pillars (Figures 2 and 3). There are 3 windows located on each east and western wall, which were probably used to control, to provide daily light and fresh air for interior.

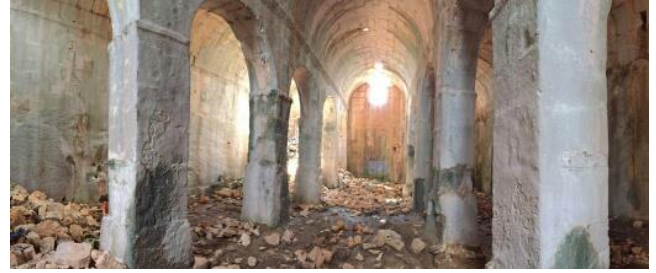
**Figure 3.** Interior view of Akkale Cistern

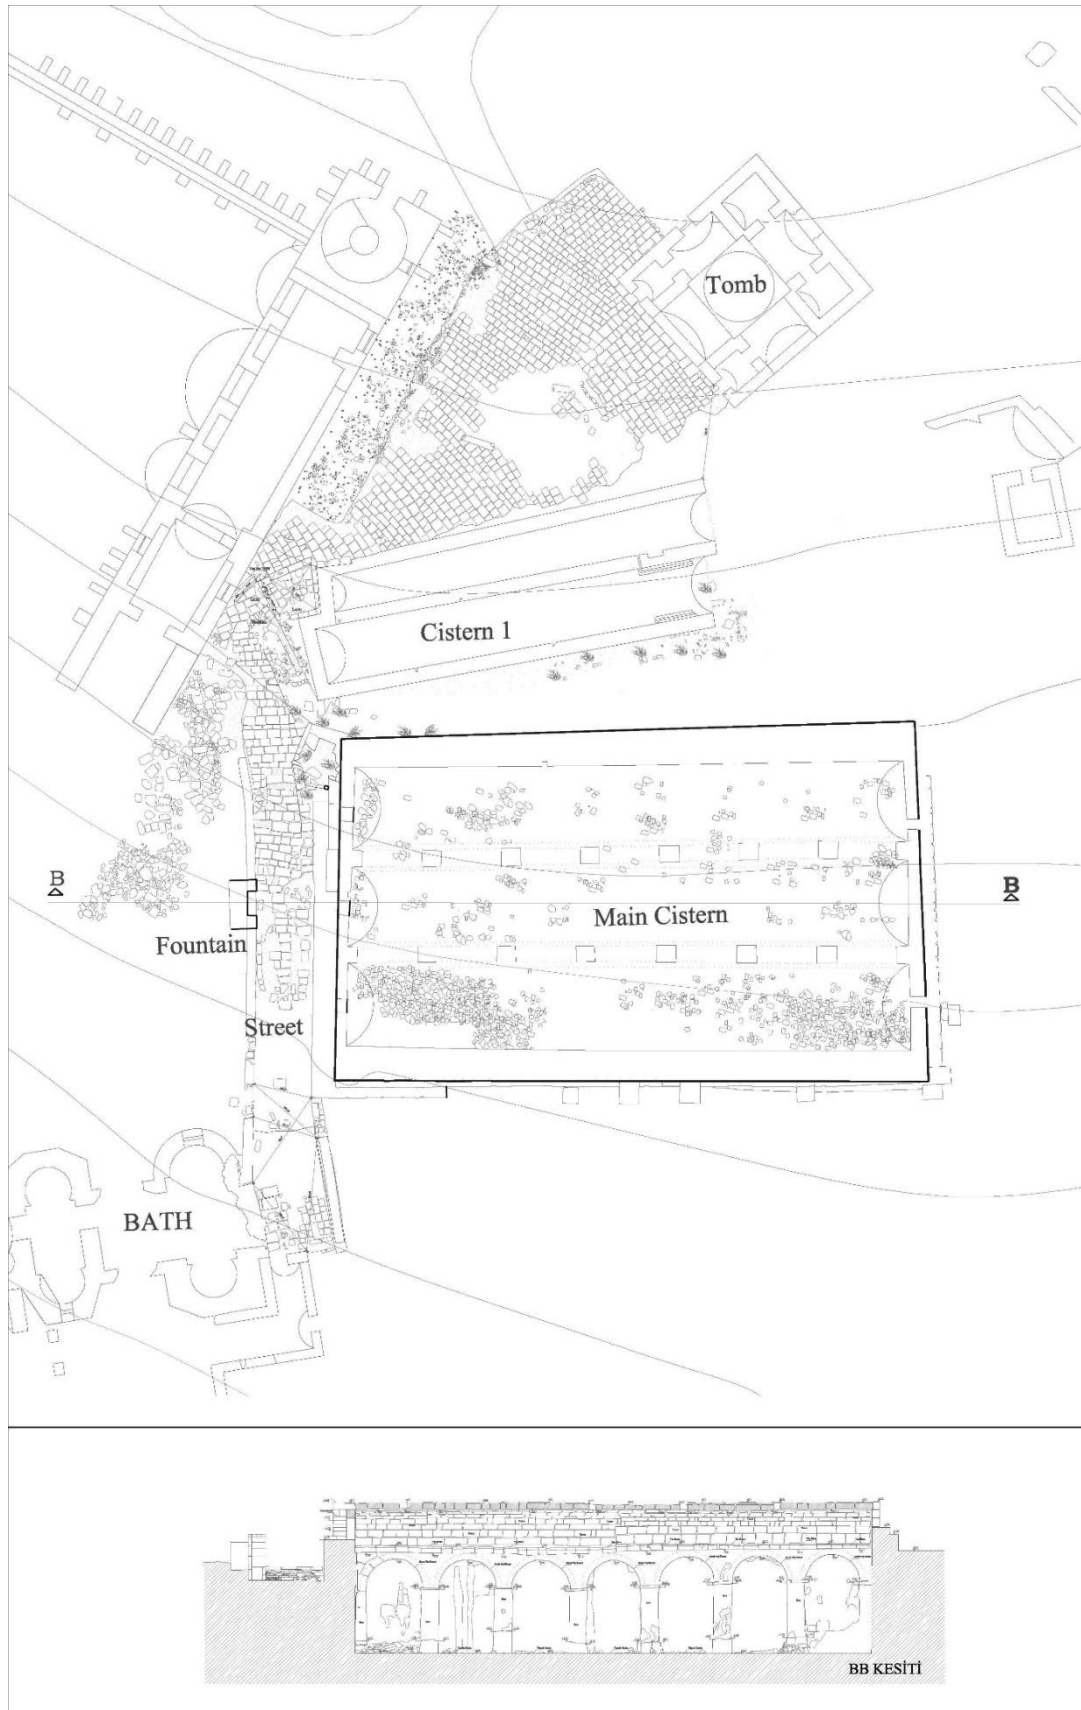
Figure 4. Survey drawings of the cistern

**- Architectural Documentation and Building Surveys:** Archaeological excavations around the cistern revealed important architectural information and traces related to original condition of the building. Following, detailed measured surveys including architectural plans, cross sections, internal and external elevations and documentation studies related to site maps have been conducted by using optic measurement and aerial

photogrammetric techniques. Survey drawings are utilized to evaluate architectural details, material use and construction techniques of the cistern. They also provide base maps for restitution proposals and condition assessments studies in further stages (Figure 4).

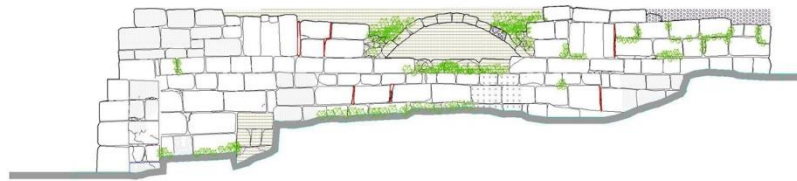
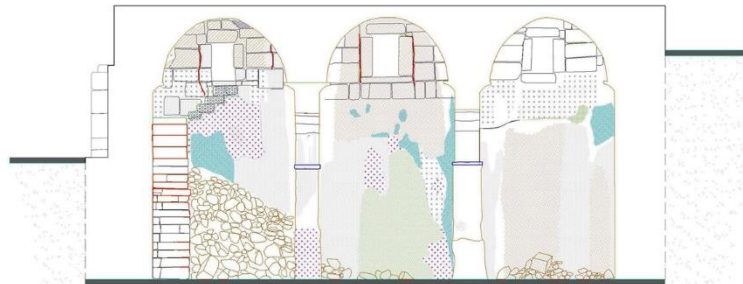
Figure 5. Mapping of material deteriorations observed in the building

**-Condition Assessment:** Condition assessment is the initial step in conservation studies since it helps understand existing situation and preservation state of the historic structure by using visual observation techniques to identify material decays and structural deformations. This fundamental phase gives direction for further qualitative and quantitative analysis to be conducted, methods and techniques to be selected to achieve comprehensive conservation decision-making process for the building. Having completed architectural documentation and building surveys; visual observations related to material decays and structural deformations are conducted. The cistern was constructed with cut-stone masonry technique by using mortar as the main binding material. Interior facades were plastered in order to prevent water leakage. Since the main construction material was stone; technical classifications of “Glossary of Stone Deterioration” prepared by ICOMOS was utilized to determine types of decay forms (ICOMOS, 2008).

Accordingly, five groups of decay types are identified from slight to severe impact level. First group represents slightest level of material decay including color alteration and surface depositions such as black crusts and salination. Second group is slight decay level, which includes moderate biological colonizations and macro-vegetation. Third group includes stone degradation and detachment problems, which are classified as pitting, alveolization, flaking, sugarization and contour scaling. Fourth group identifies material cracks and fissures. The fifth group represents the most severe level, which shows material loss and partial destruction. Having identified material decay groups, material deteriorations observed in the building were mapped onto the architectural survey drawings (Figure 5).

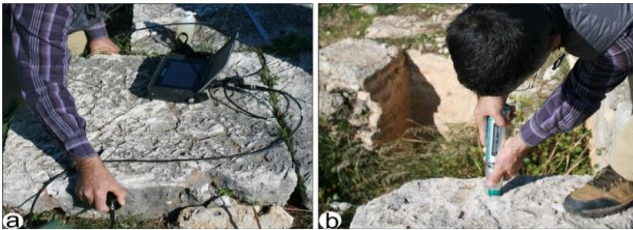
**Figure 7.** Sonic velocity and Schmidt Hammer tests applied on rocky ground (Tağa & Güler, 2018)

**-Geological and Geotechnical Surveys:** Further site investigations related to geological aspects of the site have been conducted in order to compare geomechanical properties of limestone used in masonry construction of the cistern with rocky formation of its close environment and to understand its relationship with the terrain it was constructed into. Non-destructive techniques (NDT) have been preferred for geological and geotechnical researches, since the cistern is located in an archaeological site (Figures 7 and 8). Sonic velocity and Schmidt hammer resistivity tests were performed on the locations chosen on the building. Samples from rocky ground showing similar lithological aspects with stone material used in construction of cistern building were examined through laboratory tests to provide geological data during structural analysis works. Since the cistern was settled into the topography, another NDT method of Vertical Electrical Sounding (VES) technique was applied in order to scan ground resistivity of the cistern and its environs. Ground Penetrating Radar (GPR) method was applied around the cistern to understand boundary of lateral walls inside the rock bed and how much it was buried into the ground (Tağa & Güler, 2018).

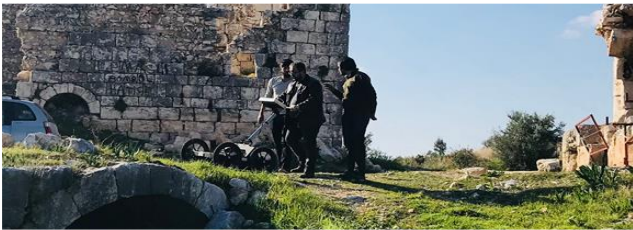
**Figure 8.** Geophysical investigations around cistern (Tağa & Güler, 2018)

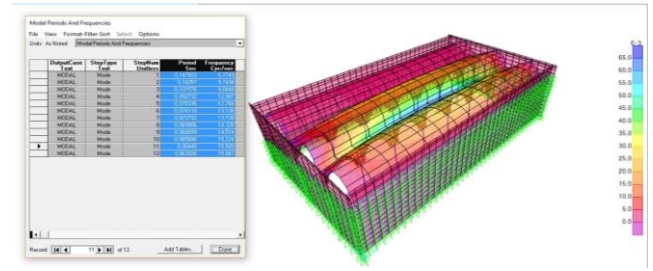
**Figure 9.** Model response and vibration mode of structural elements (Abiuso, et al., 2019)

**-Structural Analysis:** The structural condition assessments focused on the cistern building encompass field observations on structural deformations, structural analysis on original (with water) and existing situation (in relation with its environment) of the cistern, laboratory tests to understand its structural behaviour and structural safety. The results are evaluated to develop proposals in order to guarantee structural safety of the building during architectural conservation studies, possible reinforcing and strengthening activities in local critical parts<sup>3</sup> (Abiuso et al., 2019). Besides, preventive measures that should be taken in order to guarantee structural safety of the building during possible cleaning activity inside and local excavation activities outside the construction are suggested. In the light of geological data provided by geotechnical studies, structural models have been prepared to display structural behavior by using FEM methods (Figure 9).

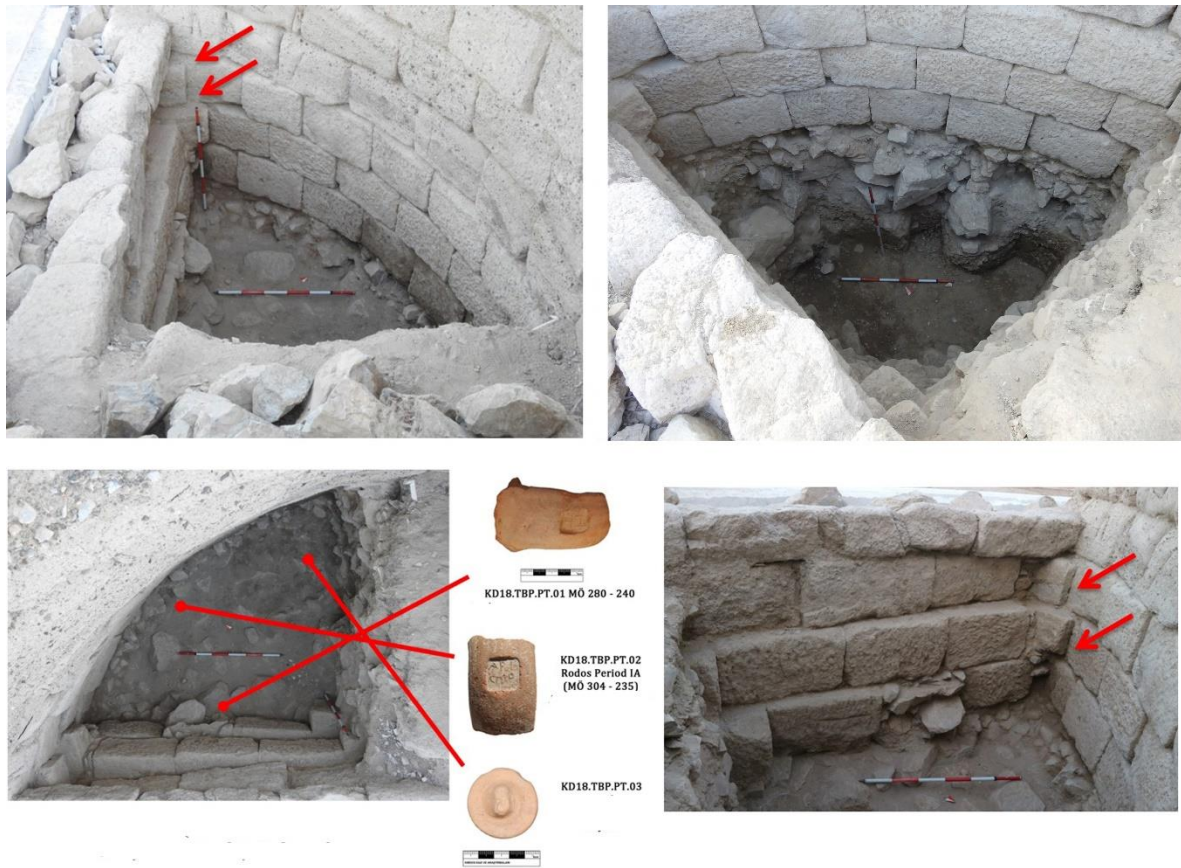
**Figure 2.** Research drilling and finds

During the drilling works, the depth reached in previous studies, from the preserved top block of the east-west wall, was reached to a depth of 2.60 meters to the bottom of the foundation levels of the walls. A filling of rubble stone and sandstone particles was found in the level from the initial level to the baseline of the apse. This filling is similar to the filling soil seen at the levels corresponding to the apse in previous studies. Not a large amount of ceramic pieces belonging to the 3rd and 2nd centuries BC were found from this fill. At the base level of the apse, there is a Zenon amphora dating from 280-240 BC (Cankardeş - Şenol 2006) and two seals containing the name of Aristotle, who was the ruler during the Rhodes Period IA (Lawall, 2007; Cankardeş-Şenol, 2015), dated to 304 - 235 BC. amphora handle was found (Fig 2).

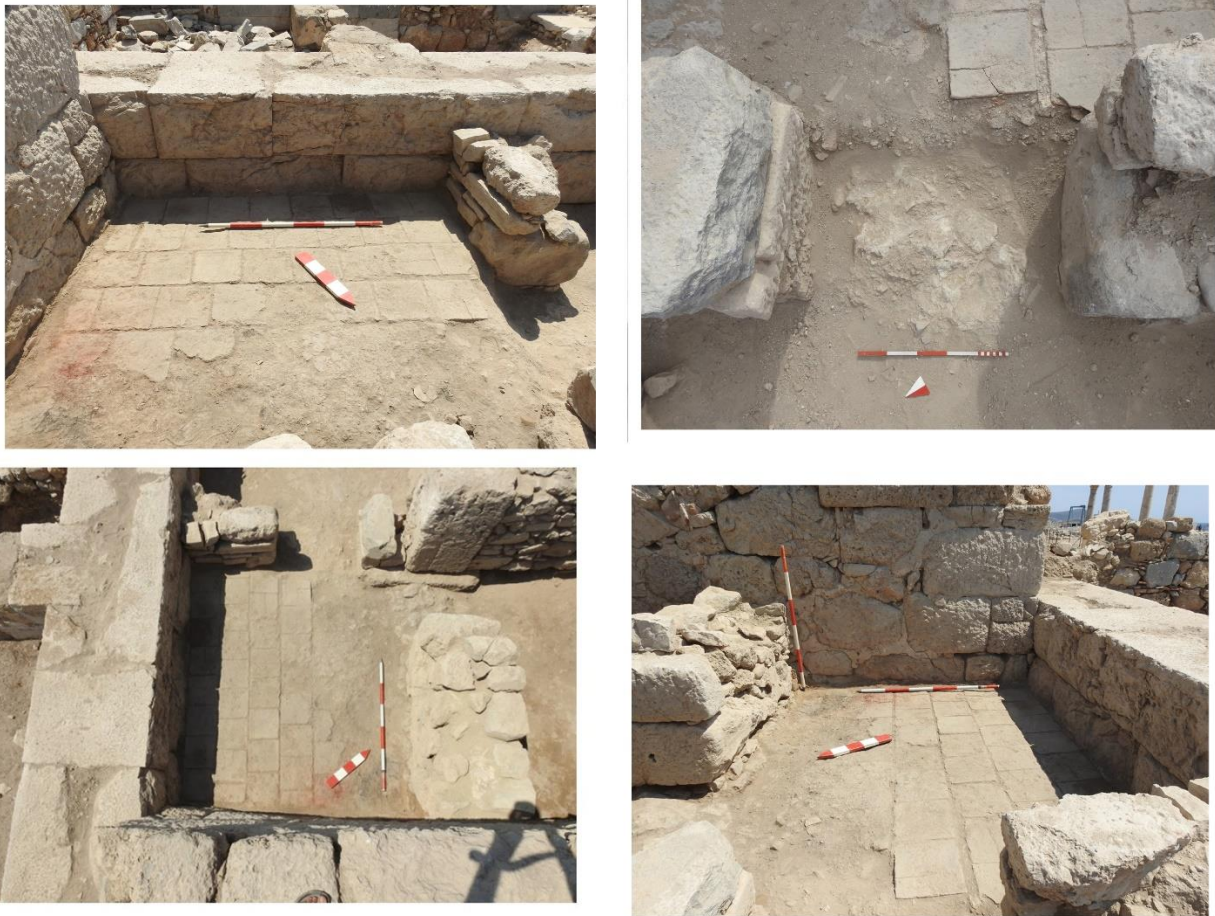
Figure 4. Room 1A

Room 1A (Fig. 4): The room, which is connected to Room 1 by a door with a width of 0.82 meters, measures 2.05x 2.37 meters. The south wall of the room also forms the north wall of the Building at the west end of the Stoa and is 0.90 meter wide, made of white limestone with an isodomic technique. The west wall, where the door to the connection with Place 1 is located, was built with a lot of rubble stones or re-used architectural elements. This wall is 2.05 m long and 0.55 m thick and joins the southern wall as a primitive.

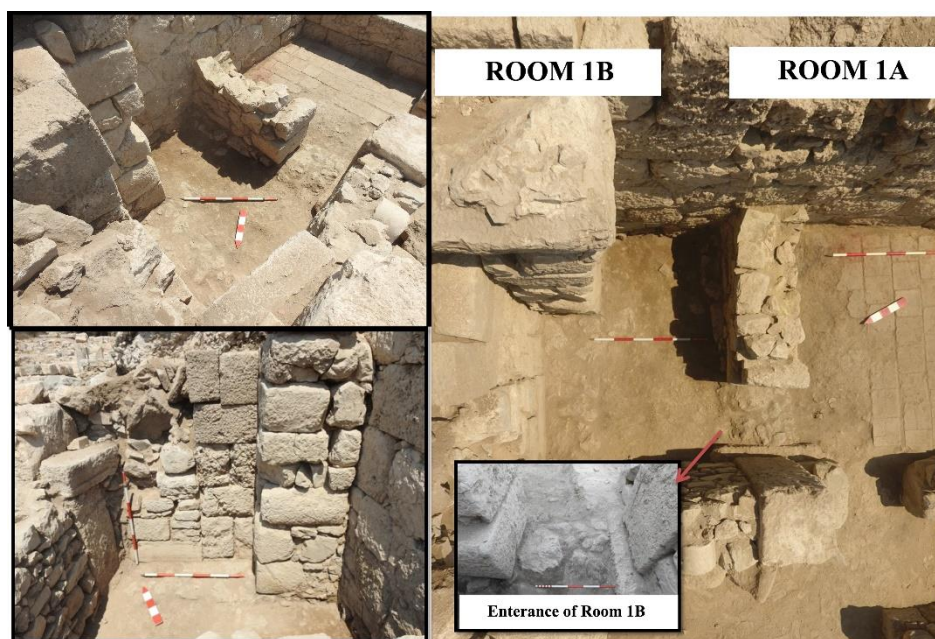
Figure 5. Room 1B

Space 1B (Fig. 5): This room at the back of Space 1 measures 1.76x 2.37 meters and is connected to Space 1A to the south by a 0.73x 0.63 meter door. In the northern corner of the east wall, which is common with Room 1A, there is a buttress that has been preserved up to 2.67 meters high, where flat cut wall stones attached with lime mortar measuring 0.78x 0.60 meters are used together with spolia blocks. The lime mortar and rubble stone layer with dimensions of 0.60x 0.40 meters and a height of 0.12 meters at the top block of this buttress suggests that this buttress might be a vaulted pillar.

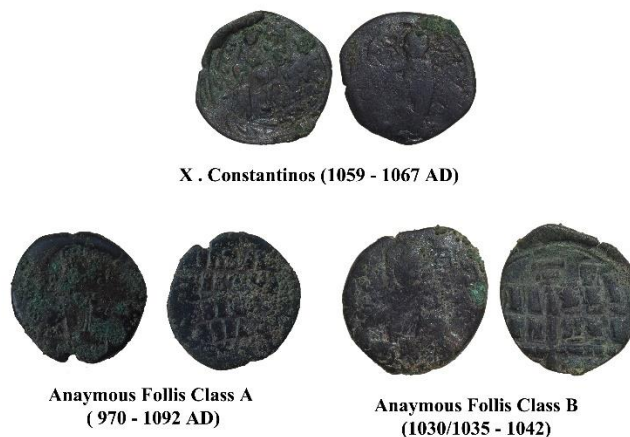
Figure 7. Late Coin Finds

An anonymous follis from 970-1092 AD, another anonymous follis B group from 1030 / 1035-1042 and Emperor Kostantinos X period 1059-1067 at the upper levels (between +8.75 m and +7.20 m elevation) and another follis dating to the years was found (Sommer, 2010; Ninety Six, 2020b). These coins are very rare late period finds in Knidos, which is thought to have been abandoned in the middle of the 7th century AD. However, in the preliminary evaluations, no other ceramic finds or remains of buildings that could be associated with the coins dated to the 11th century AD were found (Fig. 7).

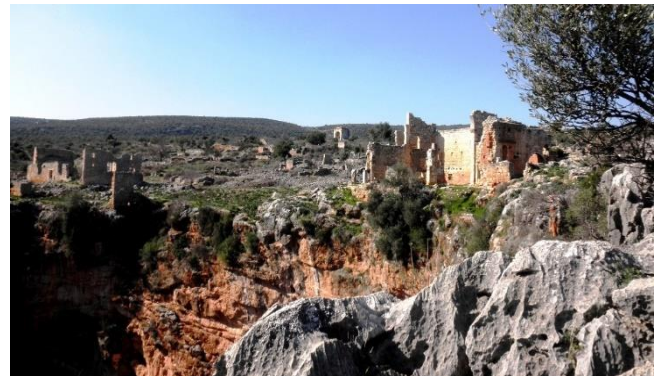
Figure 1. Kanlıdivane archaeological site

Kanlıdivane is one of the important historic sites of Erdemli town, which possesses rich and diverse monuments that belong to Hellenistic era, Roman, late Antiquity, Byzantine and traditional periods. Majority of architectural heritage of the site constitutes historic masonry structures, showing different stone masonry construction techniques of the region (Figure 1).

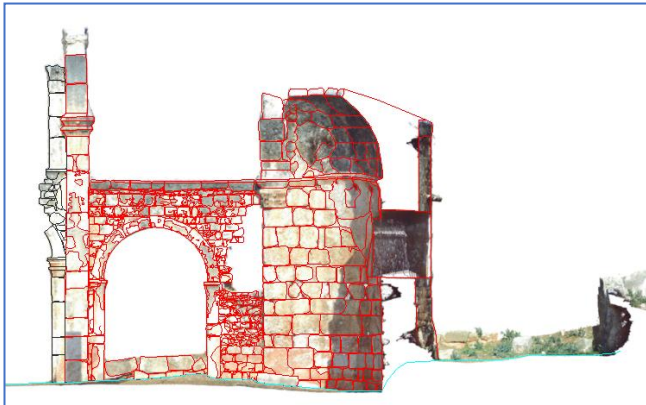
Figure 4. Architectural Survey on selected buildings

Research of building scale condition assessment has encompassed studies related to architectural survey (Figure 4) by using optical measurements techniques<sup>3</sup>, visual documentation, and detailed mapping of material deteriorations and structural deformations onto building survey drawings. Building scale studies have been conducted on the selected examples according to evaluation of site level inventory studies: The Hellenistic Tower, Tomb No 1, Tomb No 2 and Church no 4. These monuments represent characteristics of different masonry techniques applied during different historical periods (Hellenistic, Roman and Byzantine).

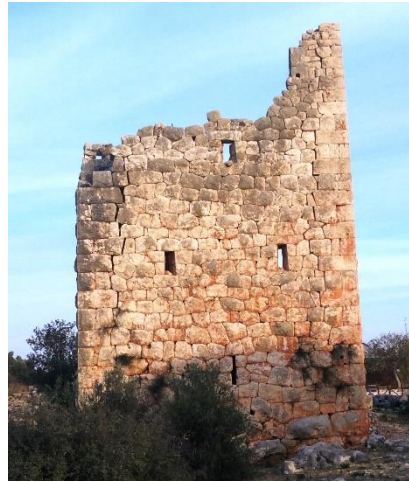
**Figure 7.** Hellenistic period Tower constructed with polygonal masonry technique in Kanlıdivane

There are two types of masonry construction techniques observed in the site as ‘polygonal’ and ‘isodom’ technique. Polygonal masonry technique was typically applied during Hellenistic era in the region. The Hellenistic Tower (which takes this name because of its construction technique) is one of the best survived examples of this era in Kanlıdivane. The corner stones selected from big size cut stones were used to make the system more rigid. The wall sections among the corner stones were constructed in polygonal technique. The irregular geometry in polygonal coursing provided more advantage in distribution of load when contributed to isodom technique (Figure 7). Roman period structures were constructed with cut-stone masonry technique in isodom style (Figure 8). There are monumental tomb examples survived from Roman period since most of them were converted or reused during late Antiquity period. The late Antiquity and Byzantine period buildings were constructed with smaller size rough cut stone masonry. The churches of the site, most of the residential buildings were constructed in this style. There are historical interventions added to these buildings generally. The wall section consists of double layered cut-stone filled with infill material. The masonry techniques applied in different periods affected structural performance of the buildings. The analysis has shown that construction technology related to wall sections, stone material use, coursing technique played important role in the structural performance of the building. There are still Hellenistic and Roman period buildings that are in good state while most of late Antiquity and Byzantine

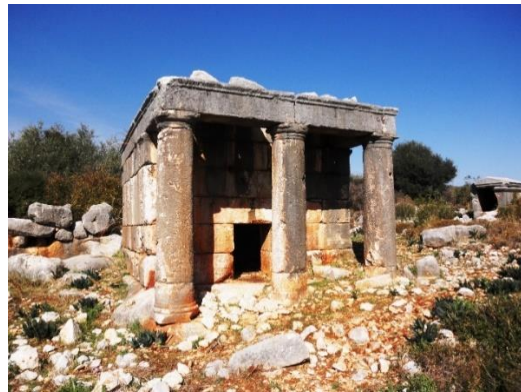
**Figure 8.** Roman period Monumental Temple constructed with isodom masonry technique in Kanlıdivane
