# CULTURAL HERITAGE AND SCIENCE

*Cultural Heritage and Science (CUHES)*

**Cultural Heritage and Science (CUHES)** is an interdisciplinary academic, refereed journal for scholars and practitioners with a common interest in heritage.

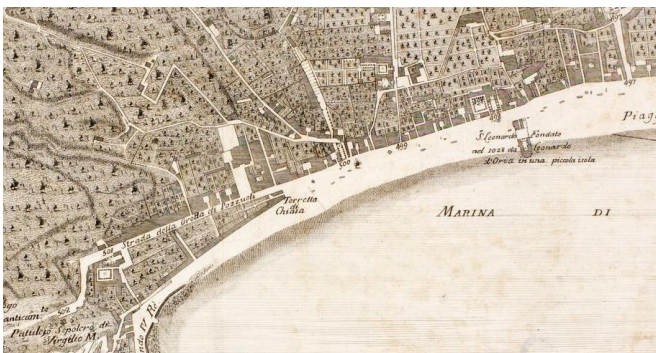
**Figure 4.** Plan of Giovanni Carafa, Duca di Noia, 1775 (detail of the Riviera di Chiaia).

In the plan “Fig. 4” of the “Duca di Noia” we can see a building located in the next block on the side of “Santa Maria della Neve” church (we can recognize the church in the plan). In fact, there are clear signs of expansion of the building volume, with a first elevation probably built in the mid-nineteenth century, with techniques similar to the original ones, and a second elevation, built with a reinforced concrete frame system with beams and columns, probably built between the 1950 and 1960 (“Fig. 8”).

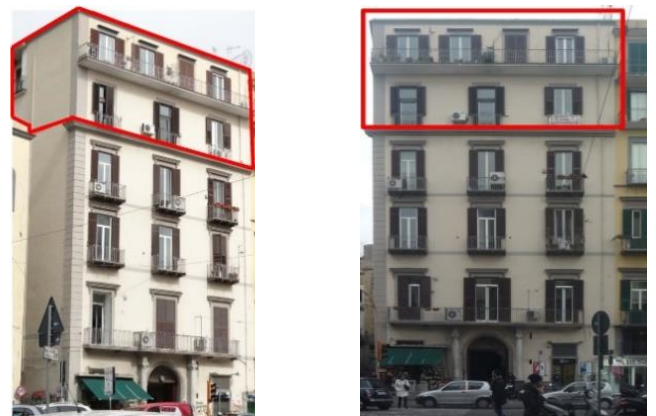
**Figure 8.** The facade of the building. In red the two floors probably added during the last two centuries

In the figures we can see that the decoration of frames in the window from the first floor up to the third floor are the same frames and finished with stucco decoration on the third floor. On the other hand, on the fourth floor in the very simple window without frames, it means that this floor was built at a different time from the floor below, perhaps in the year 1900 because of the construction technician of this floor still in masonry. After that, the top floor is recently built, because it is built in reinforced concrete.

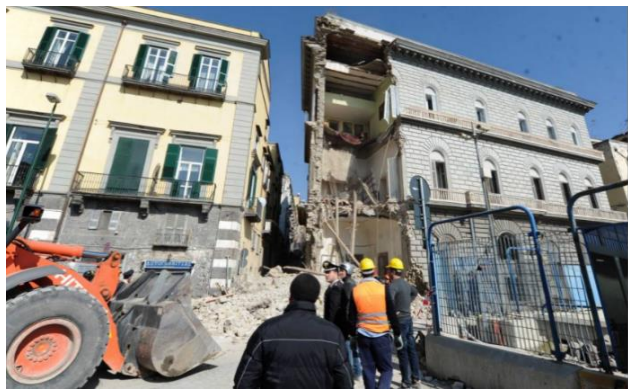
**Figure 10.** Neighboring building partially collapsed in 2013. Next to it is the construction site of the metro station

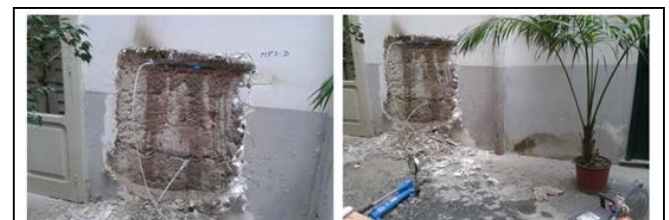
**Figure 11.** Flat jack test on the ground floor wall

Tests with single flat jacks allow determining the stress state existing in the masonry, by reading the pressure necessary to balance the convergence of the edges of a cut made perpendicular to the test surface and in which a flat jack is inserted, controlled by pump hydraulics. The displacements induced by the deformation are measured using a high-precision digital comparator on check plates previously fixed to the wall. The test with double flat jack, on the other hand, is based on the determination of the behavior of a masonry subject to monoaxial compressive stress induced by the insertion of two flat jack in two parallel cuts in the masonry, perpendicularly to the direction of measurement. The deformations of the masonry segment are induced by the load of the jack. “Fig. 12” will give information about the Young elastic modulus of the masonry and even its resistance, if the test reaches the local collapse of the material.

Single jacks and double tests, carried out on the first floor and ground floor walls, gave an evaluation of the maximum stress of the masonry due to the vertical loads.

- a) continuous masonry in squared blocks of yellow tuff with thin layers of mortar in between;
- b) continuous masonry in solid bricks laid with thin courses of mortar. In both cases, the measured operating pressure was around 0.7 MPa; the breaking point was evaluated to be at least greater than 1.5 MPa.

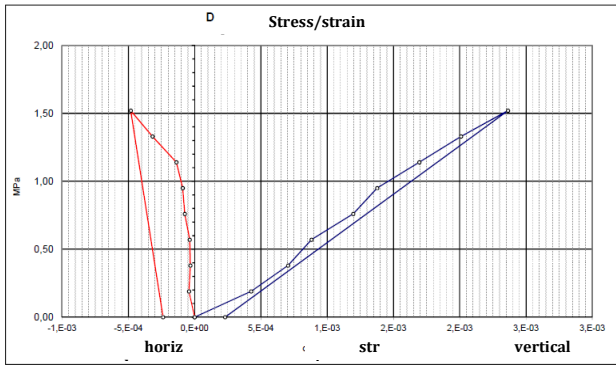
**Figure 12.** Test with flat jacks carried out on the ground floor wall

Analyzed interval	Pressure MPa	Vertical deformation	Vertical Elastic Modulus MPa
3-2	0.19	2.79E-04	681,76
4-2	0.38	4.56E-04	833,81

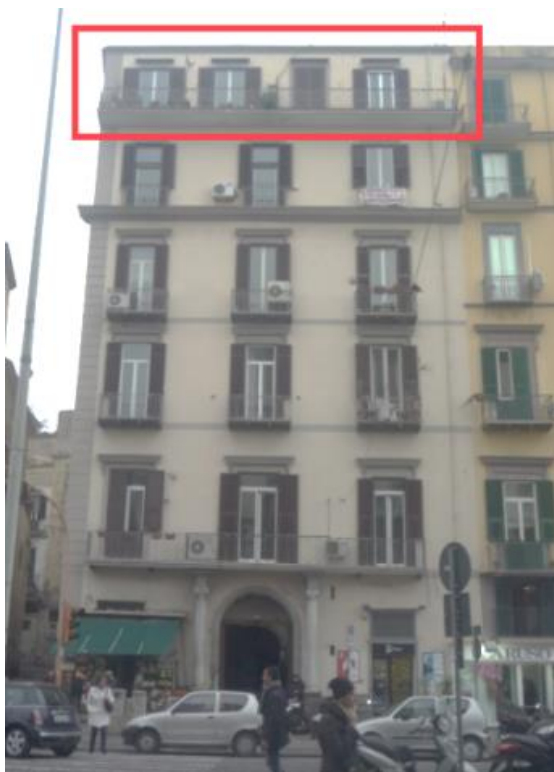
**Figure 13.** The main facade on the Riviera di Chiaia. In the red frame the last added floor made by r.c.

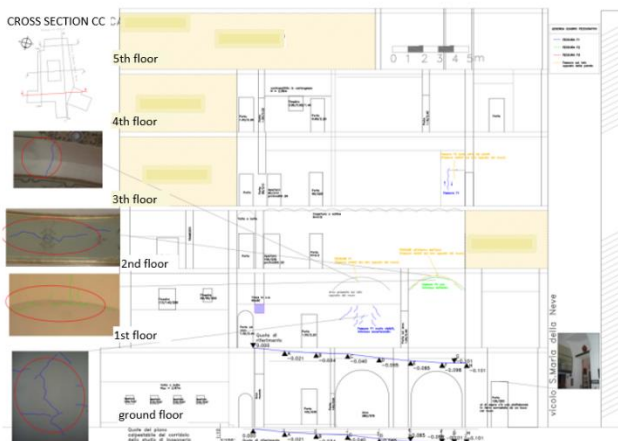
**Figure 20.** Crack map on the vertical wall in transversal cross-section C-C

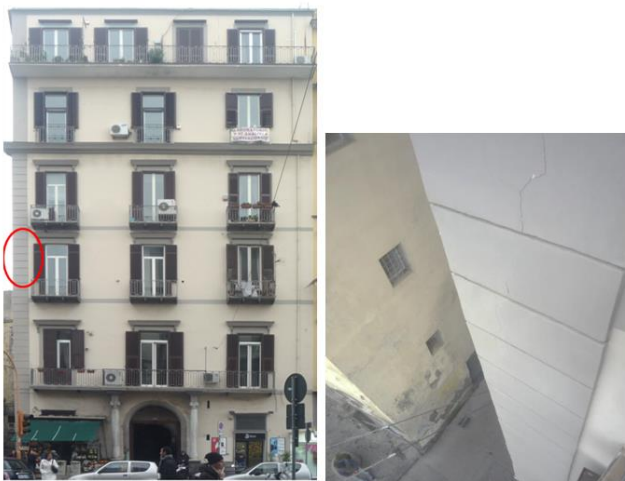
**Figure 21.** Crack on the corner of the main façade

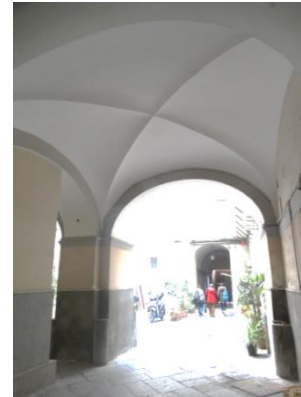
**Figure 22.** The cross vault on the ground floor, in the hall

Here we introduce the first structural analysis of the building, related to the cross vault on the ground floor. The analysis of the masonry cross vault on the ground floor considers the vertical loads, and the approach is similar to that one for a masonry arch.

As usual, the state of minimum thrust is configured as the state of natural equilibrium in the masonry cross vault. Among all the kinematically admissible thrusts, the one corresponding to the minimum thrust corresponds to the limit thrust. But since we are not going to solve this problem by kinematic approach, we assume a non-linear finite element model where the material masonry has the following properties:

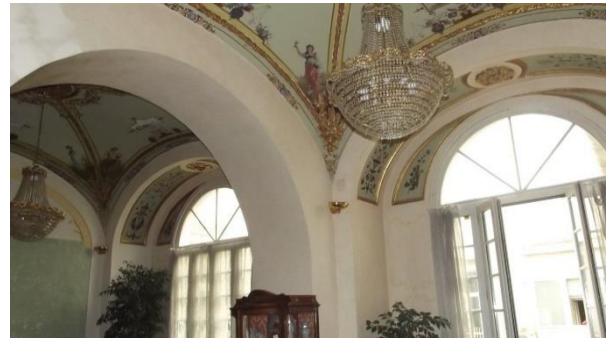
Figure 28. Photo of the sail vault on the first floor

We have two beautiful and fine-painted sail vaults on the first floor. The structure is similar to a dome structure, and it can be divided into a series of meridians and parallels, then this three-dimensional structure can be meshed for later finite element non-linear analysis, schematized as a grid formed by meridians and parallels. The material is assumed as for the cross vault. The dimension in the plan of the two sail vaults is about 43 square meters each vault.

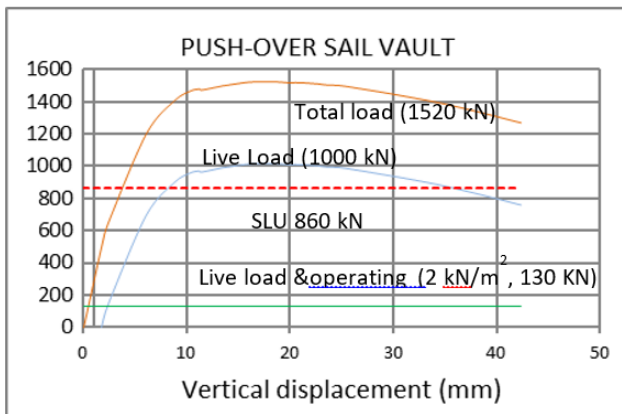
**Figure 32.** Sail vault Push-Over curves for different load conditions, without chain bar.

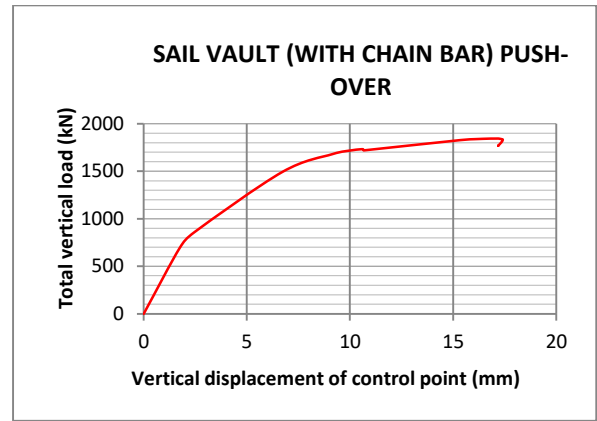
**Figure 33.** Pushover of the sail vault with the two chain bar. Total collapse load  $Q_u = 1800 \text{ KN}$

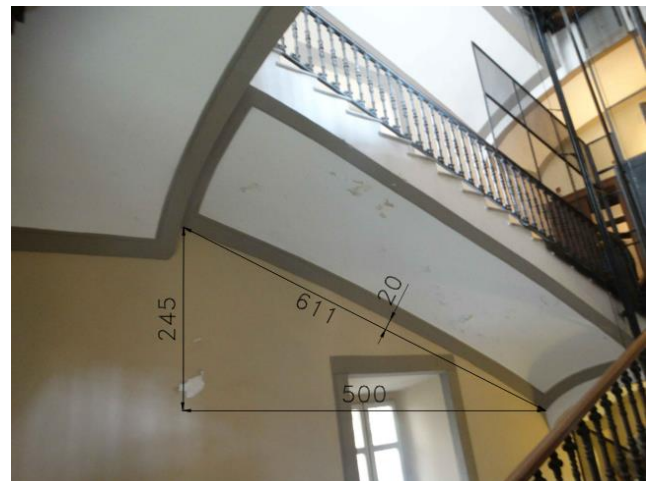
**Figure 34.** Roman-style rampant staircase and dimensions

The traditional staircase we can see in this building is a special one made only by masonry, in the shape of the half-barrel vault, in the transversal cross-section, and like a very shallow arch in the longitudinal direction “Fig.34”. The structural analysis of this kind of shape is still a big debate between the historical masonry structure experts. We did, as a modern engineer, a FEM model of the masonry non-linear structure. In fact, a limit analysis has been carried out considering the collapse load and evaluating a safety factor towards the operating load “Fig.37”.

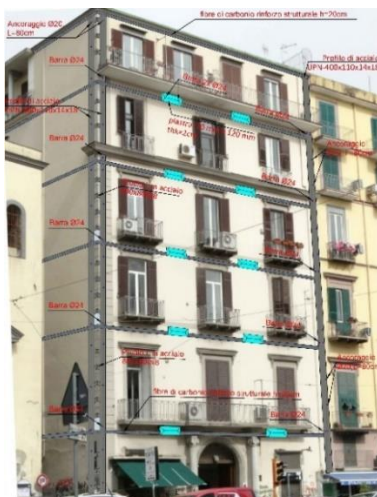
**Figure 40.** Rendering of some of the structural reinforcing on the external wall of the building

- use of extrados chain bar in the sail vault at the first floor, reducing the visual impact on the existing room;
- use of double (twin) stainless chain bar for each wall that needs to be linked to the other wall, drilling small holes in the wall, avoiding vibrations;
- using vertical confining stainless metallic profiles to better protect the corner of the masonry at every level, and not only at floor level;
- use of prestressed horizontal carbon fiber stripes, for active confinement of the wall.

The use of stainless steel is a good way to perform a durable reinforcing action, without fear of seeing the chain bars or the steel profiles becoming rusty.

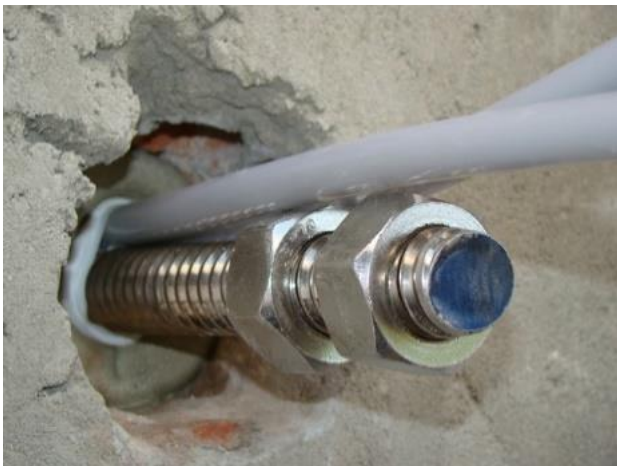
**Figure 43.** Anchorage in the masonry with the injection of grout limited by a sock.

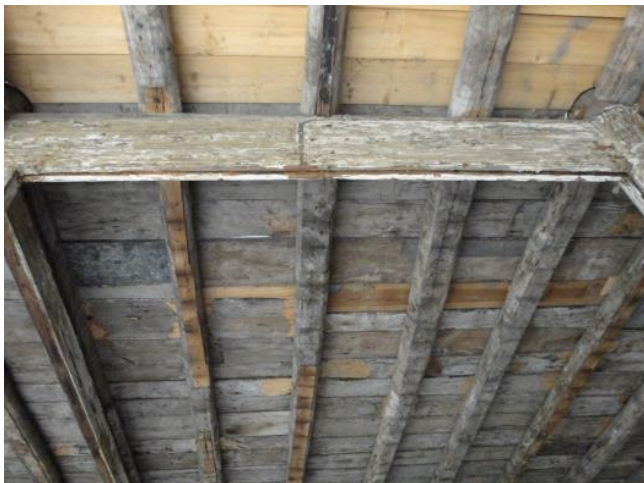
Figure 1. Cracks in square beam

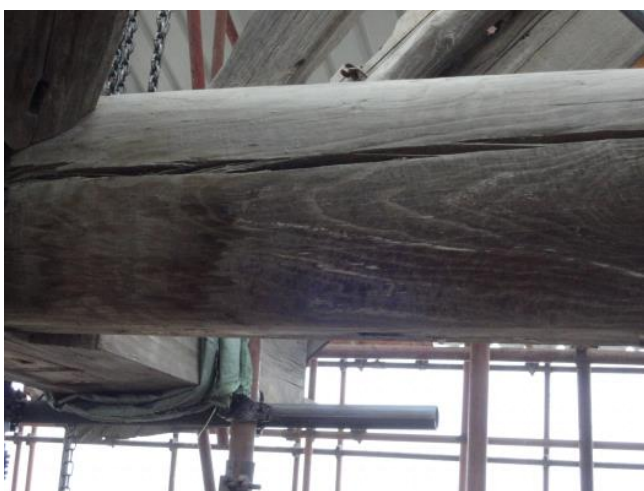
Figure 2. Cracks in square beam

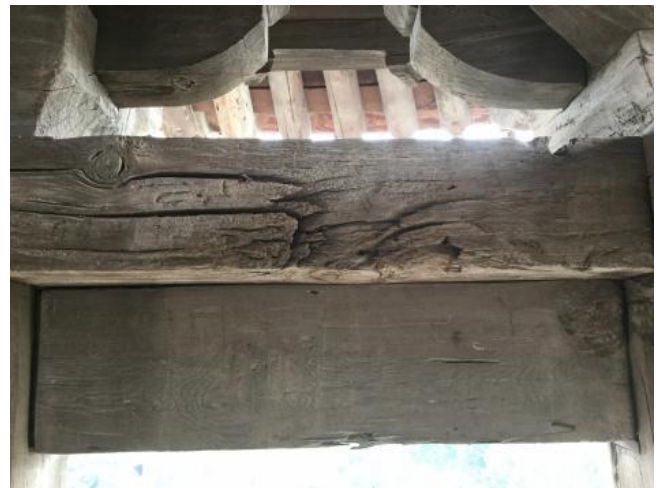
Figure 3. Damaged beam with knots

In the process of field investigation of Zhou Fujiu building timber beam in Yangzhou, it is found that when there are knots in the mid span bending area of the beam, the damage effect is the most significant. Based on this, the method of slotting in the middle of the wooden beam span is used for artificial simulation, and the simulated knots have the following characteristics: the beam section decreases when in tension; When pressed, it shows mutual extrusion and sliding. The height to width ratio of wood beam section is 3:2. Combined with the actual size of the wood beam of Zhou Fujiu building in Yangzhou, the scale of the model is 1:5.28. A total of 6 wood beams with a width of 80mm, a height of 120mm, a span of 2300mm and a clear span of 2160mm are manufactured. The wood variety is American Douglas fir.

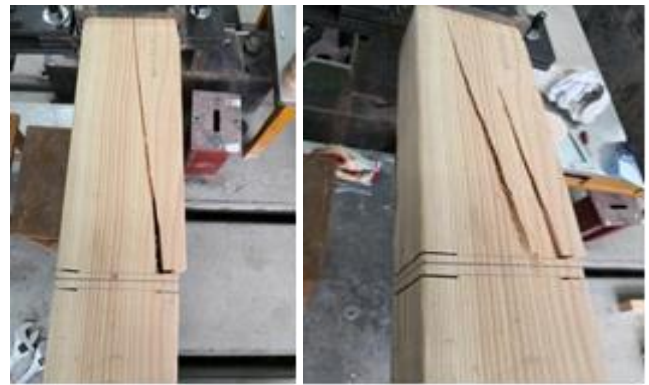
Figure 9. Midspan failure of S2 group

The damage of the six components finally occurred at the knots, which is consistent with the actual damage of the wooden beams of Zhou Fujiu building in Yangzhou. The experimental phenomena of the three members in group S1 are basically the same, and the cracks appear first on the side where the knots exist, and the deeper the knots are, the earlier the cracks appear. With the progress of loading, the cracks on one side of the knot gradually expand and eventually develop to the whole mid span section, resulting in the failure of the member (Fig. 8). There are knots on both sides of the middle span of the three members in group S2, and obvious cracks appear at the initial stage of loading. With the increase of displacement value, inclined cracks gradually appear along the middle of the span to both sides, and the width and length of cracks increase continuously until the members are completely destroyed (Fig. 9).

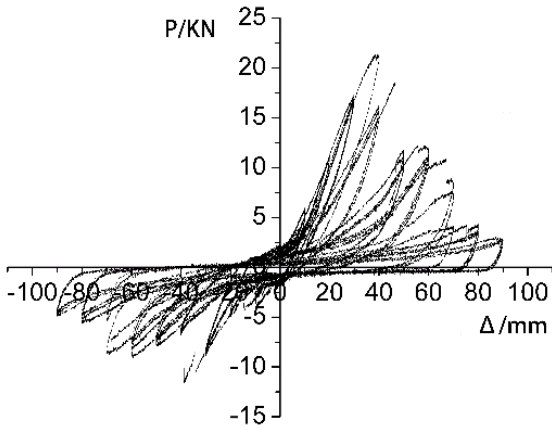
Figure 11. S1-2 hysteresis curve

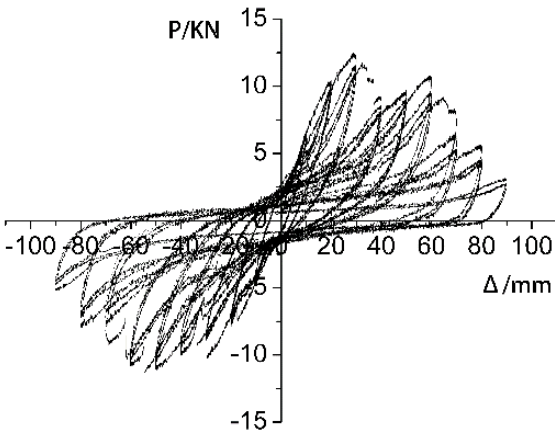
Figure 13. S2-1 hysteresis curve

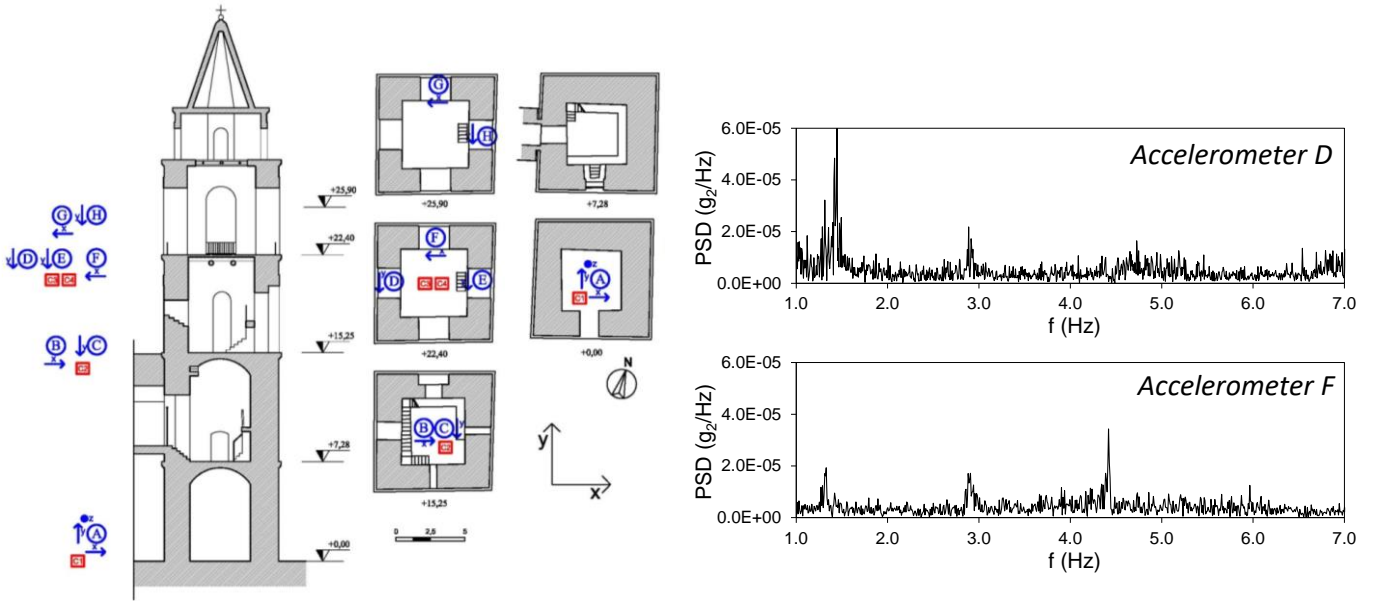
Figure 8. The bell tower of Santa Maria a Vico: ambient vibration tests

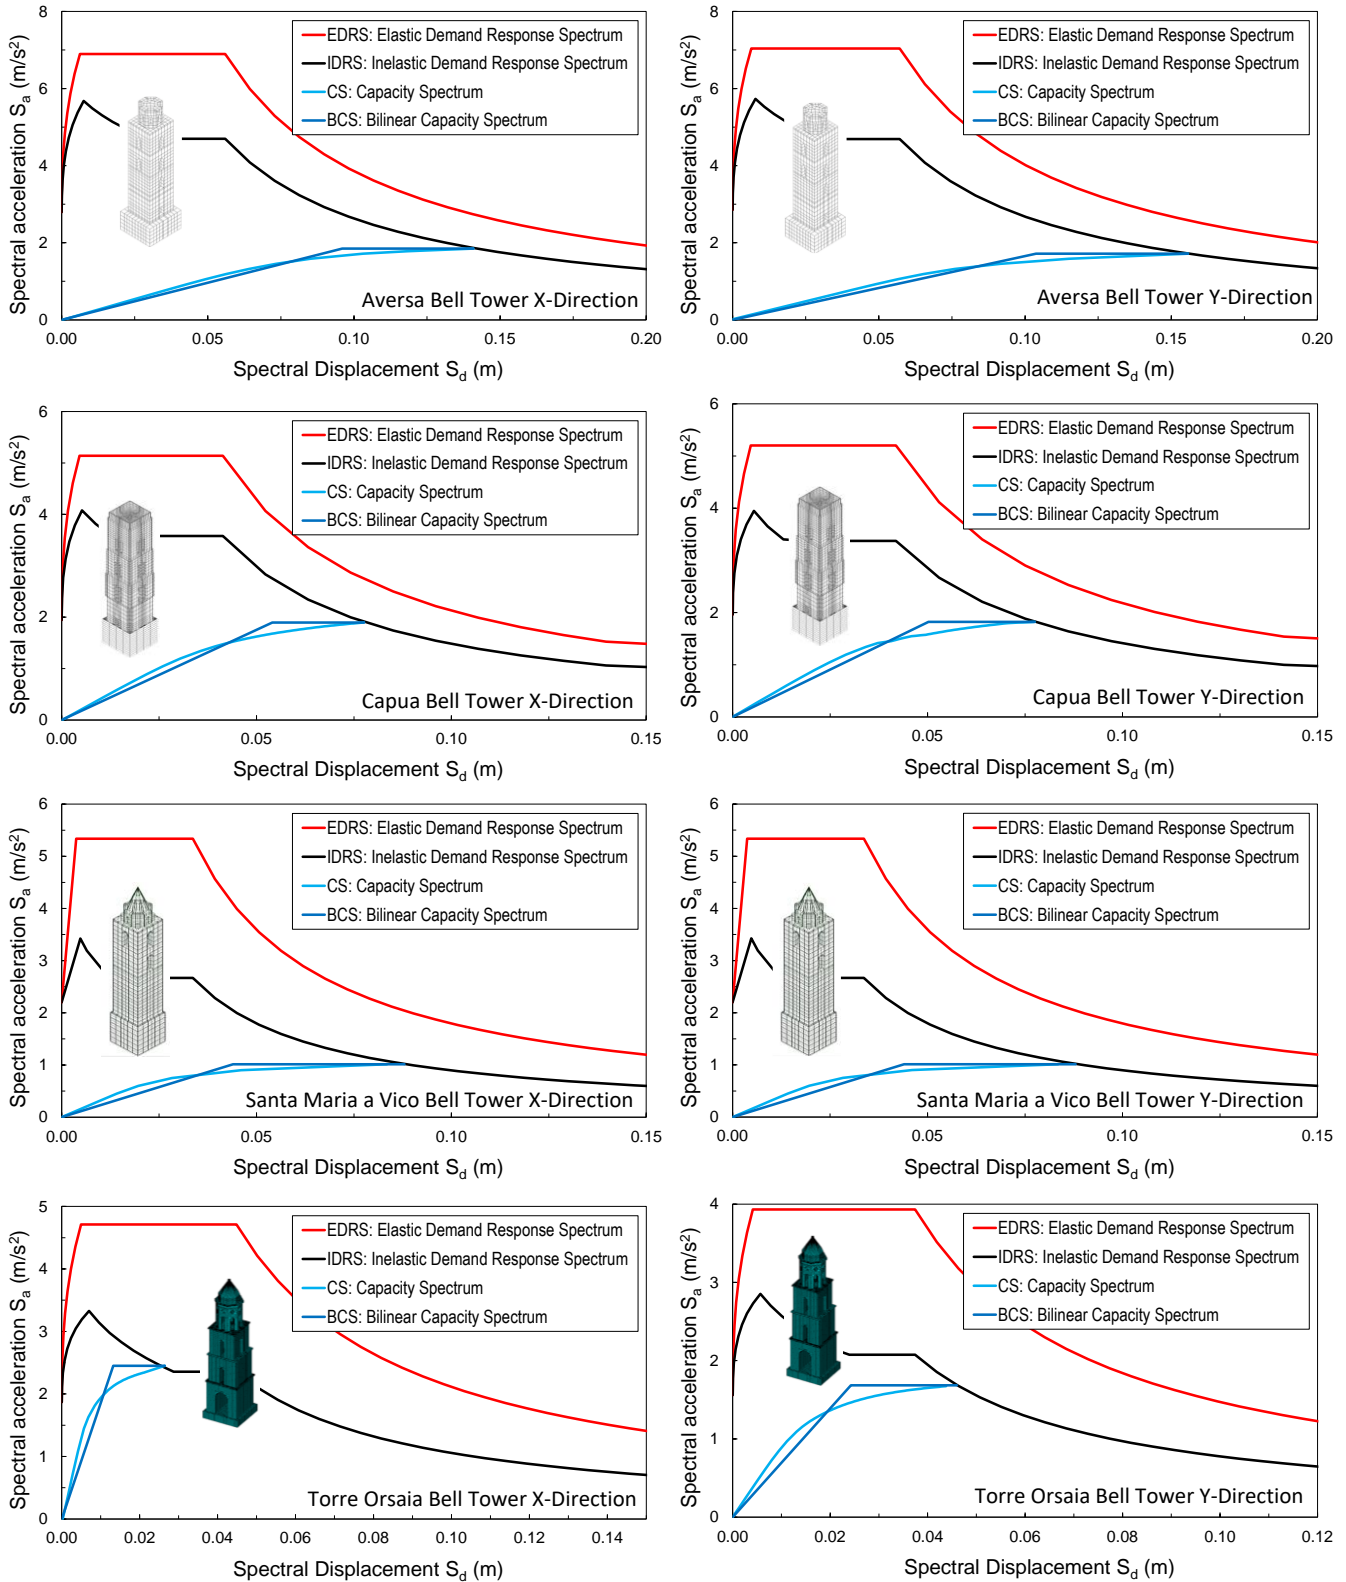
**Figure 11.** Comparison between capacity and demand in the acceleration–displacement response spectrum plane

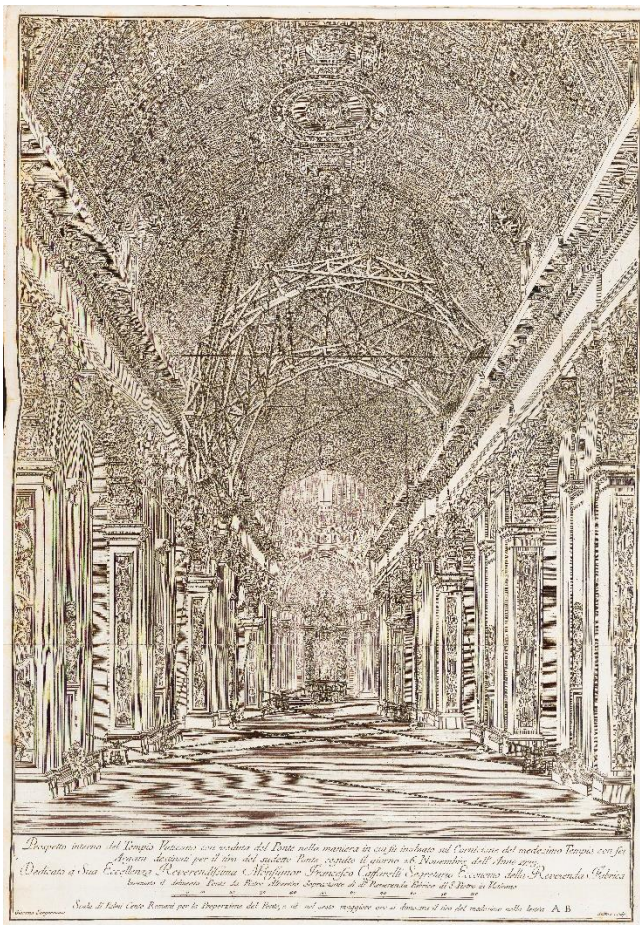
**Figure 5.** *Castelli e Ponti* 1824, pl. LX. Installation of a moving restoration scaffolding designed by Pietro Albertini in the nave of St. Peter's in 1773.

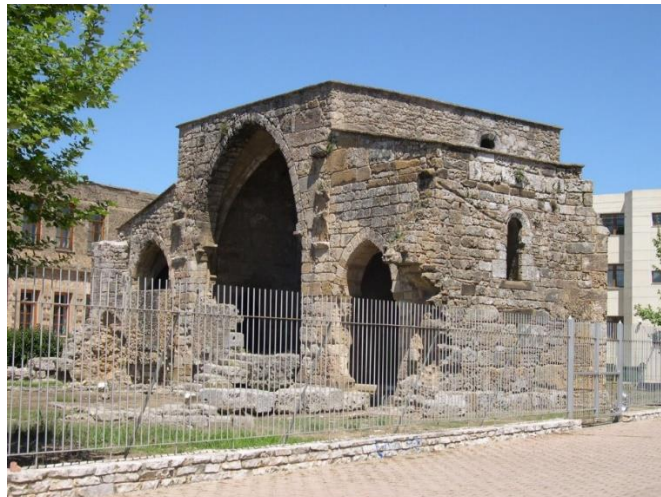
Figure 1. The vaults over the apse in Hagia Sophia, Andravida

preserved, the vaults at the apse are almost intact (Fig. 1). Using them as a case study, the aim of this work is to examine possible cultural and technological exchanges as they can be identified through the vaults' architecture, construction process and structural behaviour. The performance of their whole system will be analysed by structural assessment of the vaults, as also assumptions about the design process.

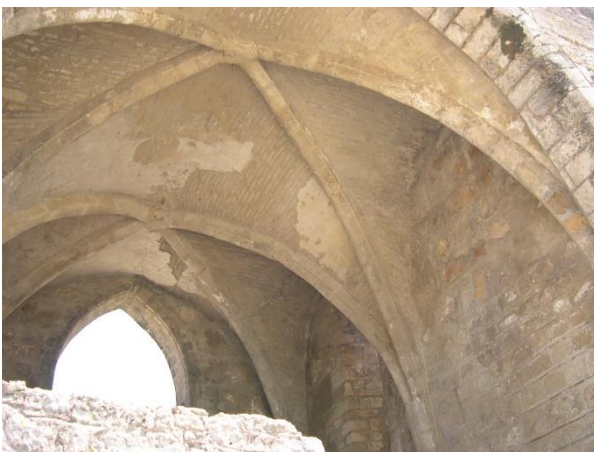
**Figure 3.** The ribbed vaults of the apse

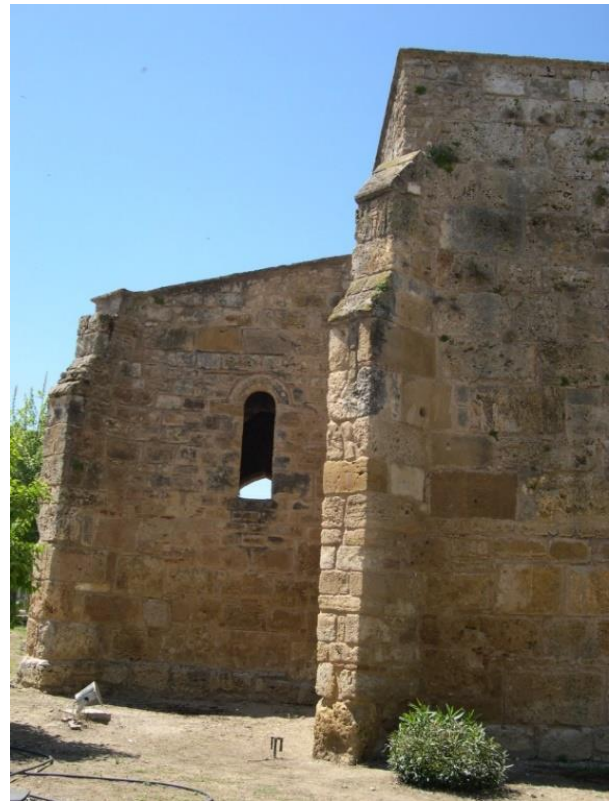
**Figure 4.** The diagonally laid pier buttresses at the exterior of the apse

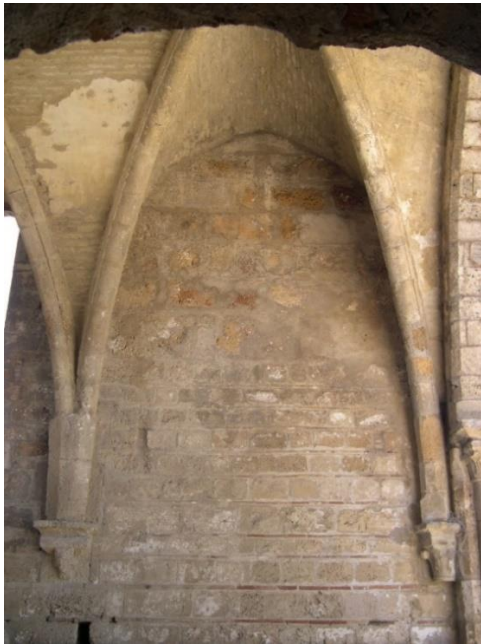
**Figure 5.** The ribs and springings of the vaults
