Production of waste polystyrene-based composites and evaluation as corrosion inhibitor for rebar coating

Abstract

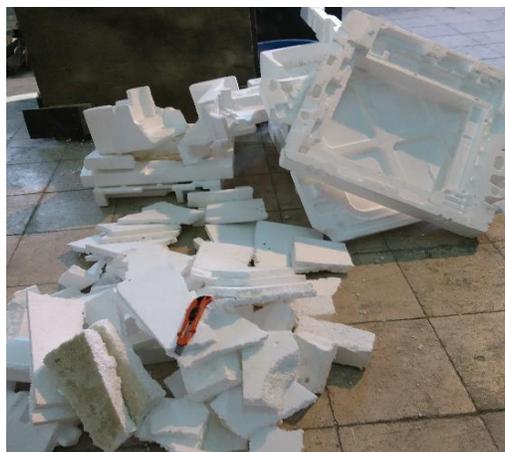
Fig. 1. Waste polystyrene foam.

In the scope of the study for rebar coatings, polystyrene foam (Fig. 1) which is a waste material has been used as the matrix material and carbon black (CB), carbon fiber (CF) and standard sand (SS) have been used as reinforcement elements. CF is a type of fiber used in building materials for different purposes [19]. SS is a standard aggregate type granulated between 0 and 5 mm. The SS used in the study was passed from the sieve and was fell below 2 mm.

Polystyrene is a material having a lower density than conventional materials and noncellular polymers. It also has superior strength / weight ratio, price suitability, high heat and sound insulation, impact resistance, toughness, fatigue life, thermal stability, low dielectric constant, low thermal conductivity. This polymeric material is used in furniture industry, transportation, bedding, carpet-upholstery, packaging, textile, toys, cap, sports applications, insulation applications. Approximately 200 g of polystyrene foam was dissolved in 200 g of benzene to give the resin consistency.

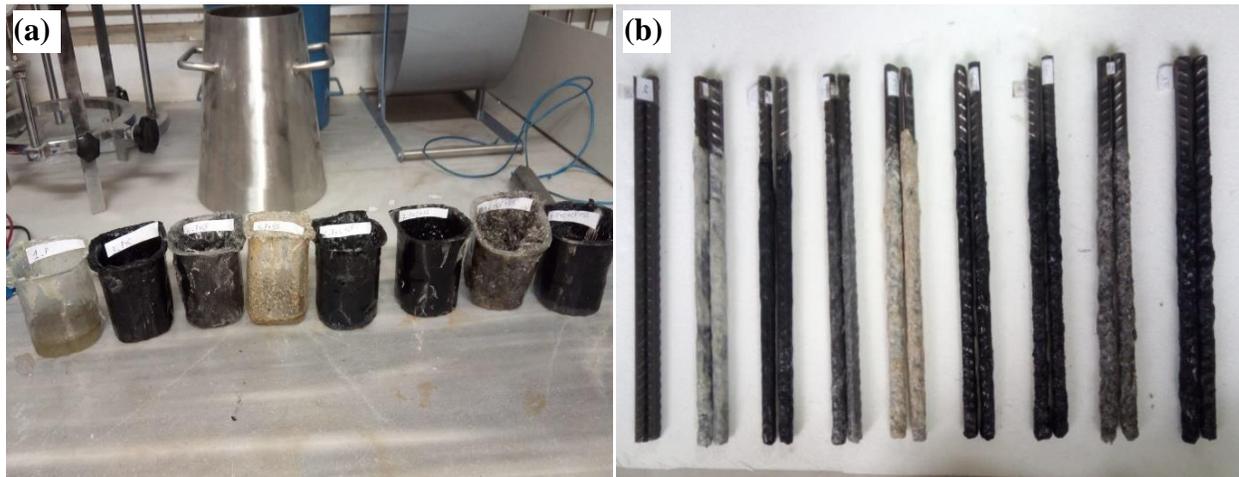
Two coated rebar specimens were produced from each composite by applying the composite materials to the previously prepared 30 cm rebar specimen surfaces. 9 produced composite materials and their application to the rebar surfaces is shown in Fig. 2. The coating thickness was adjusted to an average of 2 mm.

Fig. 2. produced composite materials (a) and their application to the rebar surfaces (b).

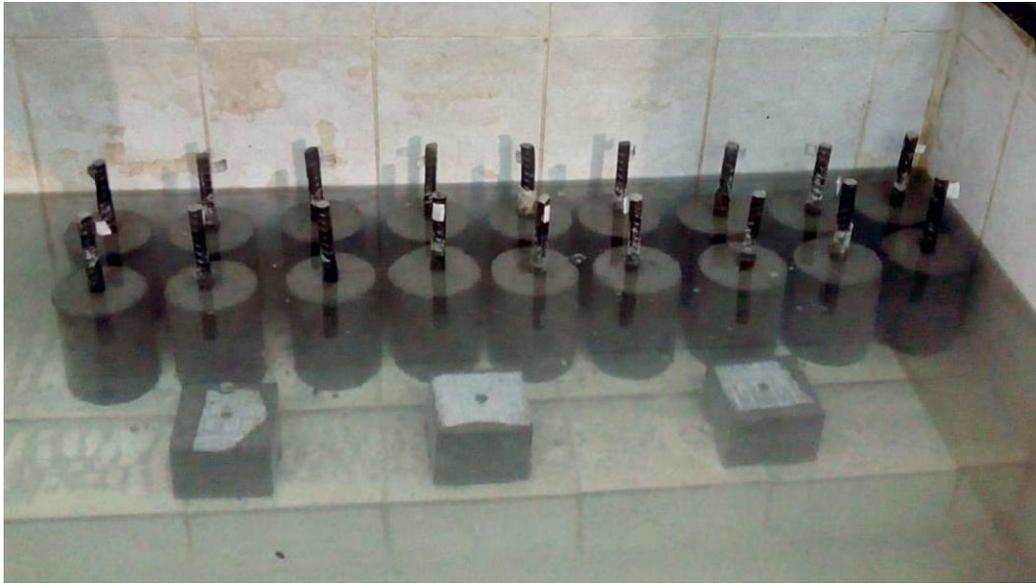
In order to determine the compressive strength of the produced concrete, 3 pieces of 10 x 10 x 10 cm cubic specimens were produced. All specimens were stored in the curing pool for 28 days and then were prepared for the experiment as seen in Fig. 3.

Fig. 3. Curing process of specimens.

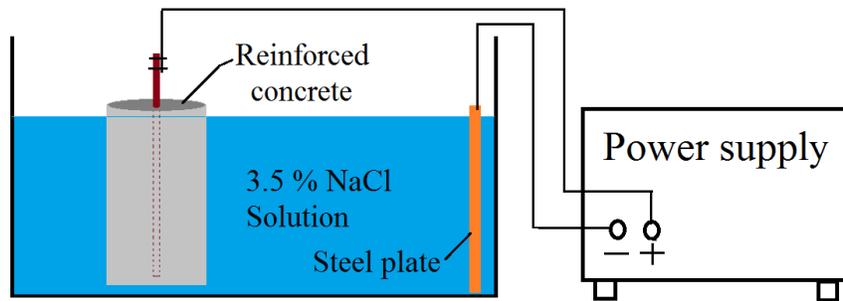
Anode-cathode method was used for corrosion acceleration in the specimens. In this method, as shown in Fig. 4, reinforced concrete sample is put into 3.5% NaCl solution. In the solution, a conductive rod or plate is placed on the other side. The rebar in the reinforced concrete is connected to the positive side of the power supply and the conductive plate to the negative side of power supply. Corrosion acceleration process continues for 48 hours by applying 70 V potential difference.

Fig. 4. Schematic image of corrosion acceleration device.

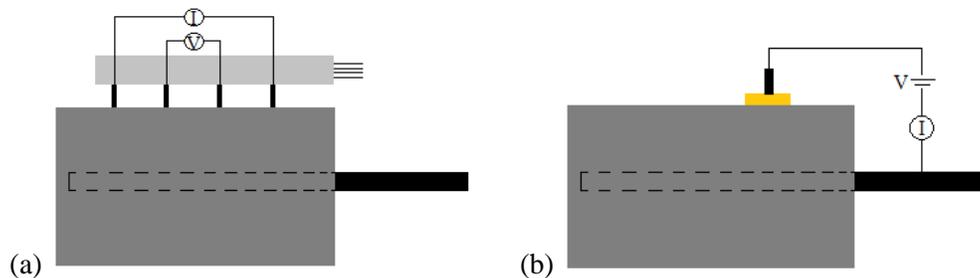
After the acceleration of corrosion, the corrosion levels of the specimens were examined by two different methods. Four-Probe and one electrode current measurement methods. Schematic views of the Four-probe and one electrode current measurement methods are given in Fig. 5.

Fig. 5. Schematic views of the Four-probe (a) and one electrode (b) current measurement methods.

In the four-probe method, a certain voltage is applied between the two inside probes of the instrument which are placed on the concrete surface. The amount of current occurring between the two external probes is measured. Resistance (R) value is obtained from equation 1. Then, equation 2 is used to calculate the resistivity.

In the one electrode method, as shown in Figure 5.b, the current value between the rebar and the concrete is measured after applying a certain voltage. The resistance (R) value is obtained from equation 1 and equation 3 is used to calculate the resistivity.

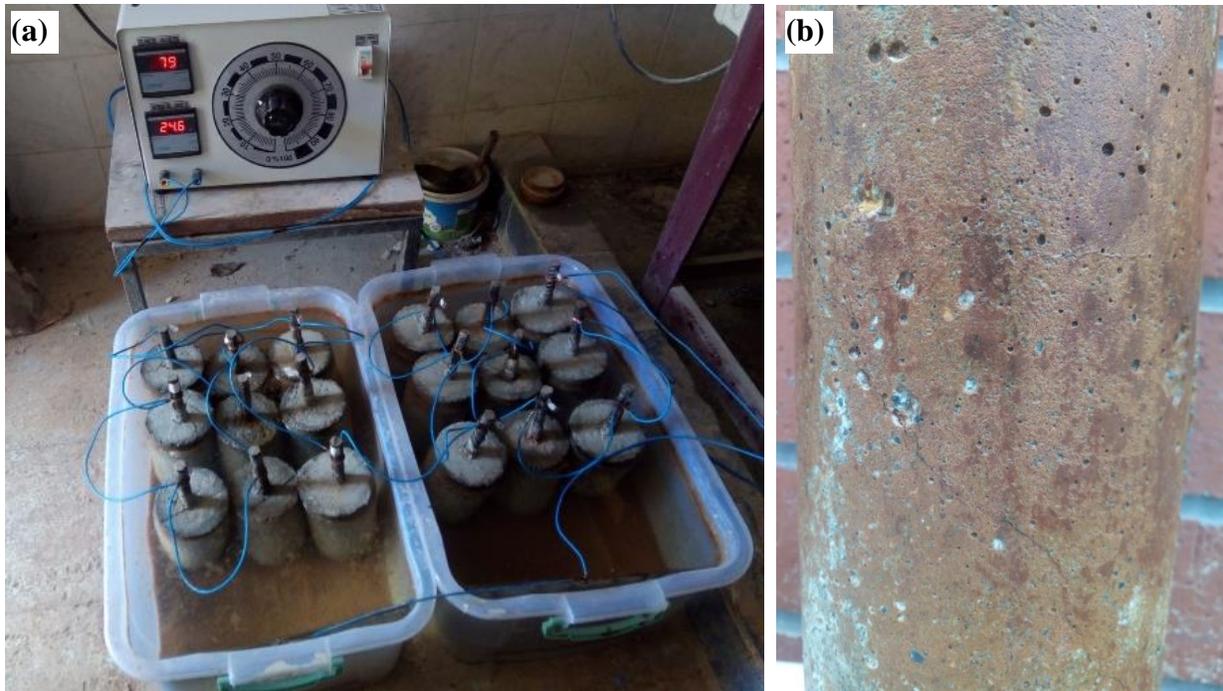
The corrosion acceleration process of the specimens is shown in Fig. 6a. In this study, all cylinder specimens were connected to the positive direction of the power supply and the plates in the solution were connected to the negative side of the power supply. After applying a voltage of 70 V for 48 hours, rust precipitation can be seen from the figure to the bottom of the solution. Many parts of the collapsed rust may belong to uncoated rebar's, as understood from the subsequent results.

After corrosion acceleration, surface changes of all specimens were examined. No cracks were formed on the surface of any specimen except the uncoated rebar reinforced specimen. The capillary cracks that occur on the surface of the uncoated rebar reinforced specimen after the process are also seen in Fig. 6b. The reason for the cracks is the increase in volume caused by the rusting of the rebar.

Fig. 6. The corrosion acceleration process of the specimens (a) and surface of the uncoated rebar reinforced specimen after the corrosion acceleration process (b).

By applying a voltage of 70 V for 48 hours, there were no defects on the surface of the other specimen except the uncoated specimen. On the surface of the uncoated rebar reinforced concrete, significant cracks have occurred due to the volume increase. This, occurs when a rust layer forms on the surface of the rebar and creates pressure inside the concrete.

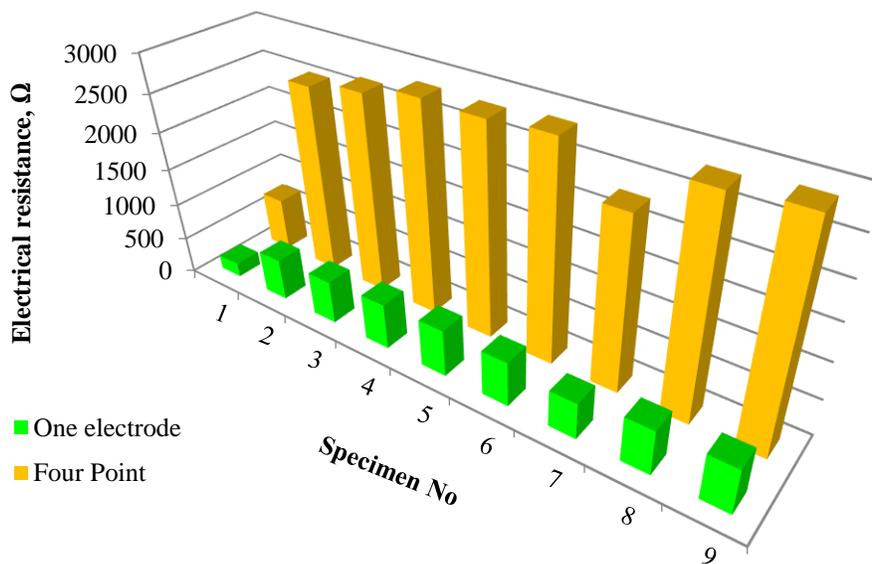
In this study, investigations between specimens are based on the resistance measurement method described in the previous section. Resistance values of all samples were obtained in both one-electrode and four-point method using equation 1 (Fig. 7). As can be seen from the figure, the four-point resistance values are approximately 4.5 times the one-electrode resistance values. This situation regarding the resistance of concrete, i.e. the difference between the resistance values measured by two different methods, has been determined in previous studies. The maximum and minimum values measured by the four-point method belong to sample 9 as 2904 Ω and to sample 1 as 726 Ω , respectively. Also, the maximum and minimum values measured by the one-electrode method belong to sample 5 as 642 Ω and to sample 1 as 193 Ω , respectively.

In general, the resistance values of the reinforced concretes with all coated samples, except the uncoated sample, were measured very close to each other. In both methods, the resistance values of the coated samples increased by more than 3 times compared to the resistance value of the uncoated specimen.

Fig. 7. Resistance results measured by two different methods.

Resistance values measured by four-point method were obtained as approximately 4.5 times the resistance values measured by one-electrode method. This has been confirmed by previous studies in the literature. In the four-point method, it obtains information about the surface resistance of the concrete specimen. Therefore, the amount of electrical current measured by this method may be less than the amount of current measured by the one electrode and bulck methods.

The maximum and minimum values measured by the four-point method belong to sample 9 as 2904 Ω and to specimen 1 as 726 Ω , respectively. Specimen 9 contains 38% polystyrene 10% CB and 50% SS. Therefore, corrosion was prevented by covering the SS and the pores between them CB on the rebar surface. Also, the maximum and minimum values measured by the one-electrode method belong to specimen 5 as 642 Ω and to sample 1 as 193 Ω , respectively. In this method, the most resistant to corrosion is composite containing 50% polystyrene and 50% SS. The only difference with the result of the previous method is the CB deficiency. Actually, the presence of CB is expected to be anticorrosive. Therefore, the misleading result in this method may be due to mistakes during coating.

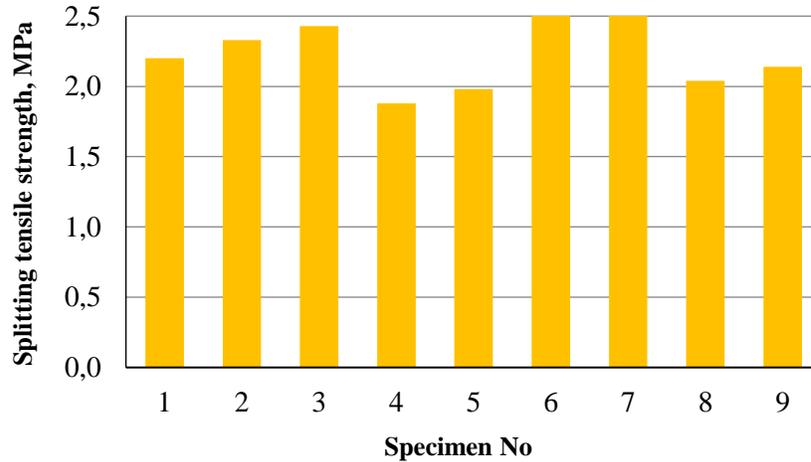
are compatible [21]. The split-tensile test results are summarized in Fig. 8. The maximum split-tensile strength values, as 2.54 MPa, belong to specimens 6 and 7. Resistance values of specimen 6 were measured as 2882 Ω and 2310 Ω by four-point and one-electrode methods, respectively, and Resistance values of specimen 7 were measured as 610 Ω and 493 Ω by four-point and one-electrode methods, respectively.

Fig. 8. The split-tensile test results of specimens.

According to the results, split-tensile strength average as 2.2 MPa similar values were obtained. In addition, the compressive strength of the cube samples produced from the concrete mixture was obtained as 26.5 MPa. From split tensile test, it is concluded that the amount of standart sand is getting increased, the strength of composite decreases. Its main reason is that.

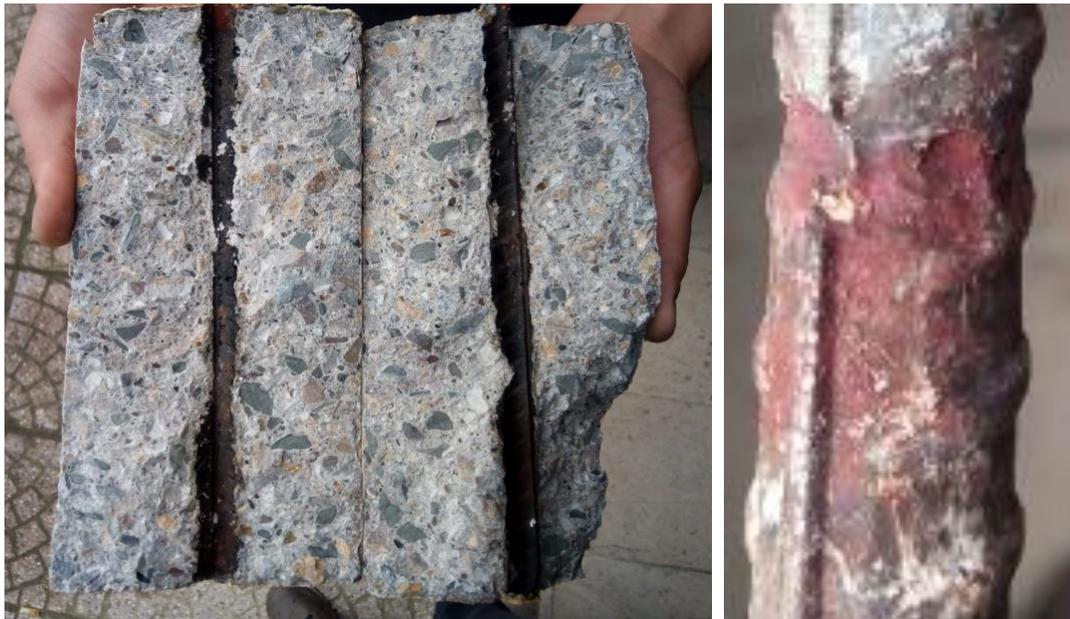
Fig. 9 shows the adherence state (a) of specimen-6 and the mass loss (b) of the uncoated specimen. A good bond between rebar and concrete in specimen-6 was found after the split-tensile test. It is understood from the above results also that specimen-6 is corrosion resistant.

Fig. 9 shows the loss of mass of the uncoated rebar clearly. The mass loss was calculated as 2.05% by weighing the first weight of the rebar and the weight after corrosion acceleration. In addition, there was no mass loss in the other specimens.

Fig. 9. the adherence state (a) of specimen-6 and the mass loss (b) of the uncoated specimen.

The mass loss was calculated as 2.05% by weighing the first weight of the rebar and the weight after corrosion acceleration. In addition, there was no mass loss in the other specimens. The loss of mass is due to the uncoated rebar being weak against corrosion. however, since all coated rebars are resistant to rust, there was no mass loss.
