HERITAGE AT RISK REGISTER AS A TOOL FOR MANAGING CULTURAL HERITAGE SITES IN KOSOVO

ALBAN MORINA, ERINË MULOLLI, KALTRINA THAÇI, SALI SHOSHI, NOL BINAKAJ

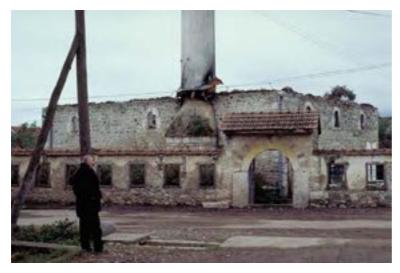
Figure 2. Mosque in Deçan burnt during the '98-99 War (Riedlmayer, 2014)

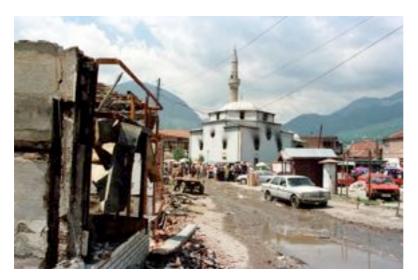
Figure 3. The market mosque in Peja during the '98-99 War (Riedlmayer, 2014)

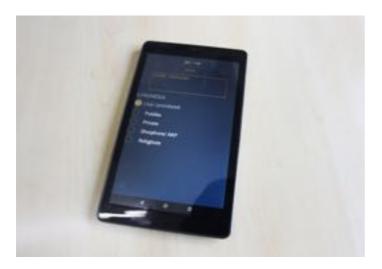
Figure 5. Tablet- the tool which replaced the equipment of the traditional method (By author, 2017)

To produce faster and better results, we started using tablets. We created an application, which interconnected very well with the online platform database. The tablet reduced the need for all the equipment used before. There was no need to carry the four pages form, because it was integrated in the application, neither was the need to have GPS tools because when the new form opened, the application generated the geographical coordinates automatically. In addition, no camera was needed because buildings were photographed by tablets. The most useful feature of the application was that it could be used in offline mode as well. It was possible to fill forms for five or more assets during the day and whenever connected to internet, all the data was uploaded in the online database system.

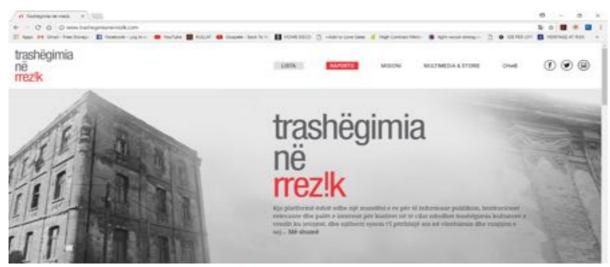
Figure 7. Print screen of Heritage at Risk Online Platform /www.trashegimianerrezik.com/ (By author, 2017)

HERITAGE AT RISK is an online digital platform, developed as a result of collected data and analyzed through mapping which consists of a list of assets that are classified in the three last assessment categories, meaning their physical condition is very bad, partially ruined or completely ruined.
