TYOLOGICAL ANALYSIS ON TRADITIONAL EĞİRDİR HOUSES

Ayşe Betül GÖKARSLAN¹

Zehra Gediz URAK²

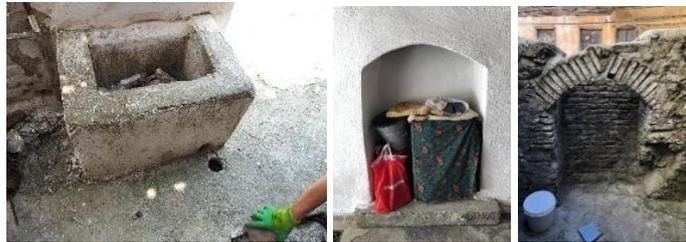
Figure 2. Examples of fountains and ovens of the Eğirdir houses

Houses have courtyards which called "Hayat". Courtyards are open spaces surrounded with stone walls which can be entered through double winged doors. It is possible to see houses with courtyards that have unique stone perimeter walls more often at Yeşil Island. Some courtyard perimeter walls of the island houses, continues as façade walls of main structure. Entrances of the structure shows variety according to the conditions of the courtyard and parcel. While, courtyards at South side, positioned as facing toward to lake, ones at North side positioned facing toward to south side of the buildings, while some courtyards have wells, fountains others have ovens that used for needs such as baking bread (Figure 2).

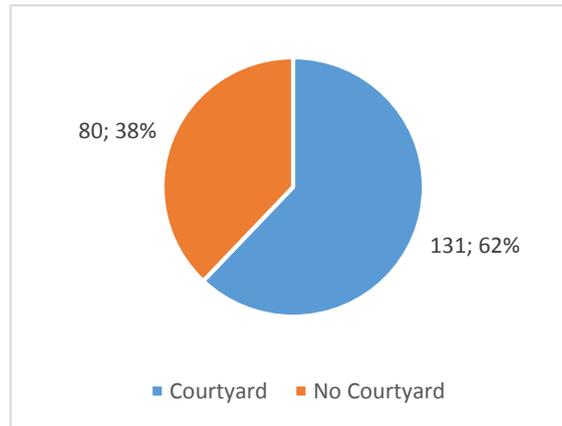
Graphic 1. Existence of the courtyard at Traditional Eğirdir Houses

Buildings can be divided into two as ones with courtyards and the others without courtyard. 131 of 211 (62%) traditional houses have courtyard (Graphic 1). According to the parcel type and positioning structures are three types namely; middle ones (surrounded with other parcels), corner (ones have at least one side that connected to street, road etc.) and single (as only structure at the block). According to the entrance, structures subdivided into three types namely; houses have entrances from courtyard, from road and from both courtyard and road. Every type varies according the entrance sides of courtyard and main structure. As an example, at the houses that have courtyard entrance and built between parcels, entrances to courtyard might be provided from sides, front and back sides of the courtyard. The determination and deduction of entrances of the houses which were not entered during study, performed with use of site observation outcomes and data obtained from Ministry of Interior's web site. Almost half of the structures positioned at the corner or in middle parcels, again almost half of them have entrance from Street and other half has entrance from courtyard. There are 106 houses constructed at middle parcels, 99 are positioned at the corner parcels and there are 6 houses built on the single parcel inside a single block. Entrances of ten of the houses were provided through courtyard, 93 houses' were provided through street, 108 houses' entrances were provided through both courtyard and street at same time (Table 2). Most frequently preferred type of entrance for Eğirdir House is the type that provides entrance form both courtyard and street, secondly the types that provides entrance from street, as thirdly and the least preferred type of entrance that provide entrance only from courtyard.

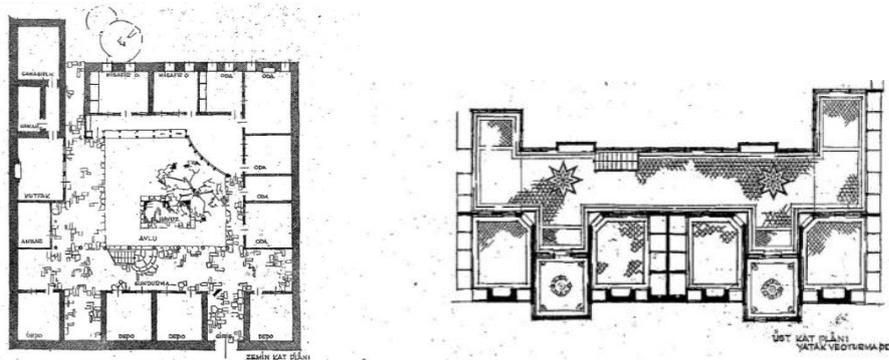
Figure 3. Measured survey drawings of an Eğirdir House that have not survive until today [7]

Houses have different number of floors and rooms depending on family's scale and economic status. At the houses that built in a way that satisfy the needs of more than one nuclear family, each room built in a way that satisfy the need of a single family. At some reachable archive sources, plan diagrams reflect that houses were larger than the ones that reach our days (Figure. 3). However, it is possible to understand that fire and calamities are the reasons behind those large houses' failure to survive up until today [7]. Eşref Adalı (2017) mentioned that some of the houses had guest houses which were single-storied, consist of few rooms and adjacent to the main structure [8].

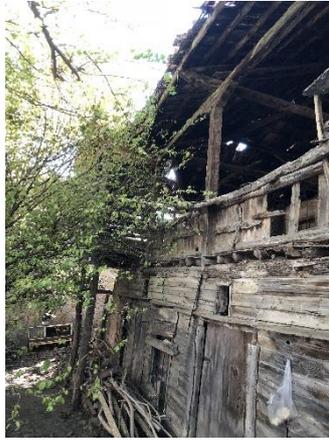
Figure 4. House at Yeşil Island which have open sofa

There are two types of plans were used at traditional Eğirdir houses (Table 3, 5) which are the plan types that have inner sofa and outer sofa. The plan type that have outer sofa has two sub types that has open and closed outer sofa. While plans that have open-outer sofa was detected at only one house (Figure 4), it was observed that closed- outer sofa type was preferred more. Closed- outer sofa type plans have sub types such as “I shaped”, “L shaped” and “U shaped” which named according to the organisation of the rooms around the sofa. Among these types “I” and “L” shaped types were preferred more than “U” shaped types, also plans that have inner sofa were preferred less than one have closed sofa. Plan types which has inner sofa has two sub types which are plans that has single faced inner sofa and double-faced inner sofa. Plan types that has double-faced inner sofa was preferred more than plans which has single-faced inner sofa. Plans types that have middle sofa which are commonly preferred at traditional Anatolian houses could not found at Eğirdir.

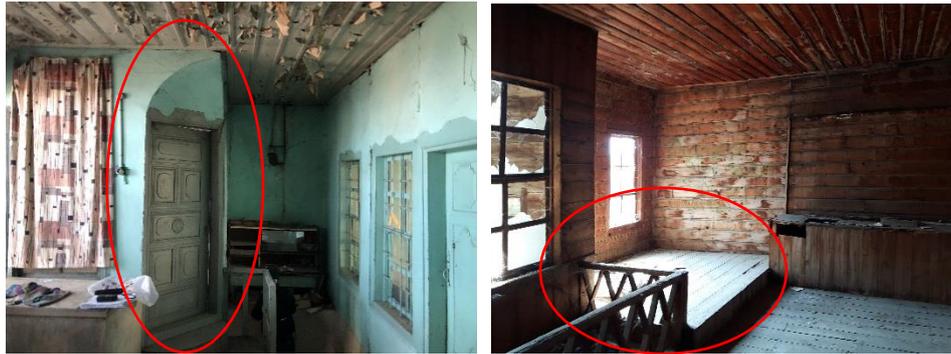
Figure 5. Eğırdir Houses – Chamfered corner entrance Figure 6. "Köşk" part at the Sofa

Rooms are the spaces where vast majority of the daily activities such as sleeping, bathing, eating, sitting are performed. The rooms where guests welcomed are larger and faces through street or lake. Named as "Baş oda", these rooms' ceilings, storage units, alcoves have rich craftsmanship in comparison with other rooms. Some houses do not have "güsülhane" (specific space allocated for bathing). Space provide circulation and interconnects rooms named as "sofa". Also, sofas named as "hane" or "hanay" by the region's people. Sofas are designed as closed sofas¹. Example of open sofa has been only found at a house that located at Yeşil Island (Figure 4) during study. Some of the sofas have elements such as "eyvan"², "seki", "köşk"³ and "abdestlik" (Figure 5, 6).

³ A space that raised from the floor with level difference, sometimes decorated with "sedir" sitting cushions. This space emphasized at the façades with projections.

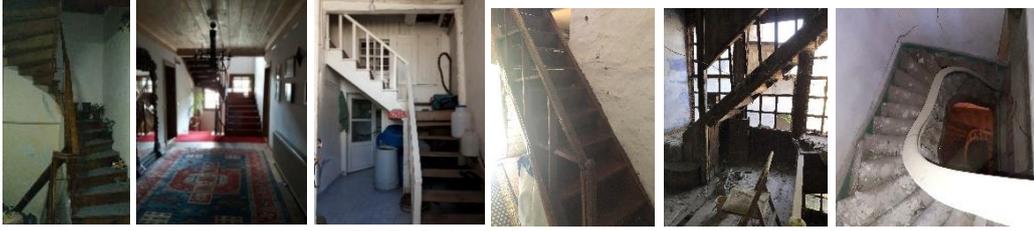
Figure 7. Examples of U, L, I, C shaped stairs of traditional Eğirdir houses

Connection between floors provided by timber stairs, from taşlık which located at ground floor, to the sofa that located at upper floors. The stairs are approximately 90 cm wide and the steps are 15cm high. Because of the level difference at some houses, there are different entrances for each floor. Shapes of the stairs are;

L, I, U or C shaped (Figure 7). The concrete stairs which can be found at some houses, are additions that added after the construction of the main structure.

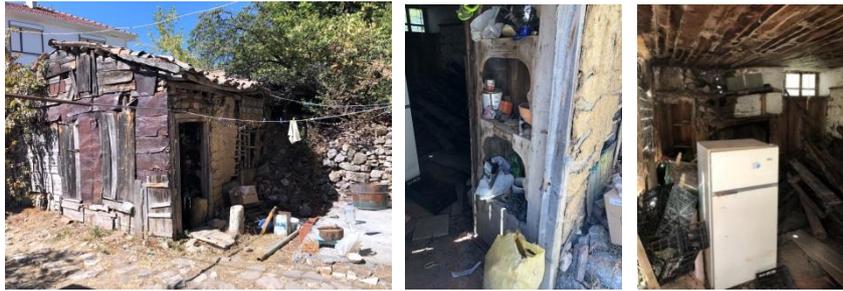
Figure8. Interior and exterior view of an outbuilding “müştemilat” which used until recently

Kitchens generally located at courtyard, inside of outhouse which called “harpışta”. At some houses kitchen takes place at ground floor’s interior space (Figure 8). Harpışta is a space that used to store kitchen ware and baking. Also, harpışta is a multifunctional space that divided into few spaces that allocated for bathing, washing clothes and extracting grape’s juice.

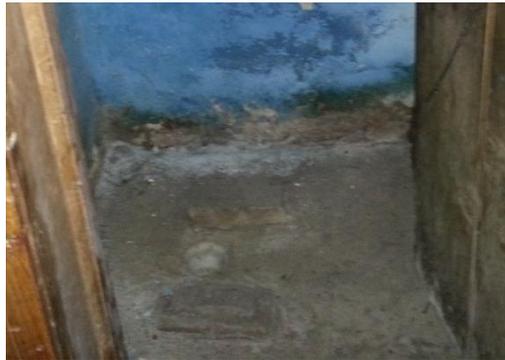
Figure 9. A toilet stone “hela taşı” example

“Hela” (toilet) generally located at courtyards, at the houses that does not have courtyard, “hela” is located at ground floors. At some houses, the space under the “sahanlık” (landings) allocated for the “hela” (toilet) (Figure 9).

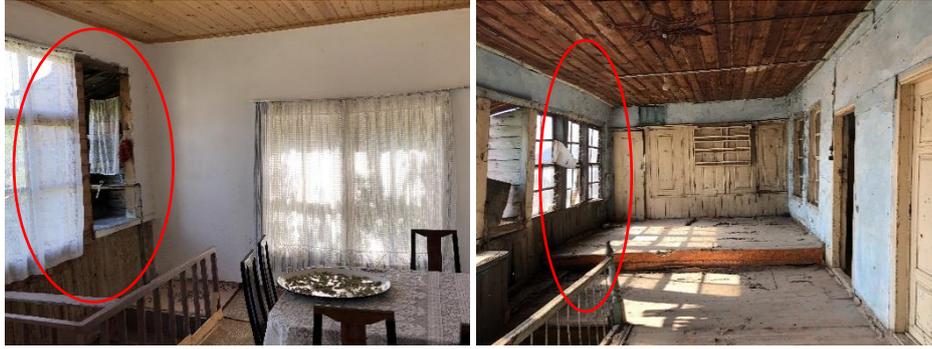
Figure 10. "Abdestlik" Washbasin at sofa

“Abdestlik” Washbasin; is a circular or rectangular shaped washbasin, that made out of stone, marble or cement, takes place at sofa, having timber window in front (Figure 10, 11). Today “abdestlik”s, are organised inside the buildings as toilets, bathrooms or cement plastered new spaces added to the building such as cellars and storages (Figure11).

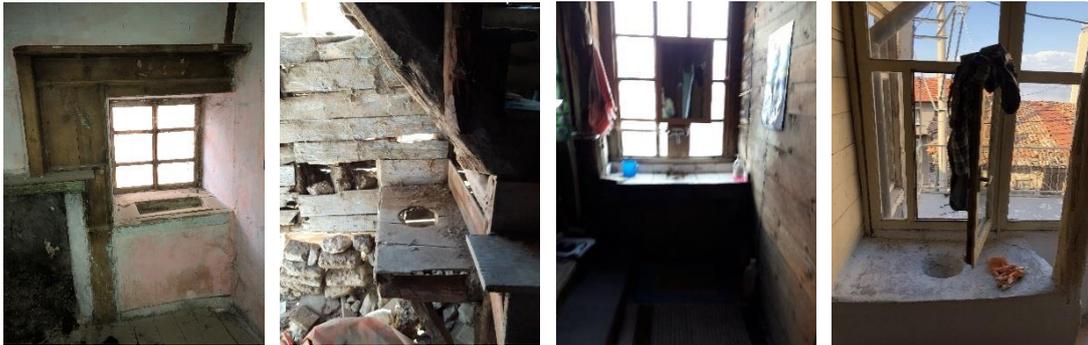
Figure 11. Examples of "Abdestlik" Washbasin

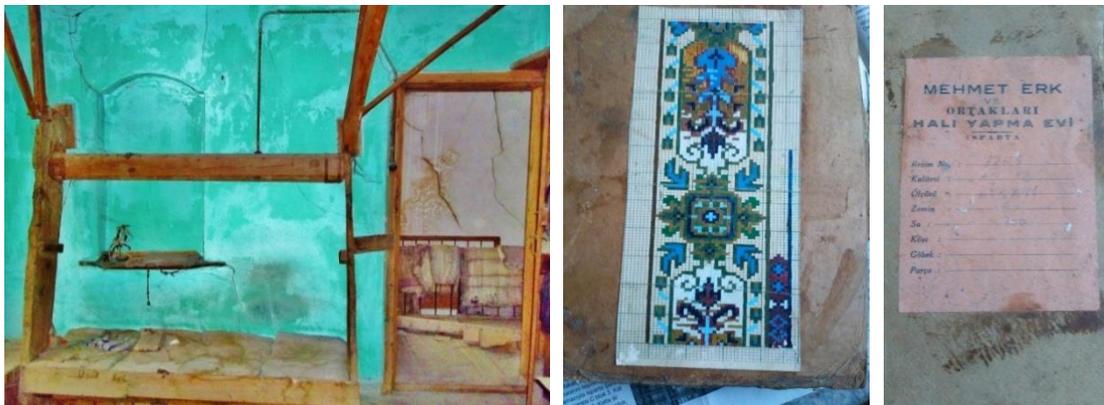
Figure 12. Carpet loom, carpet design pattern and its document that found at houses

As known as at some houses there is a "halı odası" (carpet room) which have carpet loom. About carpet rooms a thesis that Isparta Centrum studied has been prepared by Kevser Çeltik Şahlan. In the study there were a correlation between carpet looms' positioning and plan typologies of the houses. Existence of the carpet rooms was determined. In the study it is stated that carpet rooms must be one of the rooms that located far from the kitchen and close to the entrance for easy accessibility [10]. At the case of the houses at Eğirdir District, it is hard to determine the carpet rooms. Because during study, could not reached to people that interested at carpet weaving, could not found any sources that reflects existence of the carpet rooms and during the field surveys it was determined at the houses which have carpet loom, carpet looms were located at other rooms on top of the "seki" at sofas. However, it is learned from the inhabitants that one of the rooms, which have "seki", are used as carpet room. During study, number of the houses that related to the carpet loom and carpet business is 4 (Figure 12).

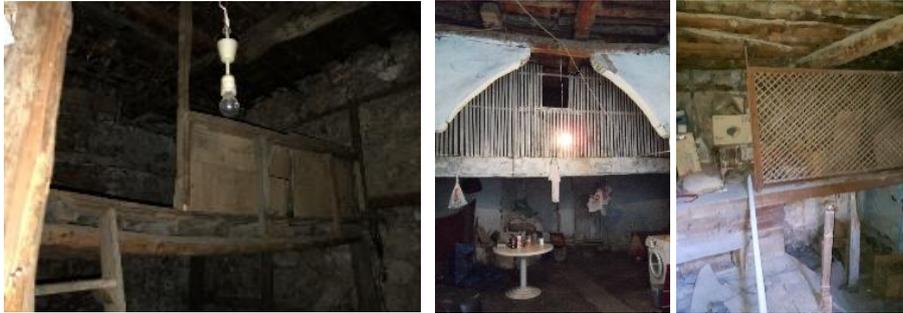
Figure 13. Mezzanines that organised by dividing elements at traditional Eğırdır houses

"Kiler" or "Hanealtı" (cellar) is a space that has 1.5-2 m. width, contains and protects food supplies in terracotta pots, has not any windows. Cellar is usually located at ground floor and rarely located at upper

floors. At some houses there are some mezzanines that used as cellars and these spaces organised with some dividing elements (Figure 13).

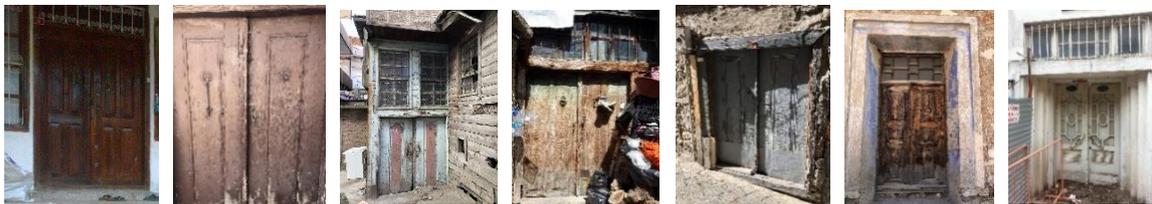
Figure 14 Examples of main entrance doors of Eğırdır houses

Architectural elements that distinguished and specific to the Traditional Eğırdır House are doors, windows, ceilings, ovens, cupboards, lamp niches/shelves and nichess. Doors; made with special care and attention according to their shape and location (Figure 14). While courtyard doors are humbler and more unadorned, entrance doors of the structures reflect owner’s economic and social power with its ornaments and detailed craftsmanship. There are doors decorated with wrought iron rounded nails and wrought iron door handles and lock mechanisms. These nails also used as a part of the decoration element of the door. Some of the doors have timber railings and lattices at the top parts.

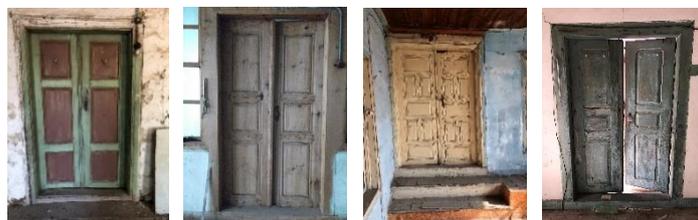
Figure 15. Examples of the double winged interior doors in the traditional Eğırdır houses.

Even if the vast majority of the interior doors are plain rectangular shaped however, there are some examples that have profiled or arched pediments. There are some gypsum plaster ornaments around the doors of the rooms that entered from chamfered corners (Figure 15, 16, 17).

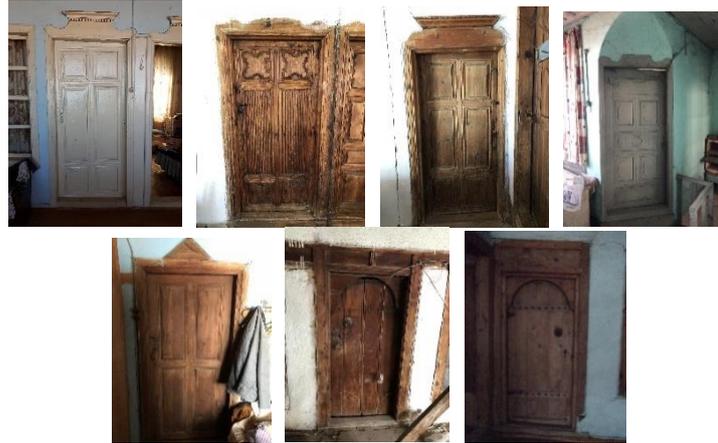
Figure 16. Example of interior single winged doors which have profiled or arched pediment in the traditional Eğirdir houses

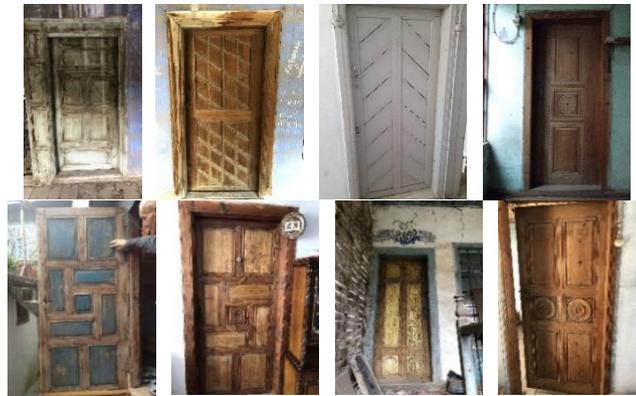
Figure 17. Examples of single winged interior doors in the traditional Eğirdir houses.

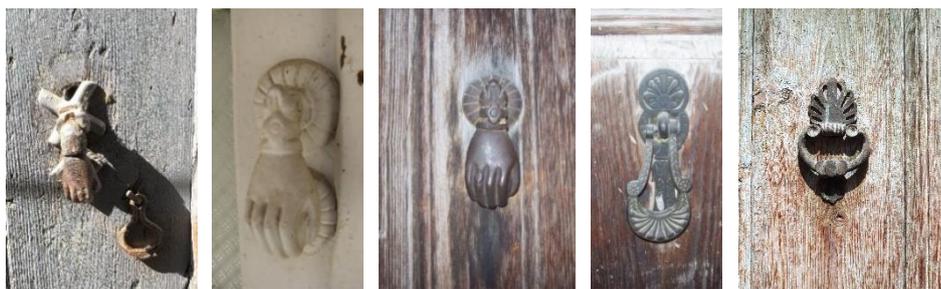
Figure 18. Examples of doorknockers of traditional Eğirdir houses

Metal and timber locking mechanisms which are still in use today, door handles and doorknockers “şakraklar” are other elements that reflect craftsmanship on the timber doors (Figure 18, 19). Some of the doorknockers are shaped like a hand.

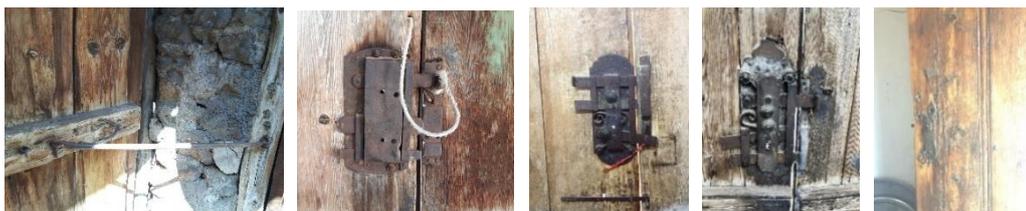
Figure 19 Examples of locking mechanisms of the exterior doors of traditional Eğirdir houses

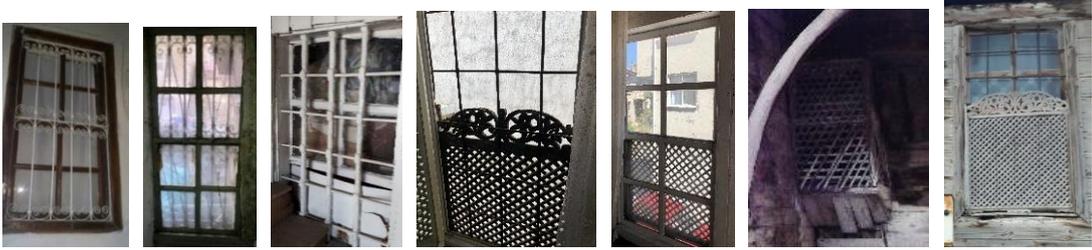
Figure 20. Examples of metal and timber railings on windows of traditional Eğirdir houses

Mostly groundfloor walls do not have windows, however there are some examples that have small windows with iron railings. Mostly straight railings used but some of them have curling decorations. Some windows have timber railings. Traditional Eğirdir houses have sash “giyotin” windows. They are 60-80 cm. width and 120-160 cm. length and also these windows have equally divided into six-eigh panes (Figure 20). At the houses that built with brick masonry techniques have arched windows (Figure 21).

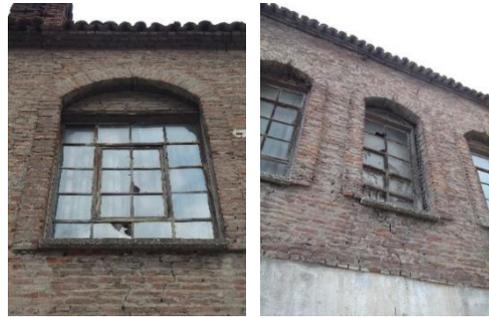
Figure 21. Examples of traditional Eğirdir houses' arched windows

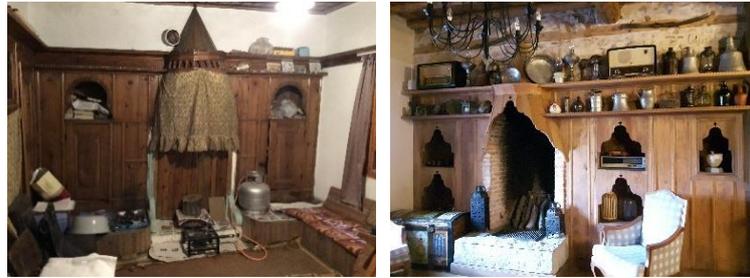
Figure 22. Example of ovens with timber hood “yaşmak” at the traditional Eğirdir houses

Eğirdir Houses have ovens at both rooms and kitchens. The oven that foods cooked and heated has timber hoods “yaşmak” (Figure 22). There are shelves and ornamented niches on both sides of the oven. However some ovens are plain and do not have timber hoods (Figure 23).

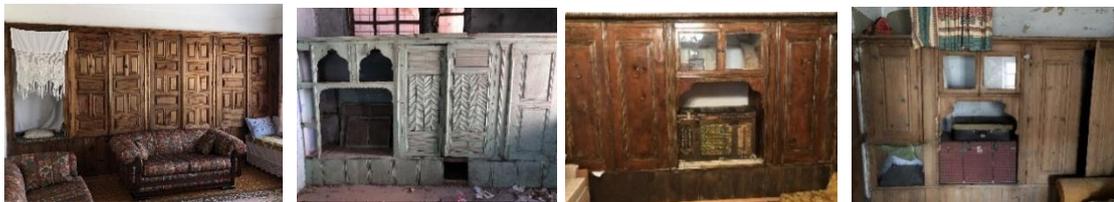
Figure 25. Examples of yüklük, sandıklık and musandıra at traditional Eğirdir houses.

According to function of these cupboards, named as “yüklük” that quilts were stored in, “sandıklık” that wedding chest of the bride were stored. “Yüklük” is a cupboard that has double winged door and raised 40-50 cm. from the floor level. The upper part of the “yüklük” is called “musandıra”. Yüklük, sandıklık and gusülhane were lined and organised on a wall. Gusülhane, is located mostly at outfacing corner of the room and has appearance of cuppoard. It is opened with a timber door and it is raised from the floor as a bathing space. Gusülhanes are transformed to yüklük because of construction of spaces allocated for bathing (Figure 25, 26).

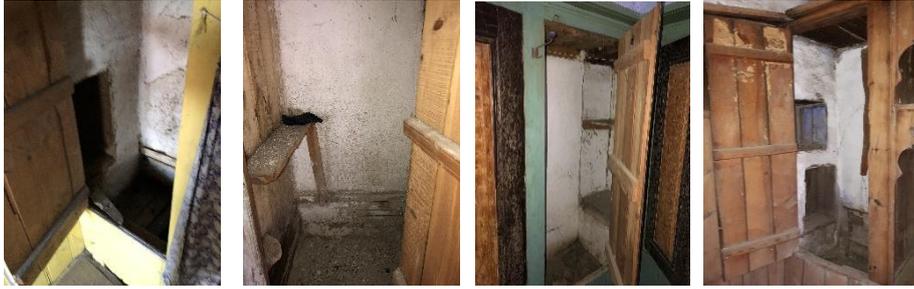
Figure 26. Examples of gusülhane at traditional Eğırdır houses.

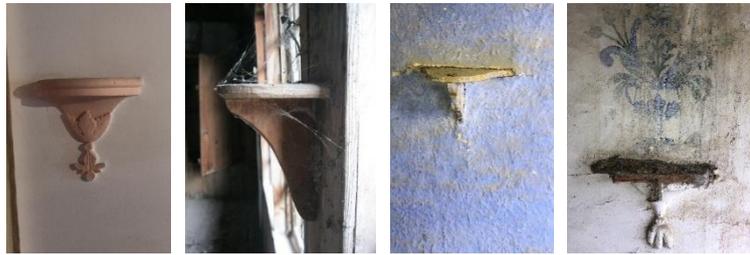
Figure 27. Examples of lamp shelves and hand-drawn “kalem işi” ornaments at traditional Eğırdır houses.

At the rooms, there are candle / oil / gas lamp shelves “kandillik” / “lambalık” which are made out of timber or gypsum, where the candle / oil / gas lamps were placed. A hand-drawn “kalem işi” ornament is detected on the lamp shelf at the wall of the house located at Yeşil Ada (Figure 27).

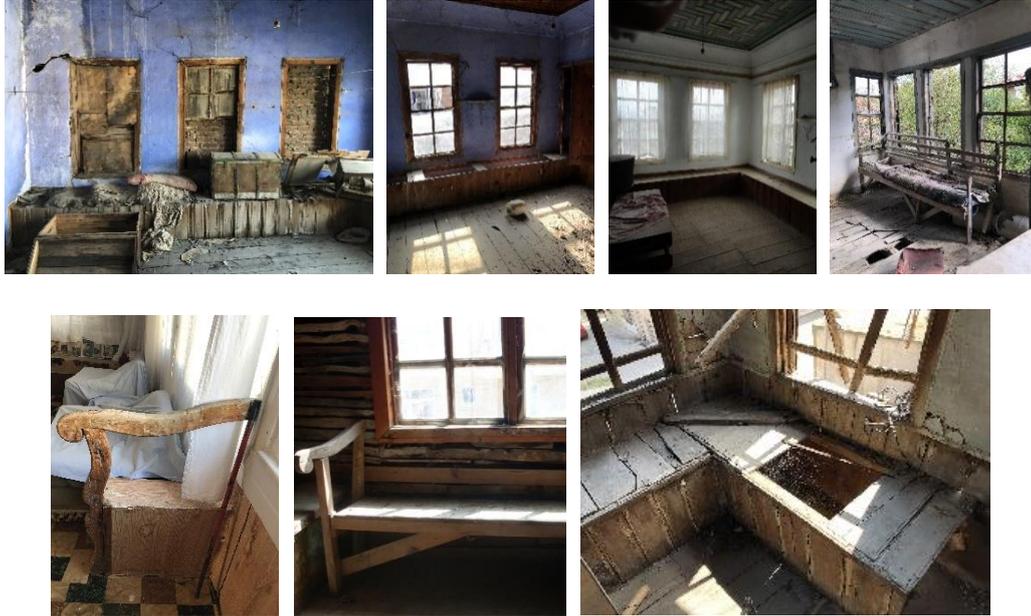
Figure 29. “Seki” Platform and hidden storages that part of seki at traditional Eğirdir houses

“Seki” Platform; is generally a raised sitting element, that has cotton filled cushions on top and at the waist supporting parts, and has storage spaces at the bottom. It is located at places where users can see outside while sitting. Some seki examples have carved timber balustrades at the corners (Figure 29). But sometimes “seki” is a wide platform in the sofa.

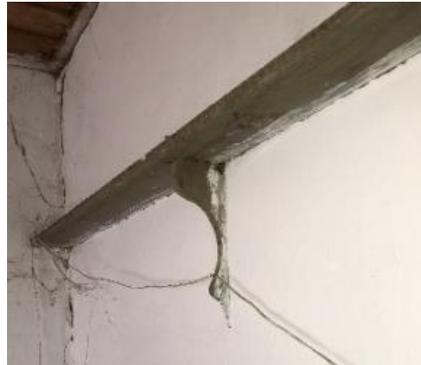
Figure 30. Example of “sergen / seren” at traditional Eğirdir houses

“Sergen / seren” is a shelf which continues all around the room at the top of the window’s top line, and it has 15-20 cm. width. It exists in all traditional Eğirdir houses. Examples at the kitchens which used at storing kitchen wares are wider than the other examples at the rooms (Figure 30).

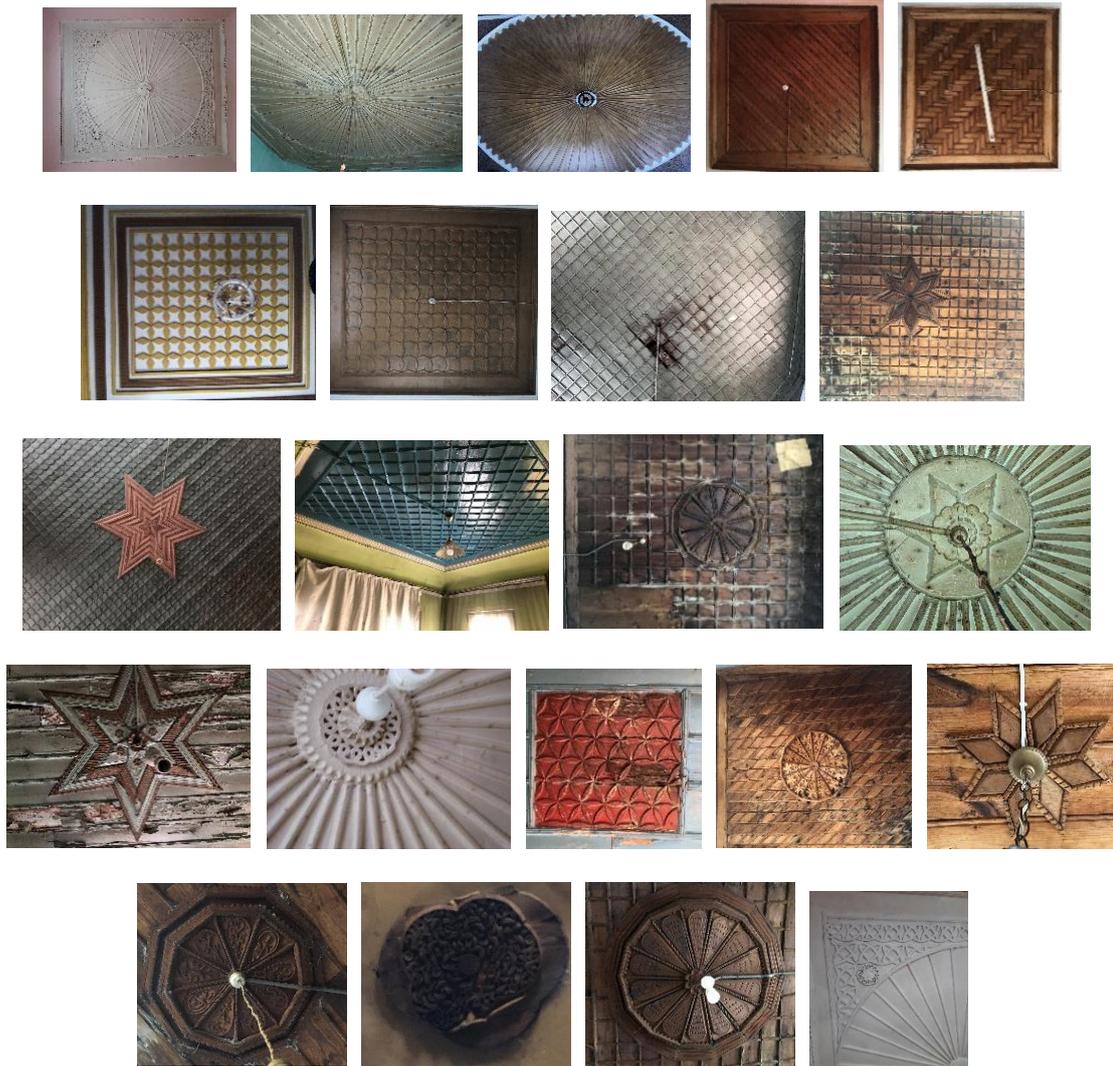
Figure 31. Examples of ornated timber ceilings and details of ceiling rose at traditional Eğirdir houses

Sofa and rooms have ornamented ceilings which have ornaments with star patterns that carefully crafted out of timber at the centers and borders. Guest rooms that named “Baş Oda” have richer ceilings in perspective of ornaments and craftsmanship (Figure 31). A special ornament craftsmanship named hand-drawn “kalem işi” detected only at the ceilings of two houses (Figure 32). At some of the houses’ ceilings, there are profiled capitals (Figure 33). Ceilings of the service spaces has simple timber plaque coverings. At the spaces such as barn and pantry, ceilings do not have timber coverings, timber beams left exposed (Figure 34).

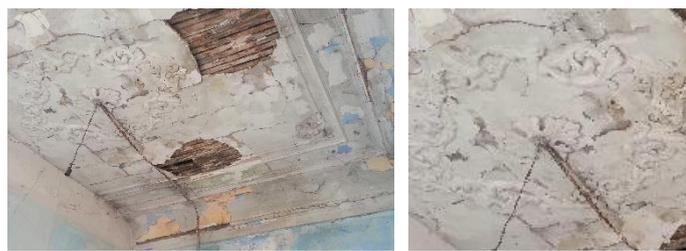
Figure 32. Examples of hand-drawn “kalem işi” craftsmanship at the ceilings of traditional Eğirdir houses

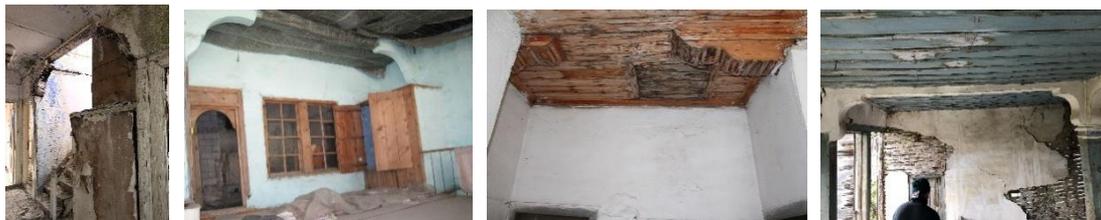
Figure 33. Examples of profiled timber capitals at traditional Eğirdir houses

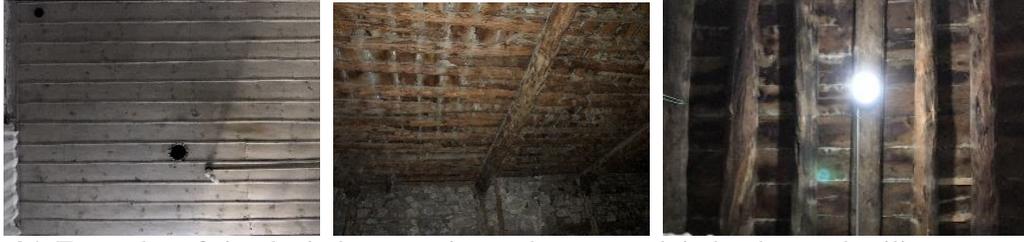
Figure 34. Examples of simple timber covering and uncovered timber beamed ceilings at traditional Eğirdir houses

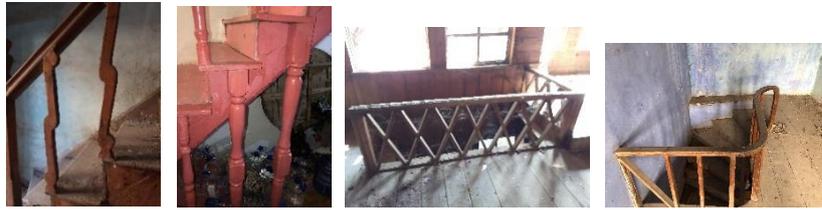
Figure 35. Types of balustrades and handrails at traditional Eğirdir houses

Stairs and elements of the stairs, such as steps, balustrades “küpeşte”, decorated top rails “zavrak”, handrails are completely produced from timber (Figure 35, 36). Tread boards have diamond or cross patterned motives (Figure 37). While some handrails have carved profiles and different craftsmanship, there are handrails which have circular or square sections.

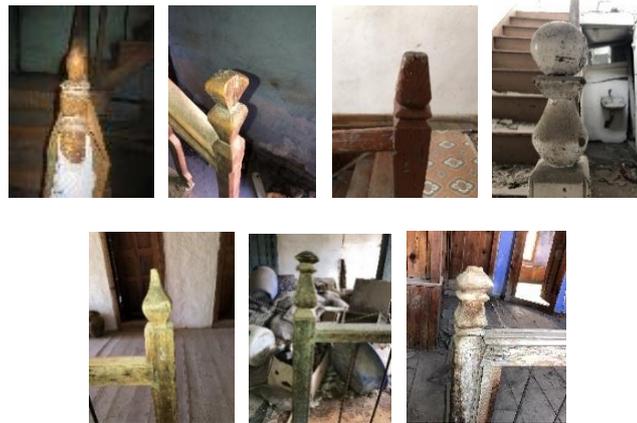
Figure 36. Examples decorated top rails “zavrak” at traditional Eğirdir houses.

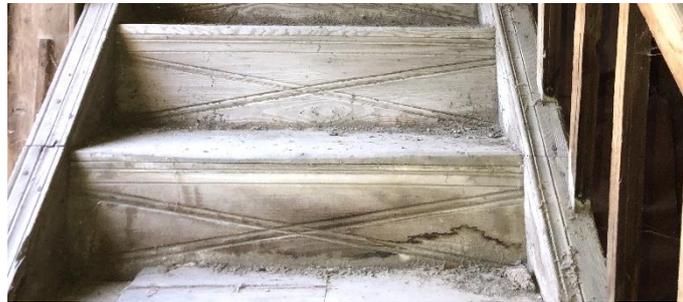
Figure 37. Cross patterned motives on tread boards of traditional Eğirdir houses.

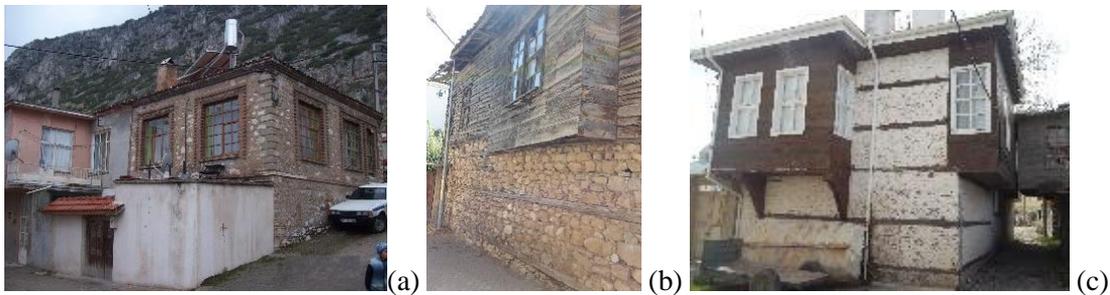
Figure 38. Construction system at traditional Eğirdir house (a) brick + stone masonry (b) stone masonry + timber framed (c) mixed use of systems.

Stone and timber material were used at traditional Eğirdir houses' construction. Usually, while ground floors of the houses were constructed with rubble stone masonry with or without bonding timber systems, upper floors were constructed with timber framed systems. Buildings which built with other construction systems such as timber frame, rubble stone masonry, brick masonry and different combinations of these systems were also detected. At the combined systems, two or three different systems and materials were used together. Houses that has outer walls which made of stone or brick masonry has inner walls that built with timber framed techniques. Some of the buildings' ground and upper floors, were constructed using brick masonry systems. Thickness of the outer walls shows variety, walls that built with rubble stone masonry have 50-90 cm, brick masonry have 50-70 cm, timber frame has 15-20 cm thickness. The timber framed inner walls are in 13-15 cm. thickness and finished with timber lathed "bağdadi" plaster technique (Figure 38, 39, 40, 41, 42) (Table 6).

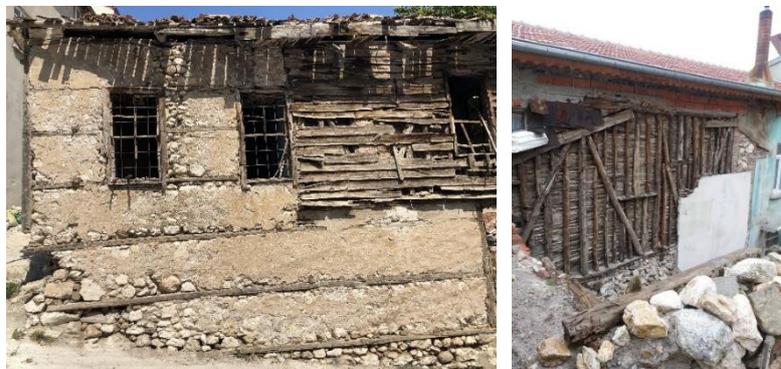
Figure 39. Using stone and timber framed system together in traditional Eğirdir houses

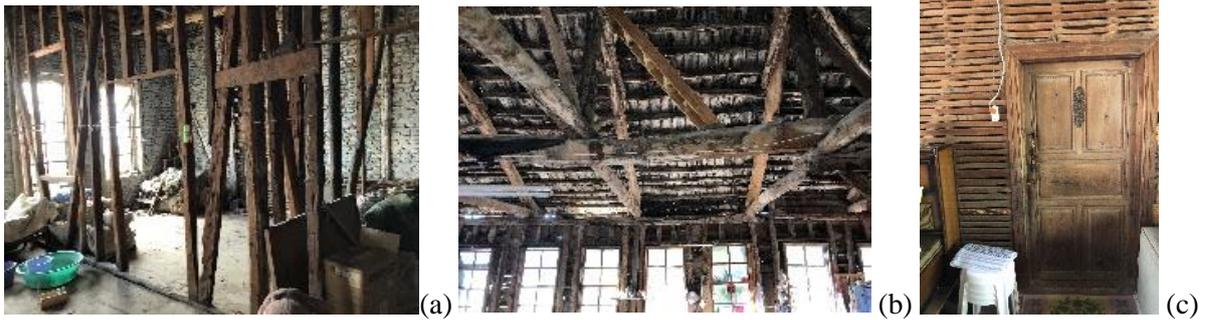
Figure 40. Traditional Eğırdır houses (a),(b) examples of timber framed system, (c) timber lathed “bağdadi”

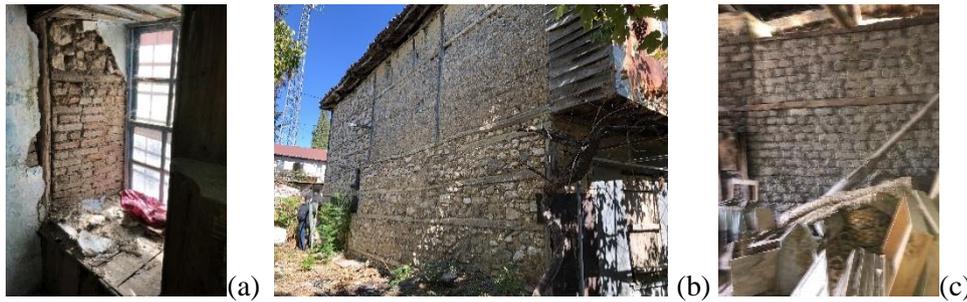
Figure 41. Wall fillings at traditional Eğırdır houses (a), brick filling (b), (c) adobe filling

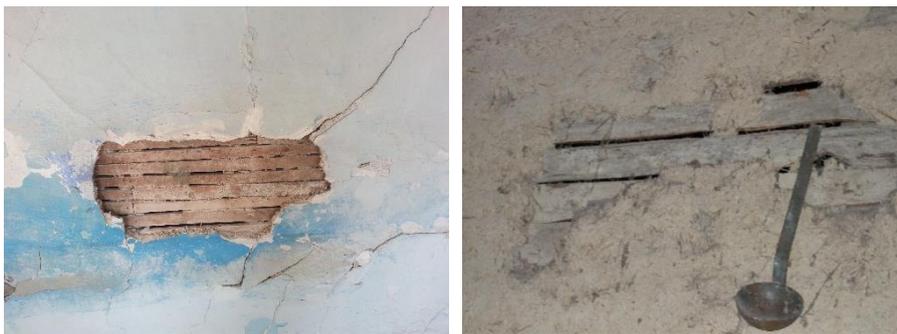
Figure 43. Examples of timber lathed “bağdadi” plaster at traditional Eğırdır houses

Plasters are generally soil based and contains straw. However, at some buildings there is lime plaster. Some buildings do not have plasters on the surface (Figure 43). At some buildings there are applied cement plasters and paints which are improper alterations that applied by property owners.

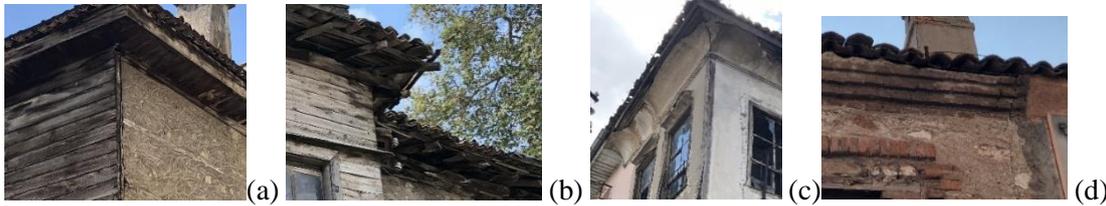
Figure 44. Eaves of traditional Eğırdir houses; (a) closed soffit, (b) open soffit, (c) profiled soffit, (d) brick saw-teeth “kirpi” eave

Eaves are divided into five as open timber soffit, closed timber soffit, profiled timber soffit, brick saw-teeth “kirpi” eaves and non-eaved. While mostly preferred types are open and closed timber soffits, other types preferred lesser (Figure 44).

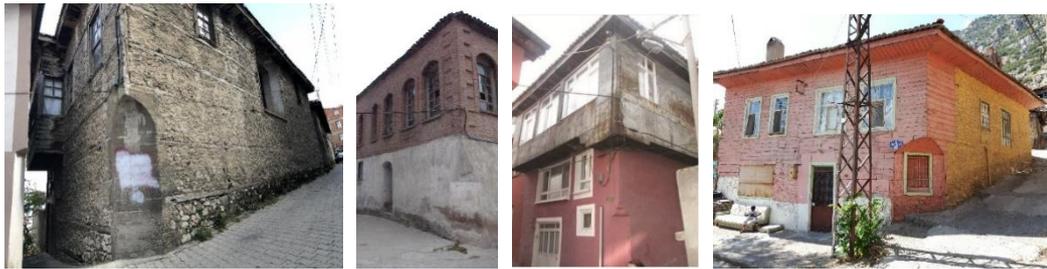
Figure 45. Example of chamfered corners at Traditional Eğırdir Houses

Many of the spectacular mansions that visible at archive photographs and drawings which belongs to traditional Eğırdir houses have not survive until today. At some examples of the survived houses, courtyard walls continue as façade of the structure. This situation is highly noticeable especially at houses located at island. There are projections on the façades which facing to entrance, street and courtyard. Openings such as doors and windows are located at façades which not facing to street. Houses that constructed in corner parcels has chamfered corners, even the houses that lost their traditional features, chamfered corners has remained until today (Figure 45).

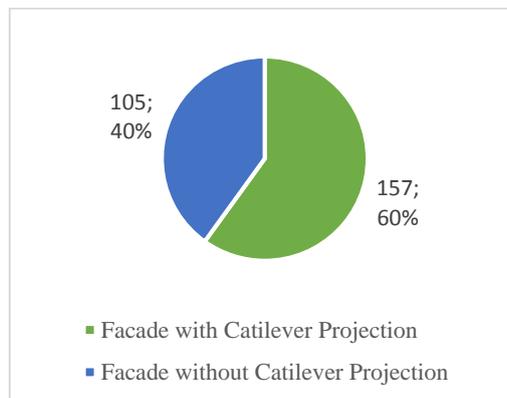
Graphic 2. Existence of projections at traditional Eğırdir houses.

According to the number of the storey, façades are classified as three groups; single-storeyed, two-storeyed, and three-storeyed. According to the elements of the façades are divided into two groups; façades that have projections and façades that do not have projections (Graphic 2). Due to the reason of each single façade of the houses, which are located in corner parcels, have various typological features, more than one façade of some houses were analysed during the study. For this reason typological analysis is conducted on 262 façades of the 211 traditional houses. In the study it is detected that most frequently built façade type is the one that has projection (%60) (Graphic 2).

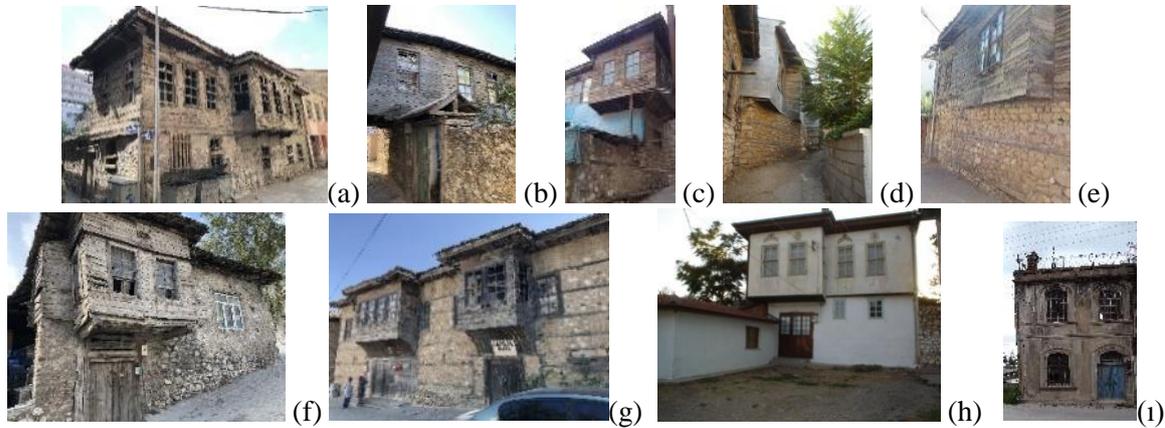
Figure 46. Façade types of traditional Eğirdir houses (a) middle projection, (b) full façade/storey projection, (c) corner projection (d), (e) saw tooth projection, (f) single side projection, (g) double side projection, (h) mixed projection (i) façade that do not have projection.

Projections divided into eight types which are middle projections, full façade/storey projections, saw tooth projections, corner projections, single side projections, double side projections, irregular projections and mixed projections. Irregular and mixed types of projections have more than one projections. Visually valuable silhouettes were created by the projections which are facing to streets. Some building' projections positioned as facing to courtyard (Figure 46) (Table 8).

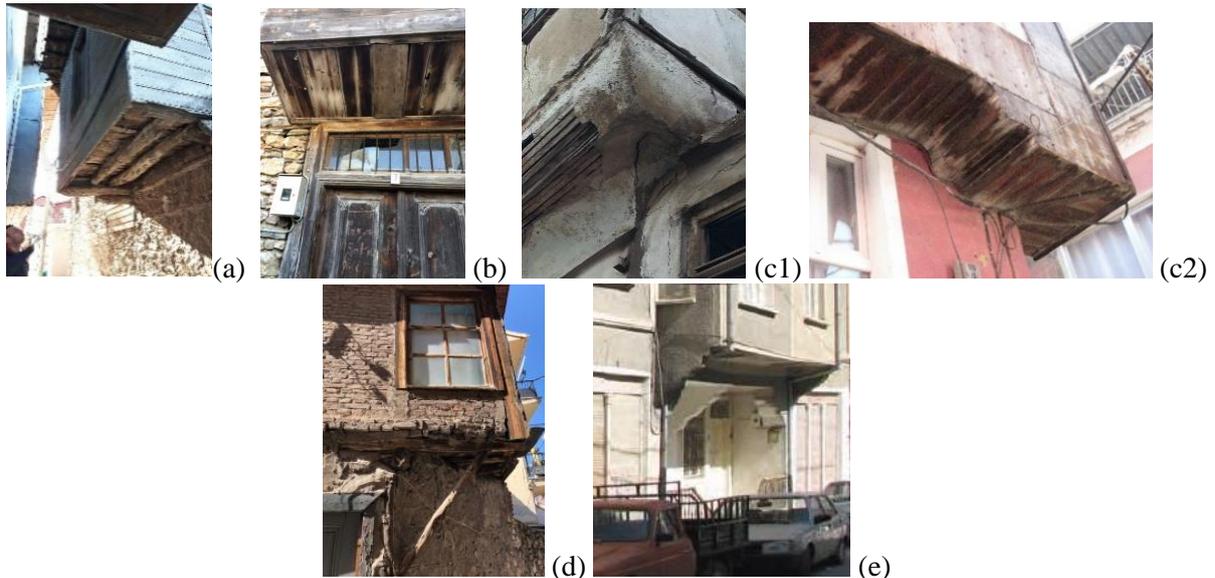
Figure 47. Projection undercoat of traditional Eğirdir houses (a) Projection with opened bottom (b) Projection that has plain undercoat, (c1, c2) Projection that have profiled undercoat, (d) Projection supported with plain buttress (e) Projection supported with profiled buttress

Projections' undercoats have two different types as opened and the covered ones that have timber plaques (Figure 47). Some projections' undercoats are covered with plastered and profiled, some projections' undercoats are supported with plain or profiled timber buttresses.
