Sakarya University Journal of Science
SAUJS

Title: Corrosion Effects on Fatigue Behavior of Zn-Cr⁺³ and Zn Flake Coated M8 DIN 933 Bolts

Authors: Sezgin YURTDAS, Umut İNCE, Barış TANRIKULU, Cenk KILIÇASLAN, Muhammed Burak TOPARLI

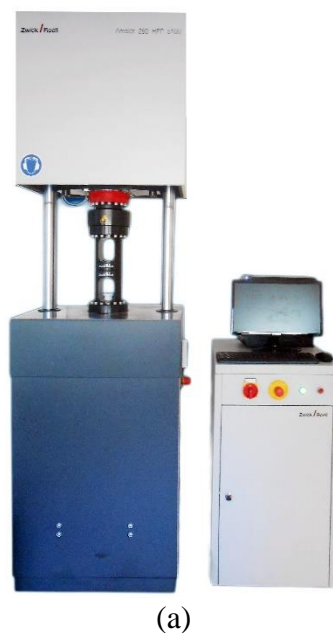
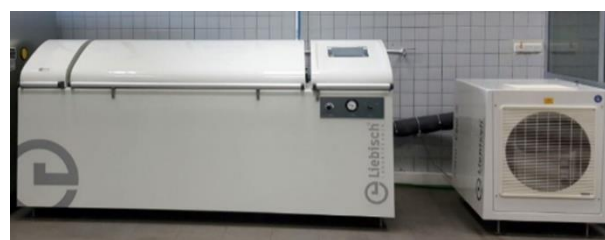
Figure 2 Test equipments; (a) Axial load fatigue and (b) salt spray testing chamber.

Fatigue tests were performed according to ISO 3800 "Threaded fasteners-Axial load fatigue testing-Test methods and evaluation of results" standard using Zwick/Roell high frequency fatigue tester. Testing equipment is shown in Figure 2(a). In order to determine the mean force to be applied, 75% of the proof load specified in ISO 898-1 (Mechanical properties of fasteners) was taken as 21.1 kN. Test frequency in all fatigue test, 75 Hz was kept constant. The Wöhler curves for each coating type were determined by means of 36 tests with 6 different applied stress amplitudes. Salt spray test system is shown in Figure 2(b). In this tests, bolts are placed in chamber. NaCl solution is sprayed constantly in the chamber and the atmosphere is controlled by pressured air cycle. The salt spray tests were conducted according to ISO 9227 "Corrosion tests in artificial atmospheres - Salt spray tests" standard.

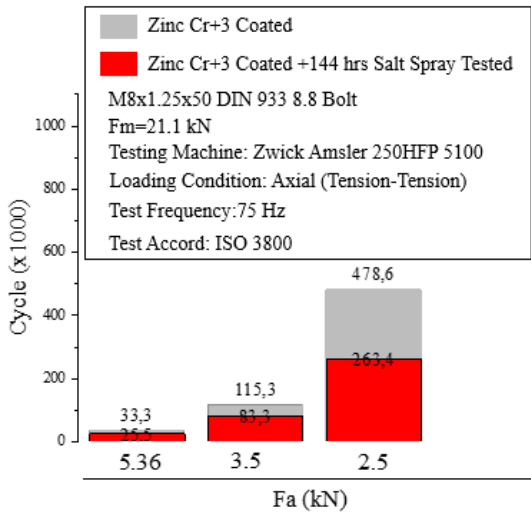
In Figure 7(a), fatigue life of Zn-Cr+3 coated bolts tested at force amplitudes of 5.36, 3.50 and 2.50 kN were presented. Significant fatigue life reduction was observed after salt spray tests. For force amplitudes of 5.36 kN and 3.50 kN, percent

reductions in fatigue life were 23% and 28%, respectively. However, when force amplitude was 2.50 kN, the decrease in fatigue life was 45%. Considering the S-N curves for the Zn-Cr+3 bolts before and after salt spray test, fatigue performance was adversely affected from corrosion (Figure 7(b)). Zn-Cr+3 coated bolts exhibits 1.30 to 1.82 times higher fatigue resistance than 144 hours salt spray tested Zn-Cr+3 coated bolts.

Figure 7 (a) Fatigue tests results and (b) Wöhler curves of Zn-Cr+3 coated bolts before and after salt spray tests.

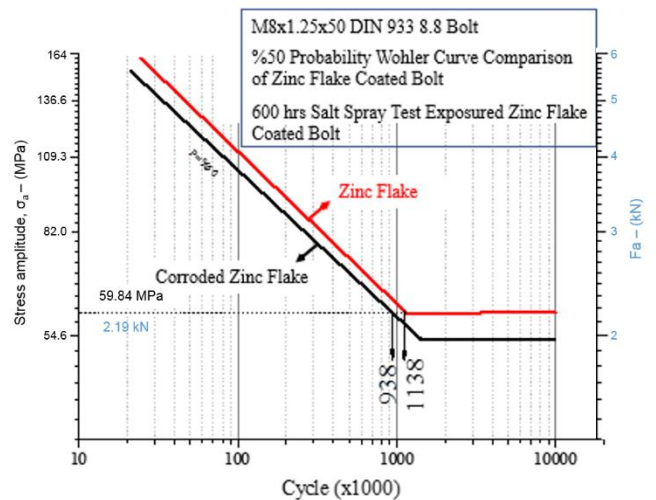
In Figure 8(a), fatigue life of Zinc flake coated bolts tested at force amplitudes of 5.36, 3.50, 2.50 and 2.35 kN were introduced. As for Zn-Cr+3, remarkable fatigue life degradation was found after salt spray tests. For force amplitudes of 5.36 and 3.50 kN, decrease in fatigue life was found as 23%. When force amplitude was decreased to

2.50 and 2.35 kN, decrease in fatigue life was 9% and 16%, respectively. Considering the S-N curves for the Zinc flake bolts before and after salt spray test, fatigue performance was adversely affected from corrosion (Figure 8(b)). Zinc flake coated bolts exhibits 1.09 to 1.29 times higher fatigue resistance than 600 hours salt spray tested Zinc flake coated bolts.

Figure 8 (a) Fatigue tests results and (b) Wöhler curves of Zinc flake coated bolts before and after salt spray tests.

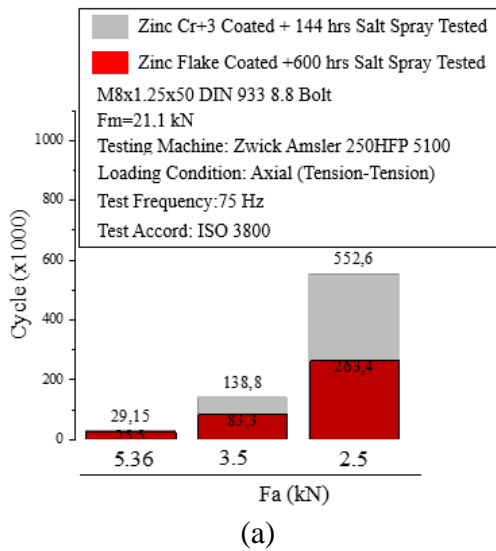
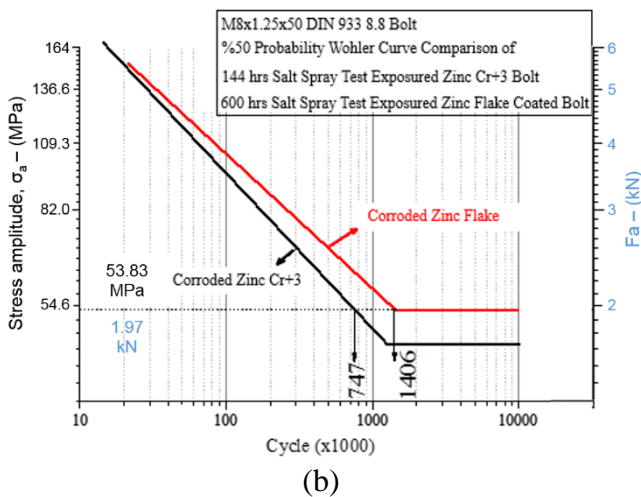
Considering fatigue life of coated bolts before and after salt spray tests, Zinc flake coated bolts showed higher number of cycles compared to Zn-Cr+3 (Figure 9) though salt spray testing was conducted for 144 and 600 hours for Zn-Cr+3 and zinc flake, respectively. The difference was more significant as the force amplitude of fatigue tests were increased; i.e. Zinc flake bolts showed 1.1,

1.7 and 2.1 times higher fatigue performance for the force amplitude of 5.36, 3.50 and 2.50 kN, respectively.

Figure 9 Comparison of (a) Fatigue tests results and (b) Wöhler curves of Zinc flake and Zn-Cr+3 coated bolts after salt spray tests.

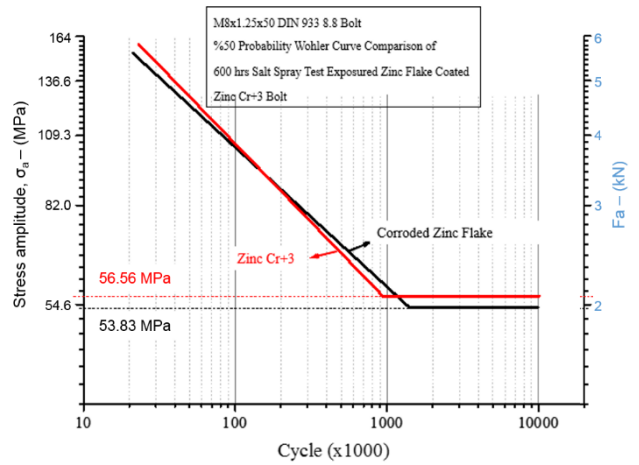
Fatigue life of corroded Zinc flake coated bolts were compared to plain Zn-Cr+3 coated bolts in Figure 10. As depicted in the figure, fatigue life of both bolts were found to be similar. Main reason of that can be attributed to the difference in coating process of Zn-Cr+3 and zinc flake. Zn-Cr+3 coating is based on electrolytic bonding between the coating and the substrate. However, zinc flake coating is non-electrolytically applied. Since, zinc plating is an electrolytic process, surface roughness is higher compared to zinc flake coating. As discussed in the literature [14-17] depending on the conditions, surface roughness can act as a stress concentrator and lead

to premature crack initiation leading fractures due to fatigue. Therefore, fatigue performance was higher for zinc flake coating having better surface finish compared to Zn-Cr+3 plating.

Figure 10 Fatigue life comparison of Zinc flake bolts after corrosion test and Zn-Cr+3 coated bolts.

- Zinc flake coated bolts showed higher fatigue resistance compared to Zn-Cr+3 coated bolts. This phenomenon can be explained by effect of porous morphology of thread roots of Zn-Cr+3 coated bolts. This porous morphology can act as a trigger for crack initiation leading to lower fatigue resistance. Another factor contributing to fatigue performance difference can be incorporated with the higher coating thickness of zinc flake leading to higher radius on thread root and decrease in stress concentration at possible crack tips.
- As a result of comparison of Wöhler curves of corroded bolts, corrosion lowers the fatigue resistance of both coating type. However, negative effect of corrosion on fatigue life of Zn-Cr+3 coated bolts was higher than Zinc flake coated bolts.
- 600 hours salt spray tested Zinc flake coated bolts and non-salt spray tested Zn-Cr+3 coated bolts exhibit similar fatigue
