## ***Restoration of Anterior Tooth Fractures Using Silicone Key Method: 3 Case Report***

The aim of this case report is to describe the rehabilitation of an uncomplicated crown fracture with direct composite restoration using a silicone key.

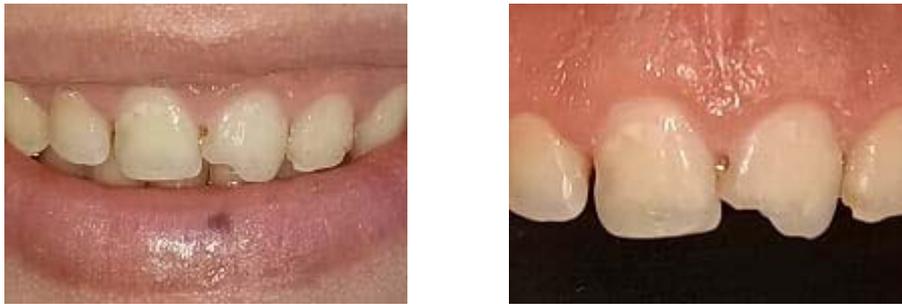
Figure 1a: Intraoral view of Case 1 before treatment

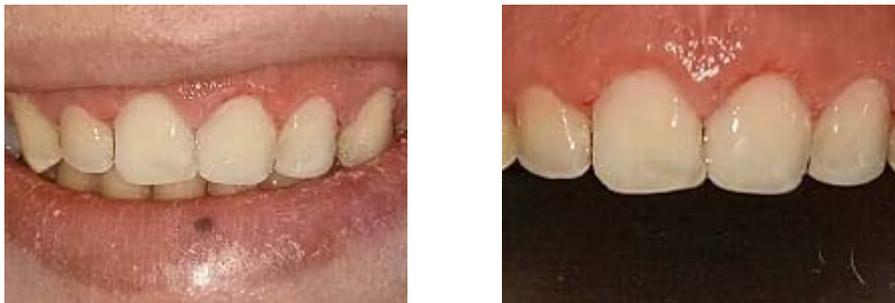
Figure 1c: Intraoral view of Case 1 after treatment

roundings and line angles were created using polishing discs in different grades from thick to thinnest (Sof-Lex, 3M ESPE, USA). The surfaces were roughly polished with a spiral, rubber polishing disc. Surface micro-texture was created with a red banded diamond bur at very low speed, in one direction and in dry conditions. The rubber dam was removed and occlusal relationships were checked (Figure 1c). It was found that the treatment result was satisfactory for both the patient and the physician.

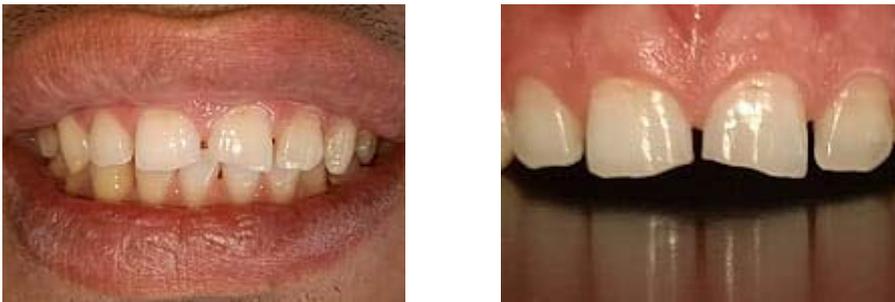
**Figure 2a:** Intraoral view of Case 2 before treatment

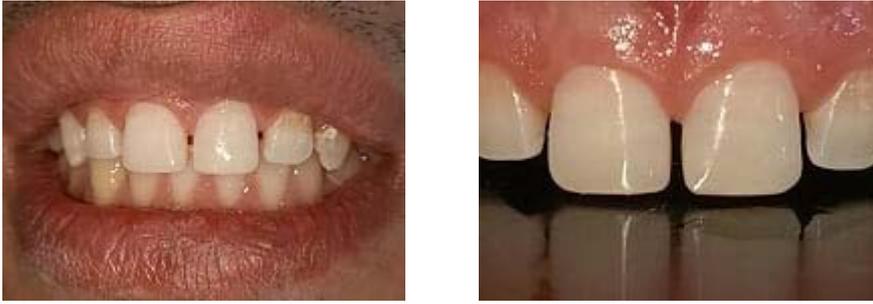
**Figure 2c:** Intraoral view of Case 2 after treatment

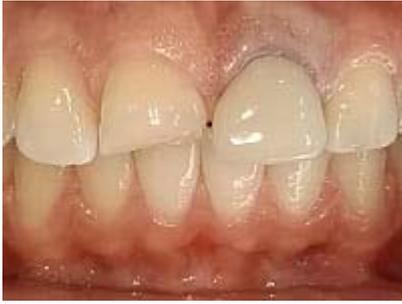
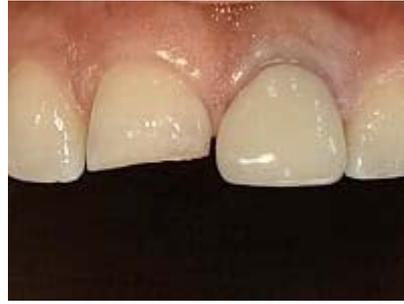
**Figure 3a:** Intraoral view of Case 3 before treatment

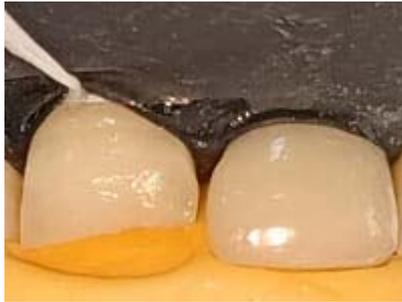
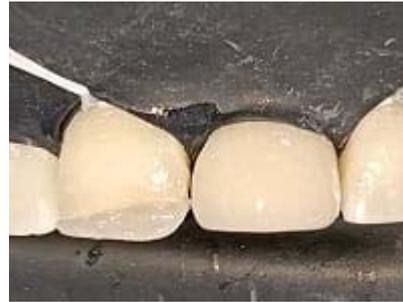
**Figure 3b:** Silicon key placement and creation of palatinal wall (Case 3)

**Case 3:** A 23-year-old female patient applied to Dicle University Faculty of Dentistry Restorative Dentistry department for a crown fracture one week after the trauma. It was learned in the medical history of the patient that she did not have any systemic disease and her primary complaint was the impaired aesthetic appearance of her tooth in the area exposed to trauma. No findings were found in the soft tissues in the external examination. In the oral examination, a fracture was found in the right upper central tooth (Figure 3a). It was determined that the relevant tooth was vital, not sensitive to percussion and palpation, and was not mobile. No periapical pathology, root fracture or alveolar fracture was detected in the radiological examination. Treatment options in Case 1 were presented to the patient. However, due to the patient's socioeconomic status and her desire to be treated in a short time, it was decided to be restored using direct composite resin. With the consent of the patient; While planning the restoration of the tooth, an acceptable gap was left between the teeth due to the possibility that the mesiodistal size being wider than normal may adversely affect the appearance and the metal-supported porcelain crown in the adjacent tooth could not be changed. It was explained that we could apply the treatment to the patient with the help of a silicone key in order to provide a better aesthetic appearance and harmonize shape and contact formation of the fracture tooth with the symmetrical tooth in the arch. After patient consent, the silicone key was obtained as described in Case 1. Before starting the treatment, composites of different shades were placed in the middle third of the central tooth and polymerized using the button technique. After choosing the appropriate composite color, isolation was provided with a rubber dam. The color of the composite resin used, treatment stages, finishing and polishing procedures were performed as described in Case 1 (Figure 3b). The rubber dam was removed and occlusal relationships were checked (Figure 3c). It was found that the treatment result was satisfactory for both the patient and the physician.

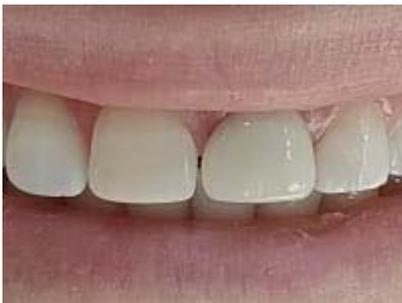
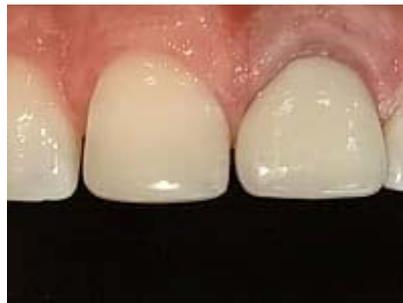
**Figure 3c:** Intraoral view of Case 3 after treatment
