Window Glass from the Excavations in the Seljuk Palace at Alanya

ÖMÜR BAKIRER*

This article concerns a small group of crown glass fragments recovered in the excavations of the Palace built inside the inner citadel of Alanya, Turkey. It was constructed during the reign of the Seljuk Sultan 'Alā'-al-Dīn Kay-Qubād I around 1221-1223 and used until 1246. This makes the dates for the utilization of the glass known, if not the date of their production. The studied glass was recovered during the first period of the excavations conducted by Prof. Dr. Oluş Arık and his team between 1985-1992.** Fragments of glass for everyday use, glass with prunts, and a few fragments from the so-called luxury glass enameled beakers, all recovered in the same context, were published by the author in two earlier papers.*** This group of glass was possibly used for the windows of the private chambers of the elite. Reference is also made to three archaeometry studies that helped in establishing the material properties of the glass finds.

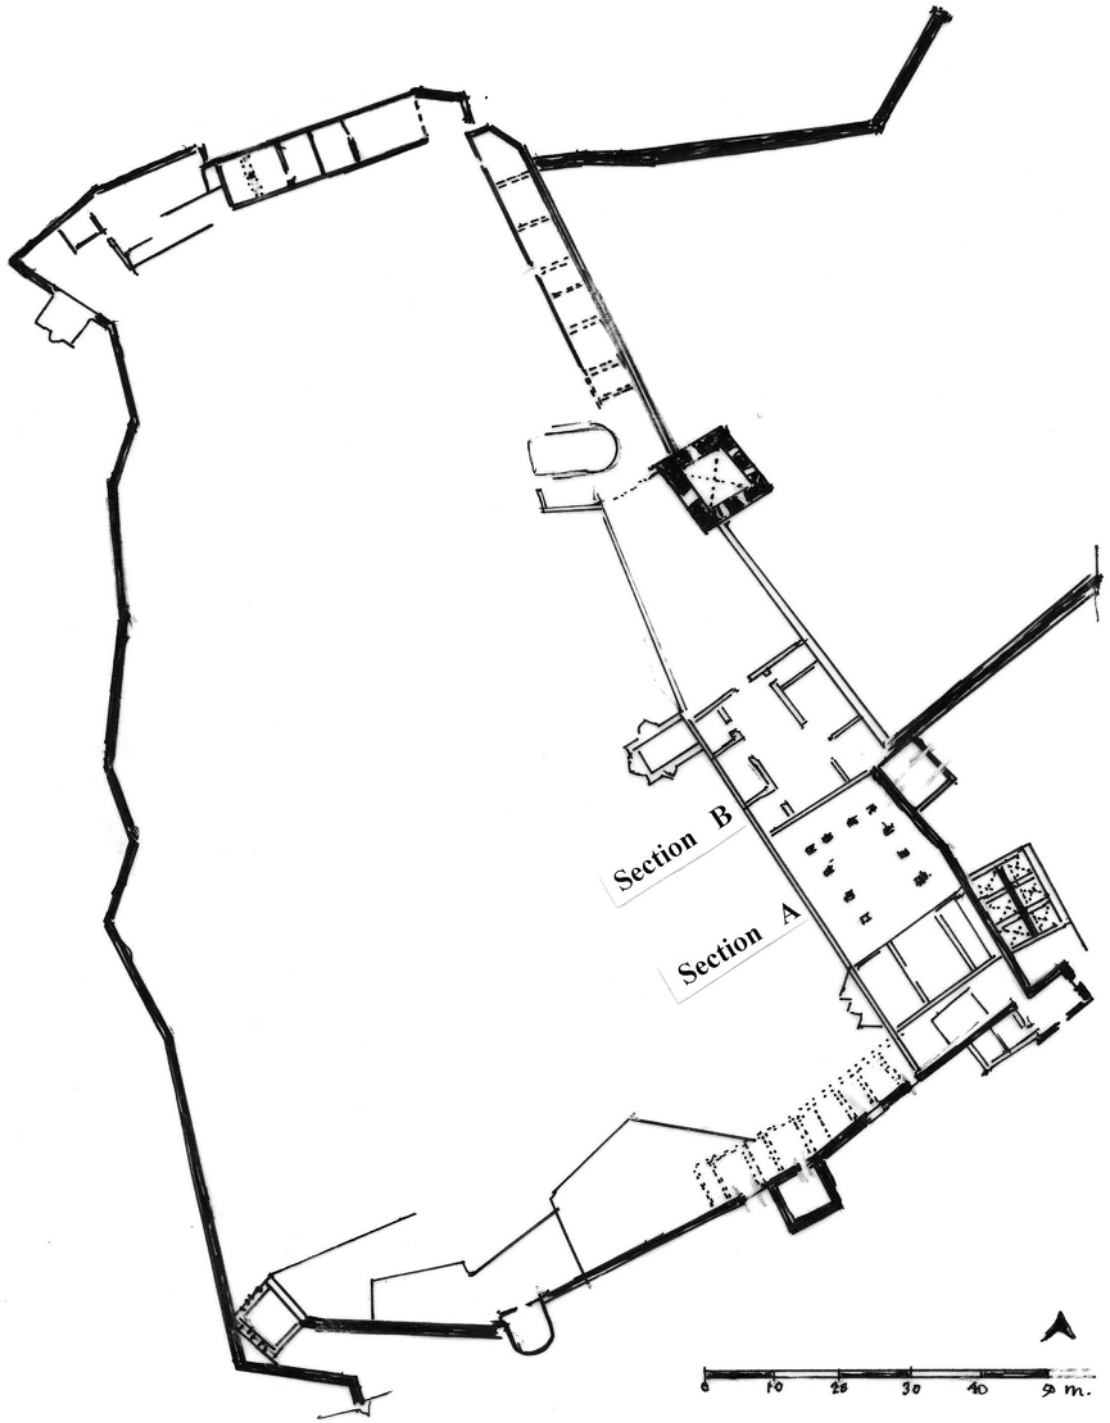
FIG. 1 Alanya, inner citadel, general plan
(Redrawn by Ö. Bakırer, from Arık 1986, plan 3).

state of preservation with the foundations and remaining walls were interpreted and original plan was restituted (figs. 1-2).²⁹ In the 1986, 1987 and 1988 campaigns the recovery of the architectural remains and the discovery of more finds helped in the recognition of the possible functions of the rooms.

Section A on the south end measures around 40x30 meters and appears more destroyed from the collapse. There are only a few identified spaces on the east and south wings, and only vague remains of the foundations on the west wing. The excavation team suggested some hypothetical restorations for Section A: an open courtyard, surrounding arcade on three sides, and rooms opening to the arcade. The space jutting out from the center of the east wall, Room X, has been identified as a tower that was part of the earlier, Byzantine-period citadel wall that surrounds the palace on the south (fig. 1).

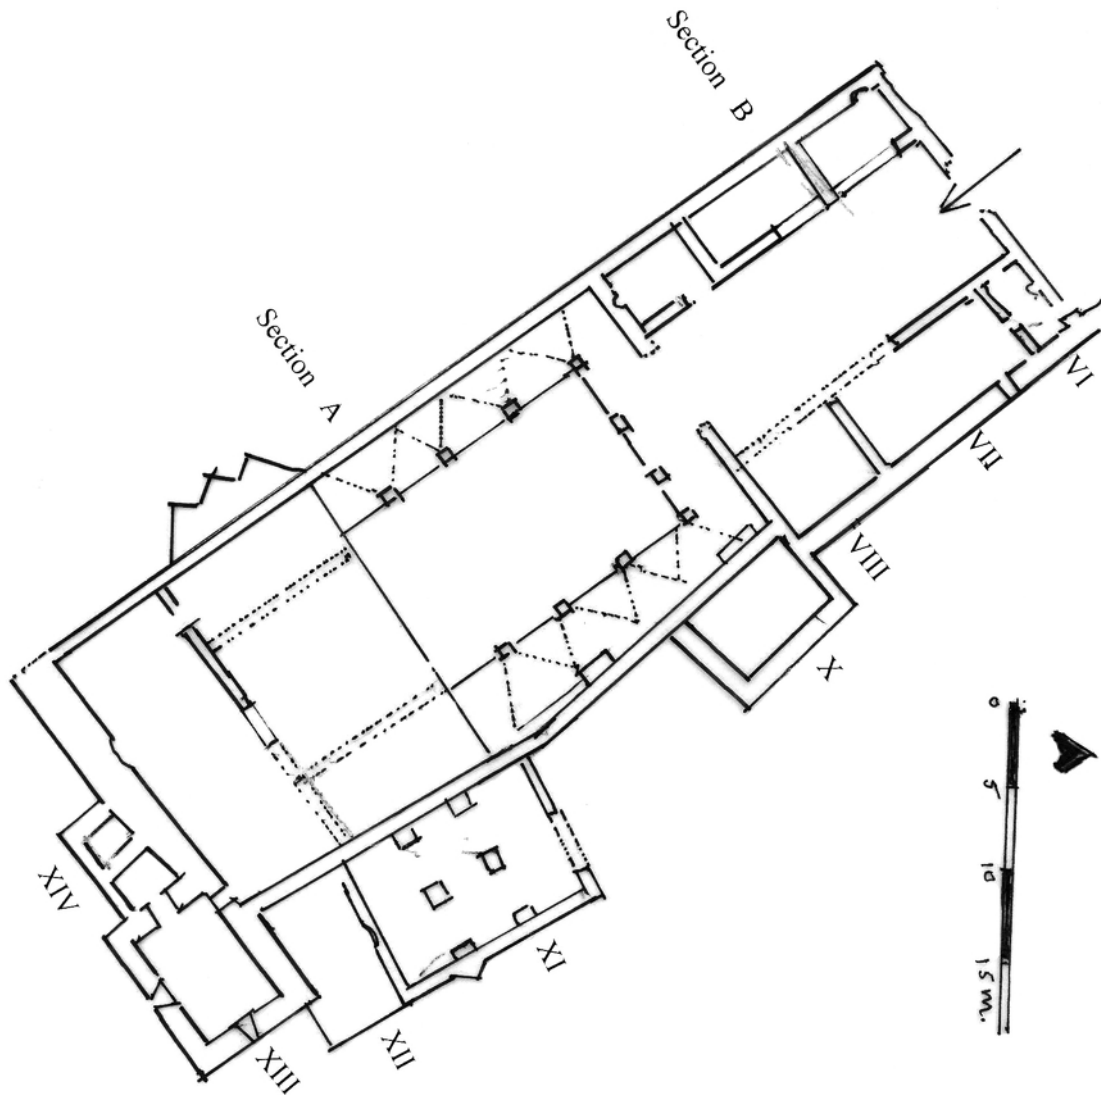
FIG. 2 Alanya, inner citadel, the Palace, plan (Redrawn Ö. Bakırer, from Arık 1986, plan 4).

According to the plan, the palace is located behind the main entrance of the Inner Citadel, with a north-south orientation on a rectangular layout. The entrance was placed on the short, north side. It measures around 50 meters in length; 20 meters in width on the north end, 30 meters on the south end. This irregularity is because the building is composed of two sections built in two different construction phases. To follow the descriptions easier in this study, these two sections are marked as A and B on the plan and will be referred to in the same manner below (fig. 2).

Room XIII (fig. 2) is identified as a tower of the Byzantine fortifications. It is claimed that this room was refunctioned for the personal use of Kay-Qubād I. The window opening on the joint wall with the adjacent Room XIV was enlarged as a door, which made it possible to refunction Room XIV as a service space attached to the private chamber of the Sultan. The excavators have assumed that there was also an elevated kiosk - an upper level on Room XIII - perhaps constructed with lighter materials like timber and top windows with colored glass insets. During the collapse, this elevated room fell over Rooms XIII and XIV below. All the contents were turned upside down, therefore fragments from window panes were recovered in both rooms, even though Room XIV, as a service space, may not have had glazed windows. The renovation date, 1221-1223, can be taken as evidence for the date when the finds like wall tiles, pottery, window glass and functional glass began to be used, following the completion of the construction. The fragments from the window panes recovered in Room XIII consist of both rim and center pieces with their estimated diameters as follows:

Section B, on the north wing, is a smaller rectangle than Section A, measuring around 15x20 m. (fig. 2). It is entered from the north wall where, in the original, there may have been an elaborate portal arrangement. Yet nothing is left today. This entrance gives access to a centrally placed open courtyard which is identified as a ceremonial hall with rooms lining both its west and east sides. The remaining foundations of these rooms have been named by the excavators as Rooms III to V on the west and Rooms VI to VIII on the east. Bilici, depending on the construction seam noticed on the exterior face of the east wall, dates these spaces to the addition and renovation project made for Ghiyāth-al-Dīn Kay Khūsraw II (1237-1246), after his ascension to the throne. Rooms VII and VIII were remodeled and refurnished for his private use, which he used until his death.³² Arık believes that Room VIII - with the remains of frescoes on its walls, the finely laid bricks on the floor, and the remains of a small pond at the center - may

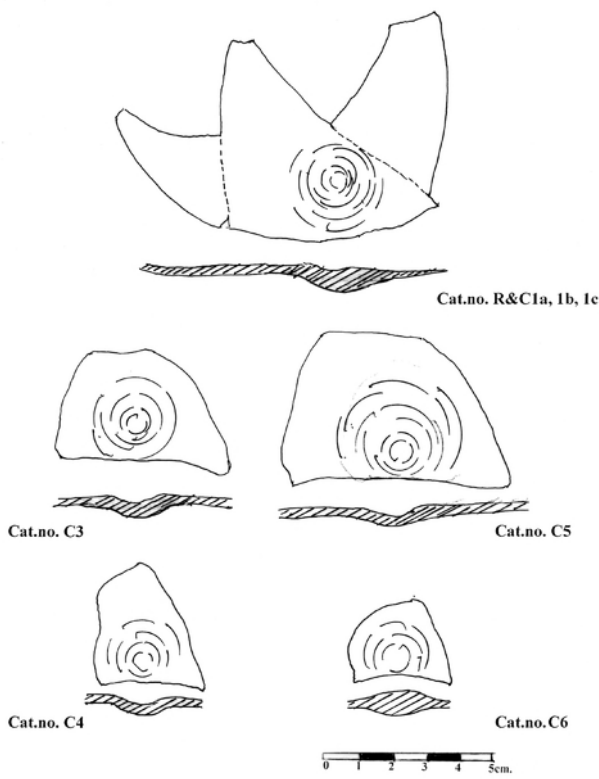
FIG. 3
Window glass, drawing
of some center fragments
(Cat. nos. R&C1 a, b, c; C3-C6).

Center fragments are only 14 (Cat. nos. C1-C7). Cat. no. C1 comprises 7 adjoining small fragments, and C2 has two adjoining fragments, the rest are single. These are usually larger sized shards in comparison to the rim fragments and vary in their sizes like: 8.2 x 8.7; 5.4 x 3.2; 4.6 x 4.7; 3.5 x 5.2; 2.5-3.0 cm. Their thicknesses vary between 0.1-0.4 cm close to the rim and between 0.3-0.6-0.8 cm. close to the center, where the bull's eye is seldom left in place. This difference in thickness might be one of the reasons why the crown glass units are broken into separate rim and center pieces, and only rarely a fragment might still contain both. Even though in some fragments the spinning lines are deep since the rim is missing, it is still not possible to estimate the diameter of the original crown (figs. 3, 8-11).

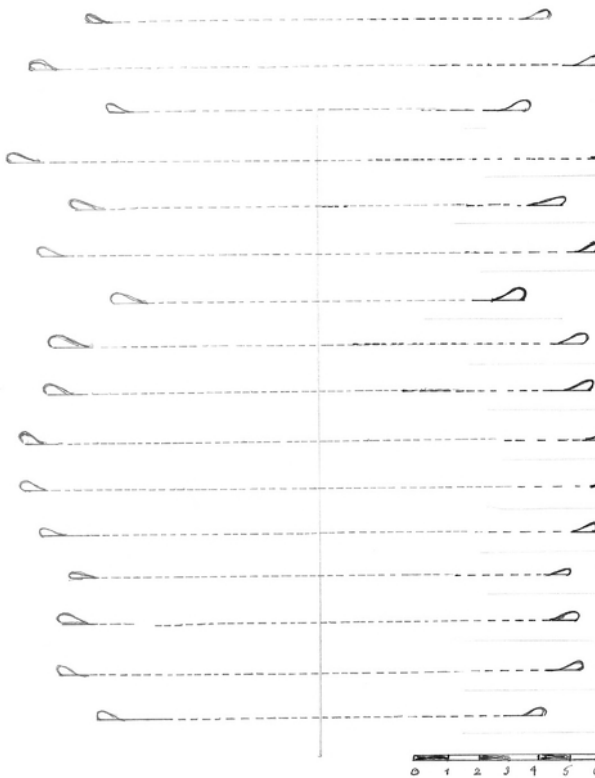
FIG. 4
Window glass, drawing of all
rim fragments (Cat. no. R2-17).

Rim fragments are usually very small pieces from the edge of the crown but still make it possible to determine their diameters and to distinguish differences in the fold of the edge (figs. 4-7) (Cat. nos. R1-R15). Two different types are distinguished:

- 1) Rims with folded edge, the fold is tubular and hollow, the edge has a rounded profile. The edge of the fold is lightly pressed with a tool, to close its end. The width of the fold is mostly 0.6-0.7 cm., rarely narrower 0.5 cm (fig. 5).
- 2) Rims with folded edge, the fold is tightly pressed with a tool, edge has flat profile. The width is around 0.5-0.6 cm.

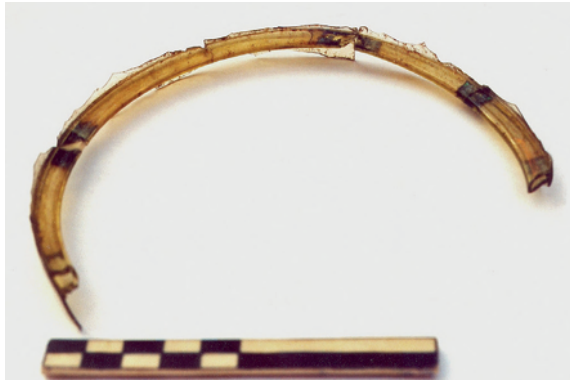
FIG. 5 Window glass, single rim restituted, dark honey yellow (Cat. no. R1).

Description: four adjoining rim fragments, from the edge of the crown, they complete the circular folded rim, with the exception of a small section missing, ca. 1/5th of the rim. Folded hollow rim, dark honey yellow (Munsell: 5 Y 7/6). Free blown, turned, edge of rim pressed by tool.

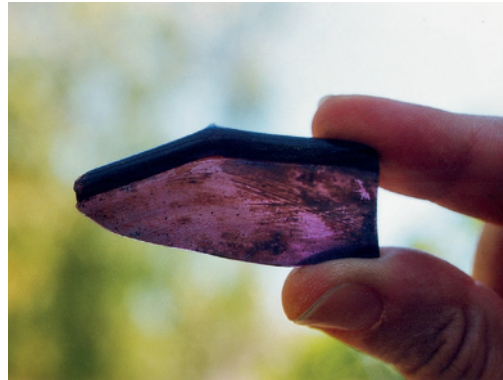
FIG. 6 Window glass, single rim, dark purple (Cat. no. R10a).

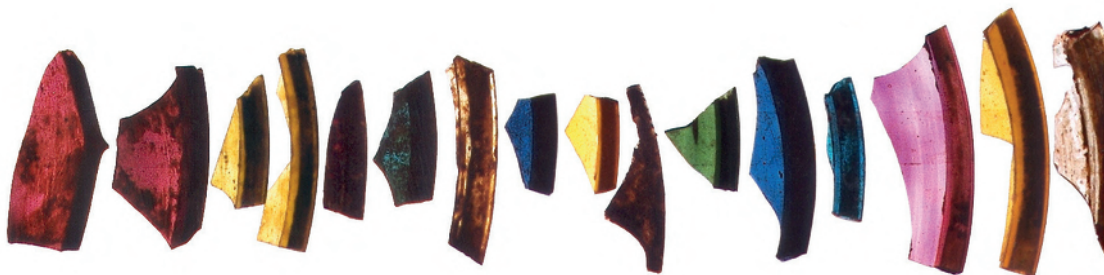
FIG. 7 Window glass, group of rims (Cat. no. R1-16).

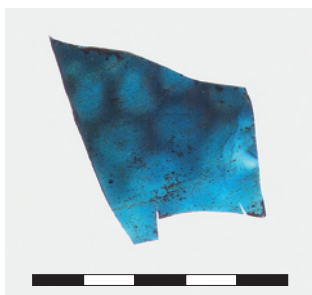
FIG. 8 Window glass two center fragments with honeycomb pattern, dark turquoise blue (Cat. no. C1a).

No applied decoration or painting can be noticed on the surfaces of the crown glass units except the honeycomb texture observed on a few Center fragments (Cat. nos. C1-C3). The production of these must have been in two steps: first, mould-blown into a mould with honeycomb patterns in reverse and then free-blown (figs. 10-11). Comparative examples could not be recorded in other sites mentioned earlier.

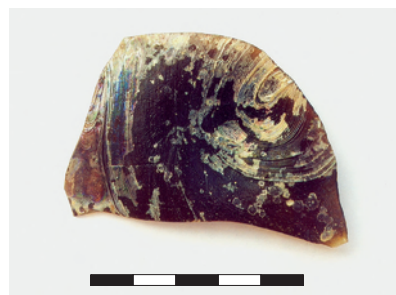
FIG. 9 Window glass single center fragment, dark honey yellow (Cat. no. C3).

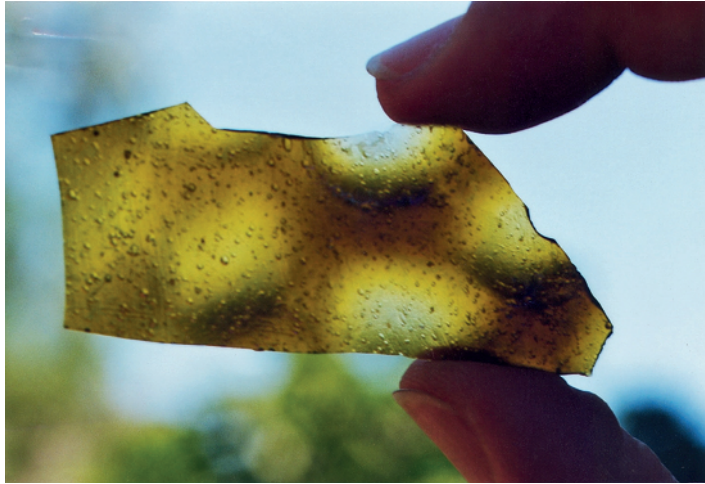
FIG. 10 Window glass, single center fragment, dark honey yellow, surface has honeycomb pattern (Cat. no. C7).

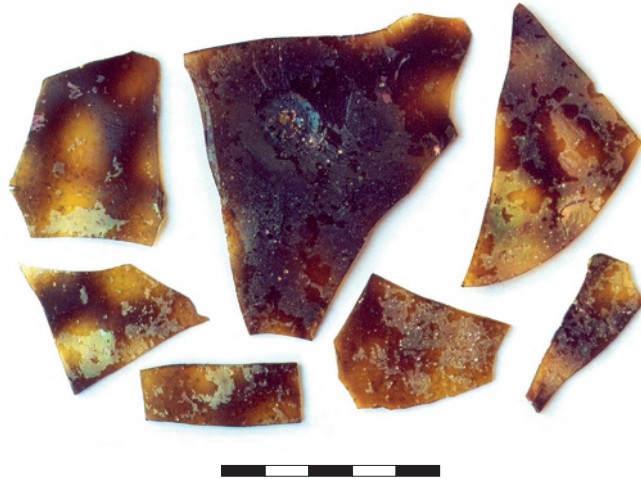
FIG. 11 Window glass, group of center fragments (Cat. no. C2a-g).
