Total dislodgement of the femoral component following cemented total knee arthroplasty: a case report

Şükrü ARAÇ, Vasfi KARATOSUN

Department of Orthopaedics and Traumatology, Dokuz Eylül University, School of Medicine, İzmir, 35340, Turkey

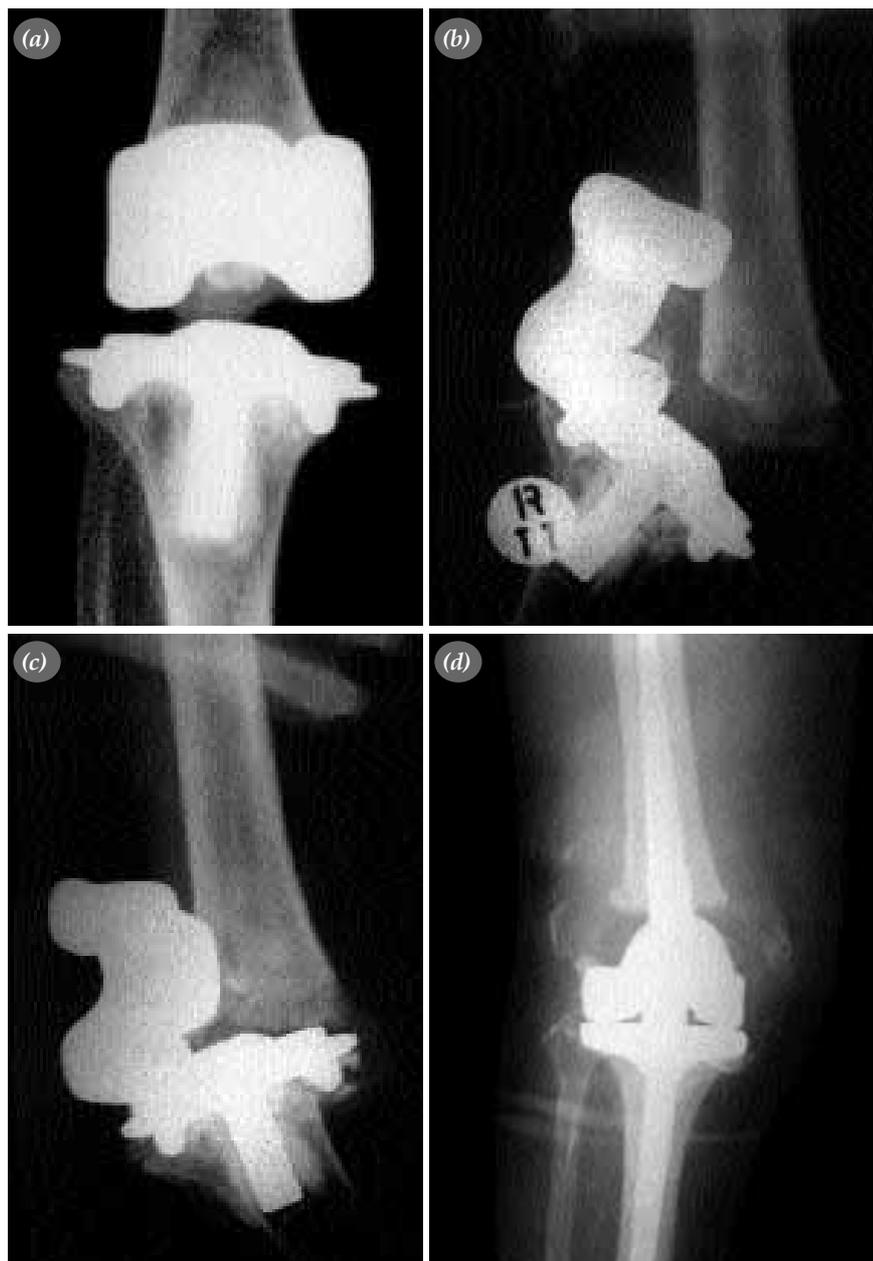
On the examination, “clunk” is felt during the movements of the knee but the radiographs were normal except for a separated fragment of the medial femoral condyle (fig. 1 a). Then examination was repeated under fluoroscopic control and dislodgement of femoral component was observed, when varus and valgus stresses were applied (fig. 1 b), but the component reduced when the stresses were discarded as in Figure 1 a. At the second revision arthroplasty, the femoral component was totally free

from the bone and loosening of tibial component was also observed, and stemmed, cemented components were inserted (fig 1 d).

Figure 1.(a) Anteroposterior radiograph of the knee shows no signs of dislodgement **b)** Dislodgement of the components are apparent when valgus **c)** and varus stresses were applied. **d)**12 years after revision
