Locking knee after intra-articular migration of broken patella tension band wire: an extraordinary intra-articular migration via pseudarthrosis line

Lushun WANG, Keng Thiam LEE

Department of Orthopedic Surgery, Tan Tock Seng Hospital, Jalan Tan Tock Seng, Singapore

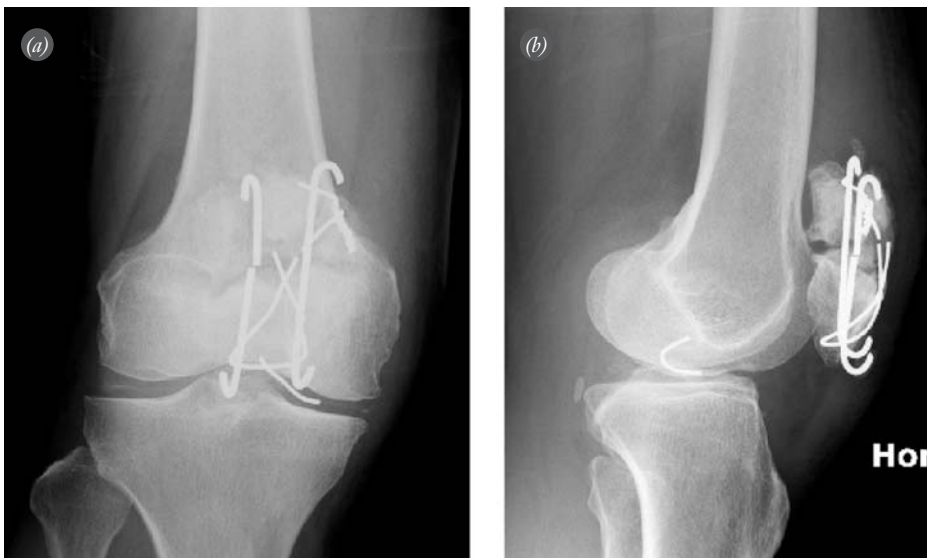
Radiographs of the right knee revealed a nonunion of the patella fracture with the metal wires broken at several places (Fig. 1). The superolateral segment of the broken tension band wire was found to have migrated into the medial compartment of the knee joint.

Fig. 1. (a) Anteroposterior and (b) lateral X-rays of the right knee showing nonunion of the patella and tension band wires broken at several places, with the superolateral fragment of the broken cerclage wire located in the medial compartment of the knee joint.

The patient underwent surgery for removal of the patella wires. An arthroscopic examination of the knee reviewed mild synovitis with pseudarthrosis at the superolateral aspect of the patella. There was no intervening fibrous tissue at this nonunion gap when viewed arthro-

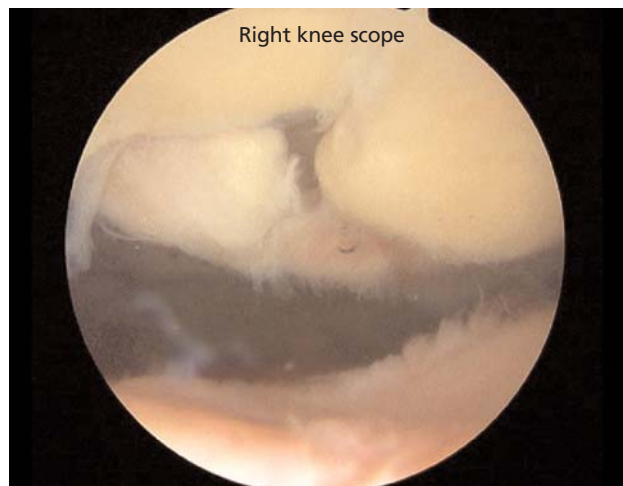
scopically. In fact, the fracture gap was mobile and narrowed with the knee in extension and widened maximally (4 to 5 mm) with the knee in about 45 degrees of flexion (Fig. 2). The migrated wire was found to have shifted to the posterolateral compartment of the knee joint (Fig. 3), requiring a separate incision at the posterolateral aspect of the knee for removal (Fig. 4). The rest of the broken wires were removed via a midline anterior knee incision along the old scar. The patella was stable after complete removal of the wires, indicating fibrous union

Fig. 2. An arthroscopic picture of the patient's right knee showing the pseudarthrosis line without intervening fibrous tissue at the superolateral aspect of the patella at 45 degrees of knee flexion. [Color figure can be viewed in the online issue, which is available at www.aott.org.tr]

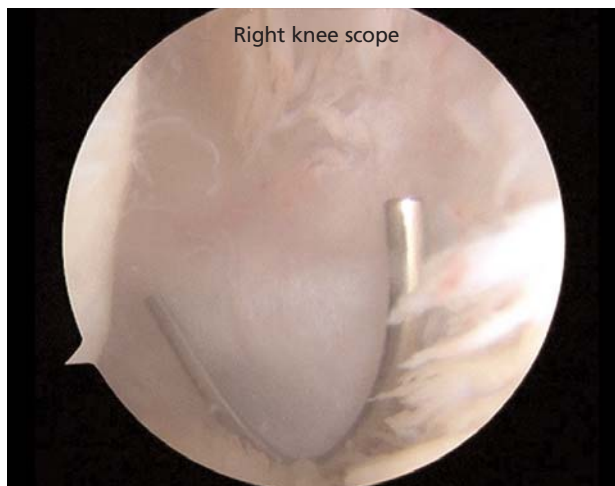
Fig. 3. An arthroscopic picture of the broken cerclage wire found lying in the posterolateral recess of the patient's right knee joint. [Color figure can be viewed in the online issue, which is available at www.aott.org.tr]

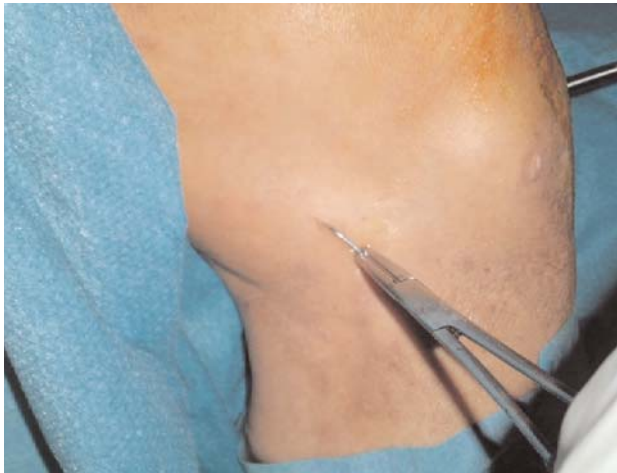
Fig. 4. A small posterolateral knee incision was made to facilitate removal of the intra-articular wire under arthroscopic guidance. [Color figure can be viewed in the online issue, which is available at www.aott.org.tr]
