Strengthening of fire damaged reinforced beams by using ferro cement

Amin A, Tamal S C, Bari A K M F, Mazumder M & Hasan Md A (2022). Strengthening of fire damaged reinforced beams by using ferro cement. Turkish Journal of Engineering, 6(3), 206-210

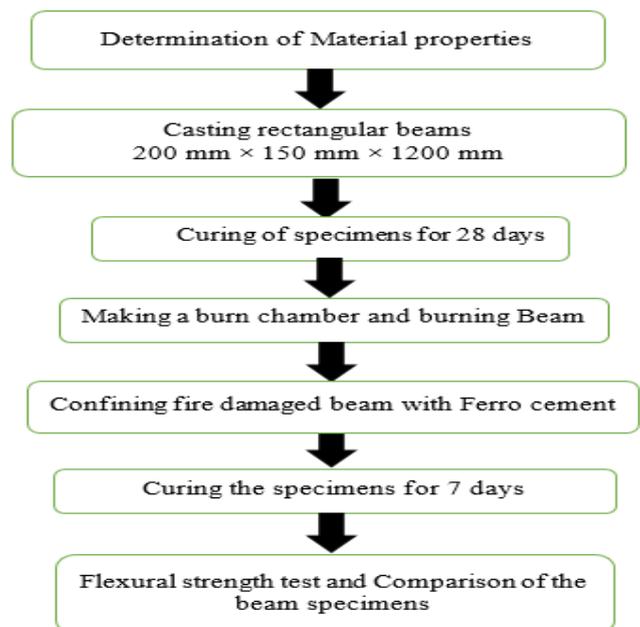
Total procedure is performed by a flow diagram which are shown in below;

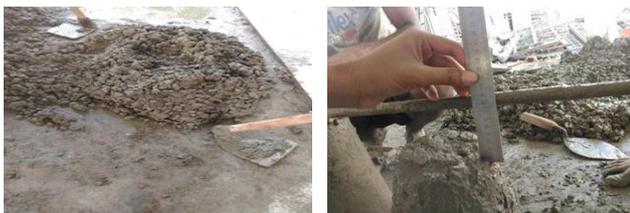
Figure 2. Preparation of Concrete

To prepare the normal strength concrete according to the ACI standard a suitable mix design ratio is used. The expected compressive strength is 3000 psi after 28 days. Cement: Sand: Coarse Aggregate (1: 1.5: 3), Water: Cement is 0.48, Nominal maximum size of Coarse aggregate 12.80 mm.

The specimens are cast into wooden frame as beam. This casting process is measured because of the slight extent of beam cross section. Hand compaction is applied to dense the concrete with the use of a 16 mm (diameter) tamping rod. Each time the slump value is measured and

it is between 80– 105mm. Beam specimens are demolded after 24 hours of casting.

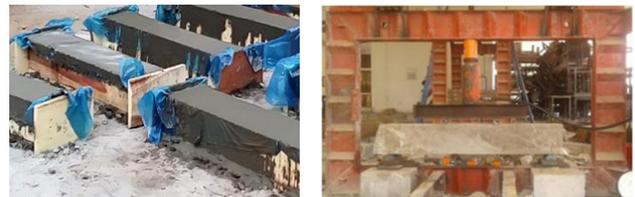
Figure 4. Beam casting and setup for test

The flexural strength of plain concrete is almost wholly dependent upon the tensile strength. Experiments show, however, that the modulus of rupture is considerably greater than the strength in tension. Flexural strength is of importance in the design of concrete pavements. 3rd point loading system for the test of flexural strength of this specimen.

a). Casting b). lab setup

c). 3rd point loading system

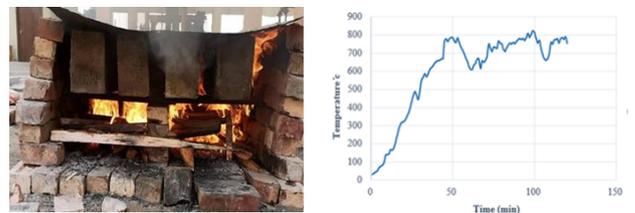
Figure 5. Process of beam damage

a). Damage by fire b). Temperature and time

For heating the beams, a chamber is made by using bricks, CI sheets and steel reinforcements. The temperature is measured by thermocouple and digital meter. The highest temperature during fire of building is 805 °c and temperature varied at a range of 700-800 °c for two hours and then cooled to room temperature. When the beams are cooled down, there are some cracks and spalling of concrete seen on beams.

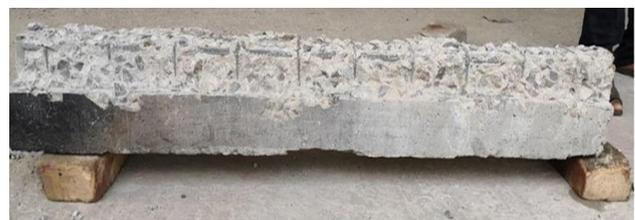
Figure 6. Chiseling of beam

As concrete is weak in tension, cracks and spalling formed in the tension zone of the beams under fire, the concrete in the tension zone become ineffective. The depth of the cracks is show in beam within 1 inch. Hence, soffit of the beams (tension zone clear cover) is chiseled, cleared of loose debris and cleaned with wire brush.

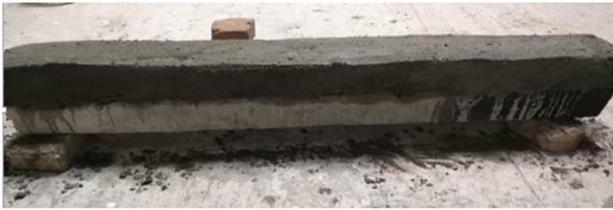
Figure 7. External strengthening of beam

After fire damaged, samples are strengthened with a Ferro cement and wire mesh (single layer and double layer). A single layer square shaped steel wire mesh having wire spacing of 10 mm and thickness of 0.6 mm is used.

A rich mortar ratio of cement/sand 1:2 and w/c ratio 0.4 is selected. The sand is used which the sample passing by No.16 sieve is 80%. Hand plastering is used for the period of the strengthening process. Mortar is pressed through the pores of wire mesh. Plastering is properly done to confirm an even and smooth surface. The Ferro cement strengthened samples are additional cured for 7 days. It necessitates a huge amount of water and proper supervision for the period of curing process, due to rich mortar and low water-cement ratio.

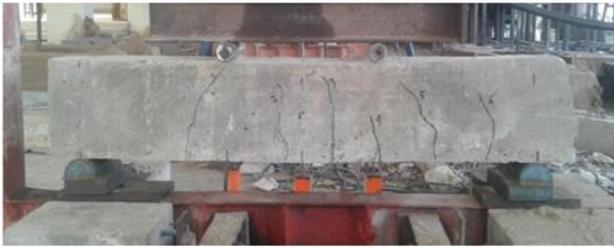
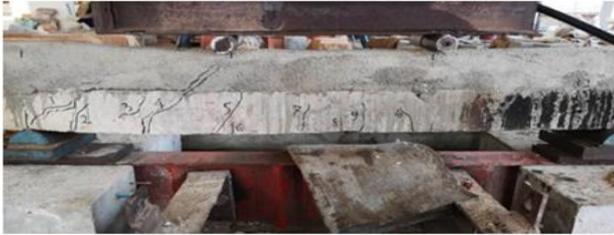
Figure 10. Cracking and failure pattern of specimens

The flexural strength characterizes the maximum stress practiced inside the material at its moment of rupture. Most of the specimens fail due to flexure failure. Flexure cracks are developed at the mid-section, after that flexure shear cracks as well as web shear crack are developed before the beam is failed.

Due to the strengthening effect, the deformations first initiated in the Ferro cement layers. After the failure of the layer, the core failure takes place. In case of single and double-layer Ferro cement strengthened concrete beams, the crack is initiated simultaneously from the base and top of the beam. After initiation, with the increase of load the cracks are propagated. The propagation of cracks is slow due to the presence of thickly populated wire mesh. Both cases showed great improvement in ultimate load carrying capacity and slow crack formation over the fire damaged specimens.

a). Fire damaged beam

b). single layer Ferro cement strengthened beam
