# The Charming Threat Against the Groundwater Resources: Tamarix Trees Utilized for Landscaping

Muhammed Ernur Akiner<sup>1\*</sup>, Časlav Lačnjevac<sup>2</sup>

(First received 20 June 2021 and in final form 22 August 2021)

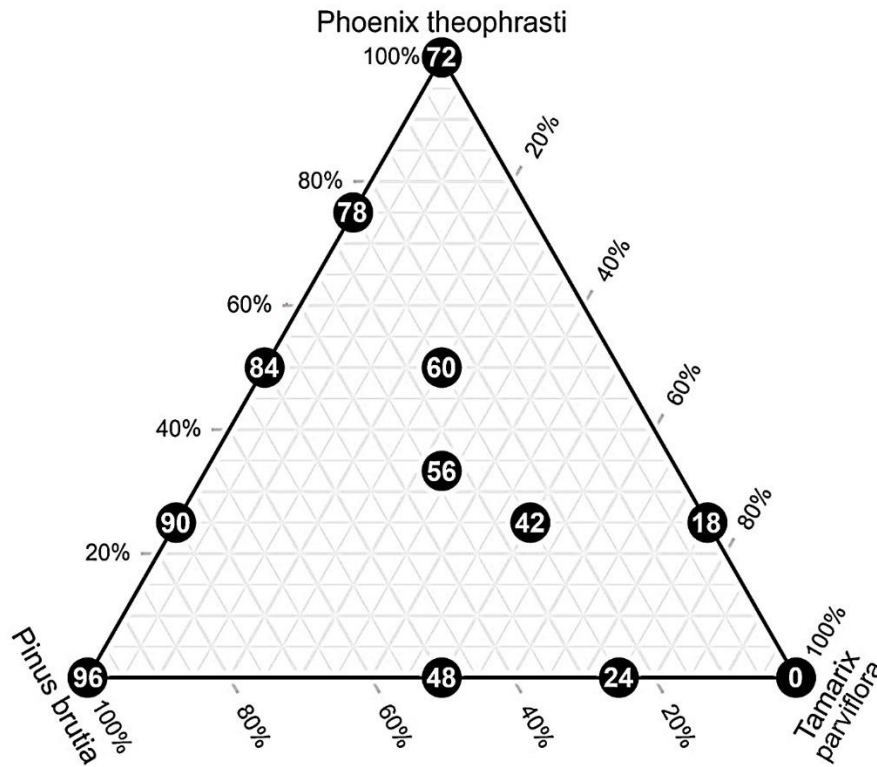
Figure 5. Percent reduction in groundwater consumption concerning the composition of plants in different percentages

Figure 5 shows that reducing the percentage of area covered by the Tamarix parviflora tree would significantly improve groundwater resources' future conservation. For example, if the area covered by Tamarix parviflora alone is shared equally with Pinus brutia and Phoenix theophrasti, fifty-six percent; seventy-two percent in the case of leaving the entire site to the Phoenix theophrasti tree; If existing Tamarix parviflora trees are replaced with Pinus brutia, water conservation of up to ninety-six percent is envisaged. Phoenix theophrasti, with its aesthetic appearance, resistance to seasonal temperature difference, and saltwater tolerance, would be appropriate for the coastal areas. Pinus brutia should be preferably planted instead of Tamarix parviflora trees in the inner regions, as it consumes very little water. Table 1 shows the comparison of Tamarix parviflora, Pinus brutia, and Phoenix theophrasti in terms of water scarcity, species displacement, fire hazards, inhospitality of riparian areas, and altered soil systems to understand their favor in the Datça peninsula.

27 liters per day (Özçelik, 2018). It was highlighted that how the plant community composition change affects the result (see Figure 5).

Besides, it was revealed that, in replacing *Tamarix* trees with Phoenix theophrasti and Pinus brutia trees that are native to Datça in specific percentages, the groundwater consumed by the trees for metabolic water use could decrease high rate.
