Cultural Heritage and Science

Multidisciplinary Researches in Cultural Heritage Studies: An Approach on Akkale Cistern in Erdemli, Mersin

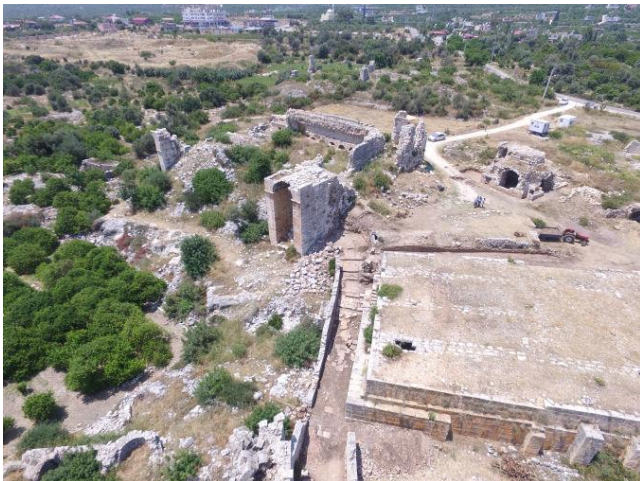
Figure 2. Akkale Cistern and buildings in Akkale

There were harbour bath, accommodation facility (inn), public cistern, monumental tomb and remains of religious buildings (Aydınöğlü & Mörel, 2017). Archaeological surveys have also revealed remains of water channels leading from Elauissa-Sebaste Korykos water work towards Akkale. Moreover, there are remains of additional water structures excavated nearby Akkale cistern indicating that there was an integrated water distribution network through the settlement (Figures 2 and 3).

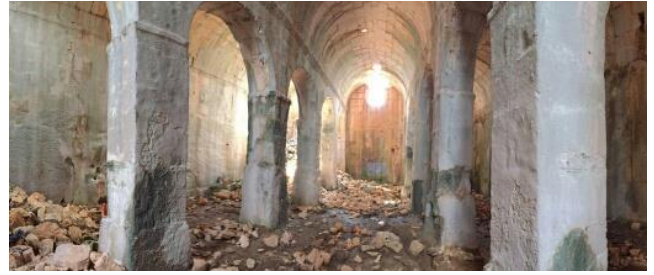
Figure 3. Interior view of Akkale Cistern

Akkale cistern is one of the remarkable and well preserved buildings of the whole site. It has a rectangular size with 21.53 m × 36.40 m dimensions and 9.80 m interior height. The main construction technique of the cistern is cut-stone masonry walls, with two rows of arcades supporting the vaulted superstructure. The cistern finishes with flat roof located onto the three rows of barrel vaults. There are top windows and remains of cut-stone roof claddings on the cistern roof. The roof top might have been utilized for additional rainwater harvesting into to the cistern, since there is remarkable catchment capacity with its roof size. Each arcade has 7 arches supported on stone pillars (Figures 2 and 3). There are 3 windows located on each east and western wall, which were probably used to control, to provide daily light and fresh air for interior.

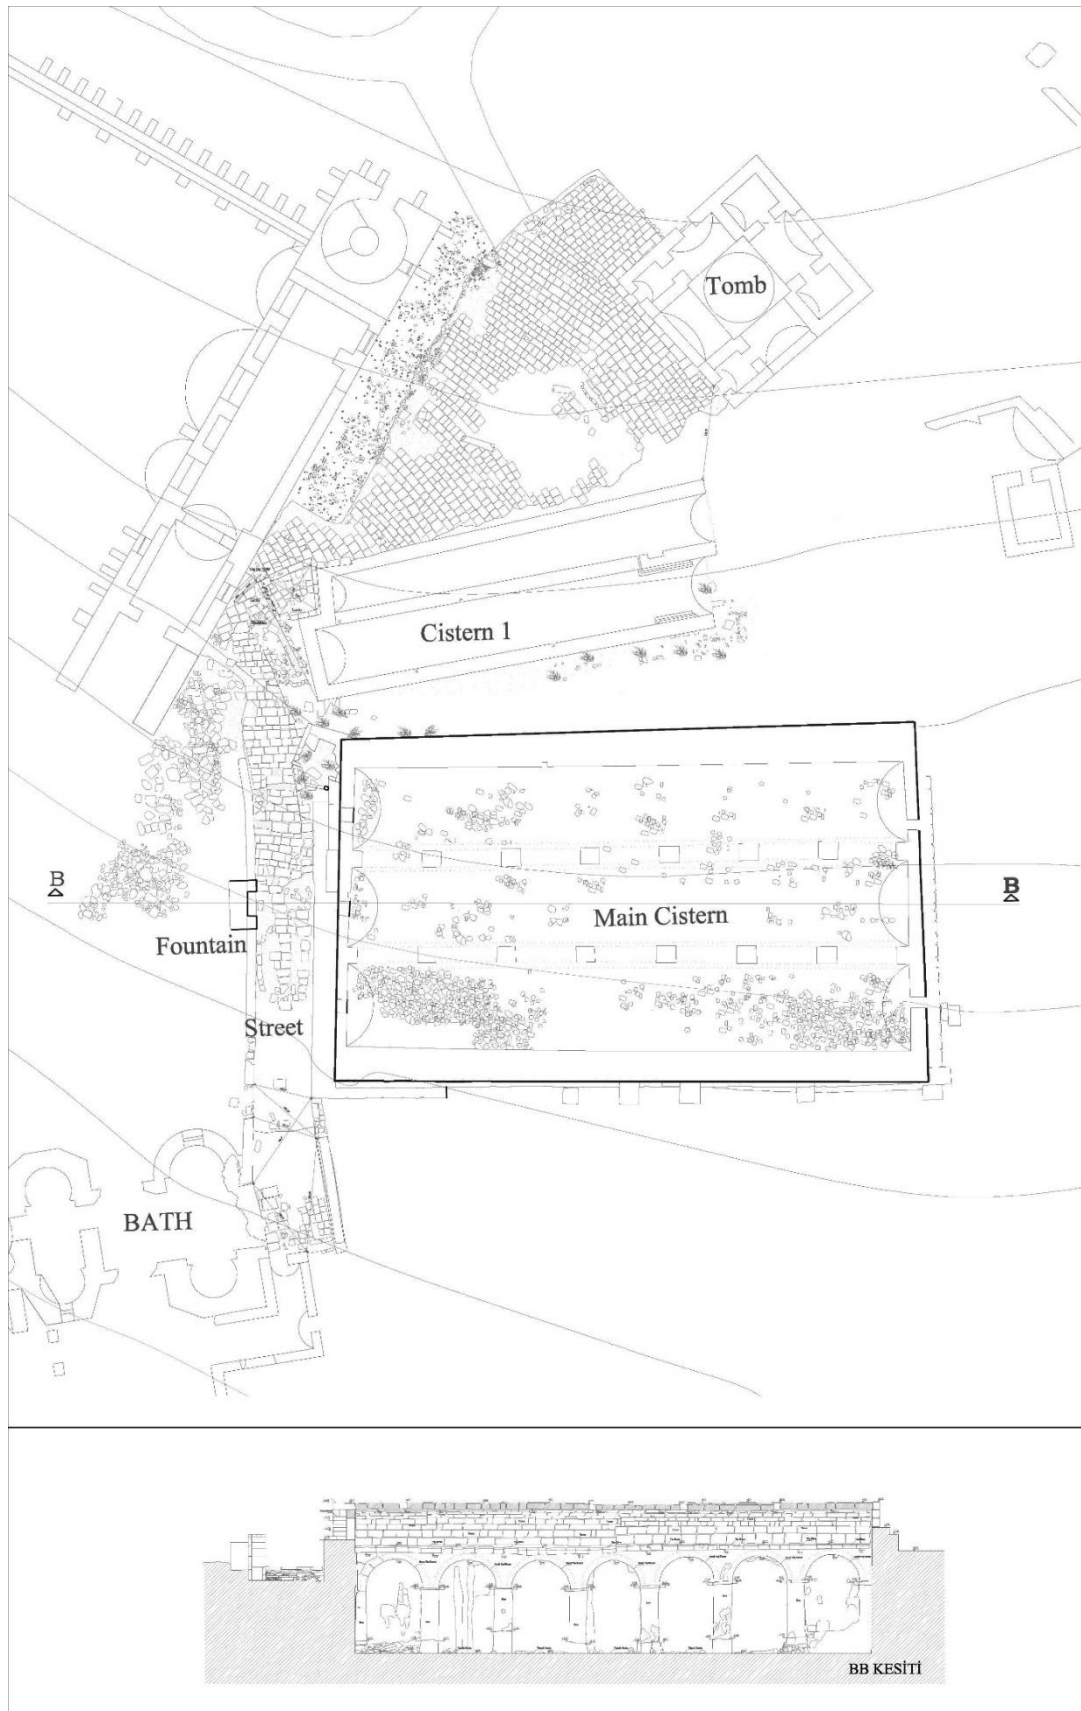
Figure 4. Survey drawings of the cistern

-Architectural Documentation and Building Surveys: Archaeological excavations around the cistern revealed important architectural information and traces related to original condition of the building. Following, detailed measured surveys including architectural plans, cross sections, internal and external elevations and documentation studies related to site maps have been conducted by using optic measurement and aerial photogrammetric techniques. Survey drawings are utilized to evaluate architectural details, material use and

construction techniques of the cistern. They also provide base maps for restitution proposals and condition assessments studies in further stages (Figure 4).
