## Evaluation of alterations on historical urban structure of Erzurum with fractal analysis method

Ömer Atabeyoğlu<sup>a,\*</sup>, Hilal Turgut<sup>b</sup>, Pervin Yeşil<sup>c</sup>, Hasan Yılmaz<sup>d</sup>

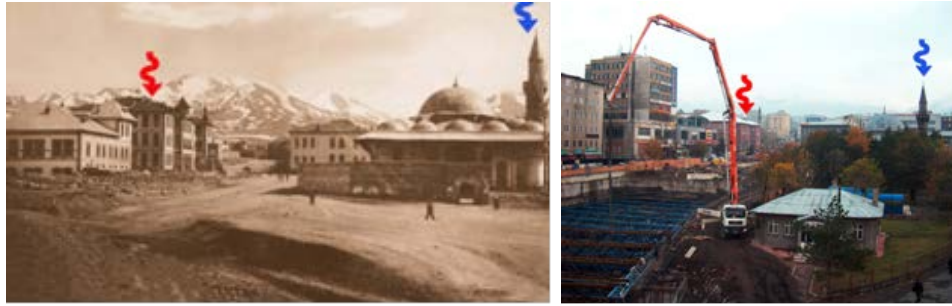
a) (Anonymous, 2012c), (Fractal value: 1,526) b) (Original, 2007), (Fractal value: 1,495)  
Figure 2. Physical alterations in the Old Governorship Office square

In Figure 2a located at the corner linking Ali Ravi Street to Cumhuriyet Street, this place was a spot that had not been improved completely in 1930s yet. The streets were not opened and asphalted entirely. The old high building on the left is Government Hall. The mosque on the right is Lala Paşa Mosque, built in 1562. As it is seen in Figure 2b, taken in the same place in 2007, the Government Hall and the Mosque still stand. However, today the government hall is used as Judicial Court Hall. There is an underground car park still under construction along the street (Figure 2, Table 1).

The fractal analysis difference between the two pictures has shown a small decline from 1.526 to 1.495. As the linear value increases, the fractal analysis value increases as well. In previous studies, the increase in the linearity on the face of the buildings had been attributed to the increase in aesthetic value. In this photograph, the fractal value is seen to decrease as the aesthetic value declines.

Table 1. Alterations in the Old Governorship Office square

Stress type	Distorted urbanisation, false plantation, road, construction of parking lot
Stress degree	Very high
Field preservation	Absent
Structure preservation	Present
Perception	Low
Image alteration period range	Approximately 80 years

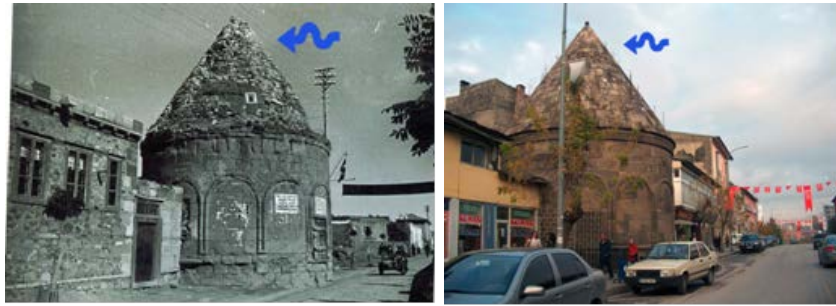
a) (Anonymous, 1936), (Fractal value; 1,826) b) (Original, 2007), (Fractal value; 1,527)  
Figure 3. Physical alterations in Cimcime Hatun Dome and its location

Figure 3a, the dome in this picture, which is thought to belong to the early years of Republic, still stands. However, old structures collapsed. The dome in the Figure 3b is one of the monuments that still stand by restorations. However, it remains between the shopping centers at present. The street on which this monument is present is city's main axis and under dense use. New commercial centers were built demolishing the old structures. Restoration of the city is of course a positive approach whereas building ugly business offices around the dome is a negative attitude (Figure 3, Table 2).

The analysis of the two pictures shows that the fractal value declines from 1.826 to 1.527. This is therefore to show that the old structure of the setting displays a progress in terms of fading and corruption. Though the historical dome still preserves its existence, the traditional structures nearby have disappeared. This leads a decrease in fractal value and the aesthetic value changes in parallel to it.

Table 2. Physical alterations in Cimcime Hatun Dome

Stress type	Distorted urbanization, road
Stress degree	High
Field preservation	Present
Structure preservation	Present
Perception	High
Image alteration period range	Approximately 85 years

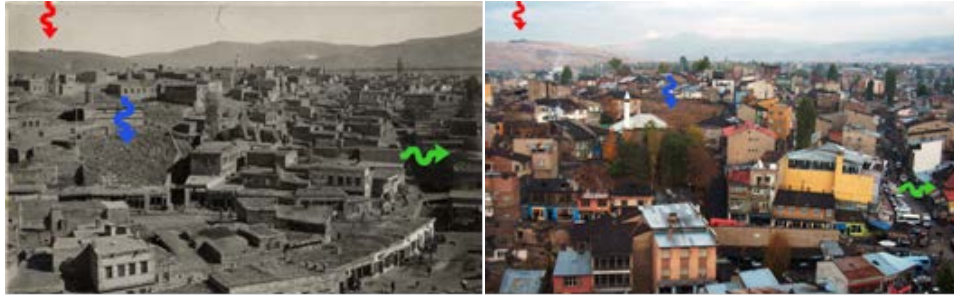
a) (Elginöz, 2007), (Fractal value: 1,890) b) (Original, 2007), (Fractal value: 1,923)  
Figure 5. Physical alterations in Cedit Neighborhood and its location

Figure 5a is thought to have been taken in early 1900s, and reflects the traditional old urban tissue. The houses here have a traditional architecture with wide walls made of stone and earthen roofs fitting the climatic conditions. They are important actors of old city texture. The earthen roofs of these houses are the first representatives of today's roof gardens. The people in the city used the earthen roofs as terraces for years. The houses were planned in an adjacent order due to the climatic reasons and they were located along the narrow streets preserving the topography. In addition, the streams passing through the city were preserved in their natural state. In Figure 5b, which reveals the present situation of the area, it can be seen that the historical texture apart from tiny traces has been completely destroyed and the city has entered a degeneration trend through an unplanned structuring. As a result of irregular urbanization, we see that a city texture surrounded by shapeless, multi flatted and multi colored structures masking the historical elements, city identity and aesthetics is composed. There are few unchanged elements that we can see between the two photographs: bastion, graveyard and mountains (Figure 5, Table 4).

Although the fractal value of the traditional Turkish cities is determined to be 1.7, the result of the analysis indicates that the fractal value is high for both of the pictures. When the two photos are evaluated in isolation, instead of a planned setting, an improvisational setting system is observed in both photos. This structuring becomes

more haphazard and crowded in the second photo. This result is reflected in the fractal analysis as 1.923.

Table 4. Physical alterations in Cedit Neighborhood

Stress type	Distorted urbanisation
Stress degree	Very high
Field preservation	Absent
Structure preservation	Absent
Perception	Absent
Image alteration period range	Approximately 100 years

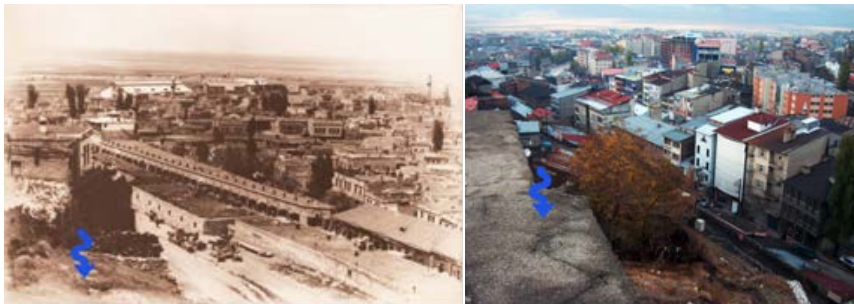
a) (Elginöz, 2007), (Fractal value: 1,87)

b) (Original, 2007), (Fractal value: 1,844)

Figure 7. Physical alterations in Taşmağazalar Neighborhood and its location

The structural compactness is pretty high in both photographs. On the other hand, though there is not much difference between the two photos, the biggest change is observed in the height of the buildings. This leads close fractal values between the two photos. The reason why the fractal value of the first photograph is comparatively a bit higher can be interpreted as it is much more harmonious and aesthetic.

Erzurum has an important place in gold workmanship with respect to its artistic creation and trade for a long time. Figure 7a is thought to have been taken in 1930s. It belongs to Stone Shops Street known as the place where golden products were exhibited and sold. The Stone Shops seen on the Figure 7b have not been preserved today. Either they were replaced with new buildings or new flats were built on them removing their old characteristics.

Protecting the cultural wealth is not only important for the people and societies using them but also vital for the future of the people of the world. While the Stone Shops Street, attracting us with its different texture until late 1900s is a component that could have added much to the city with respect to its aesthetic, cultural and recreational features and it could have contributed to city tourism and therefore boosted the economy if it had been preserved with its old features, today it is almost impossible to perceive this artistic value even from some of the spots of the city (Figure 7, Table 6).

Table 6. Physical alterations in Taşmağazalar Neighborhood

Stress type	Distorted urbanization, traffic density
Stress degree	Very high
Field preservation	Absent
Structure preservation	Absent
Perception	Very low
Image alteration period range	Approximately 70 years

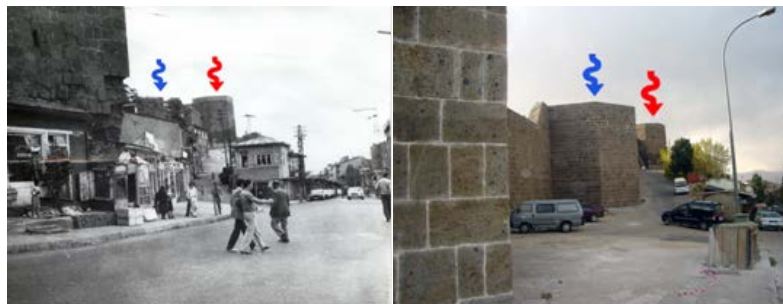
a) (Anonymous, 2006), (Fractal value: 1,717)

b) (Original, 2007), (Fractal value: 1,412)

Figure 8. Physical alterations on the Inner Castle walls and its location

In Figure 8a, which belongs to recent years, small shops constructed on the castle walls and their locations are seen. These irregularly built shops influence the castle walls negatively and they cover the scenery to a great extent.

These shops, covering the walls completely, were demolished; therefore, the walls can be seen today (Figure 8b). They were restored. However, the restoration around the walls still continues.

The restoration and cleaning has been an important progress since it has let the oldest historical structure of the city, the castle and its walls appear. However, the area should be prevented from irregular structuring, because more positive progresses and efforts and arrangements regarding recreational needs should be increased (Figure 8, Table 7).

A big difference emerges between the two photographs in terms of fractal values. The fractal value of the old photo yields a higher value compared to its new version. The reason of this difference stems from the fact that most of the buildings in the old photo do not exist or they have been destroyed when the new photo has been taken. Though the new state of the site has become plain, its old state is rather dense and complex. The old structures were removed to make the front side of the castle walls plain and put the walls into sight. When the application is compared to the fractal values, it can be said to be successful.

Table 7. Physical alterations on the Inner Castle walls

Stress type	Absent
Stress degree	Low
Field preservation	Present
Structure preservation	Present
Perception	Very high
Image alteration period range	Approximately 70 years

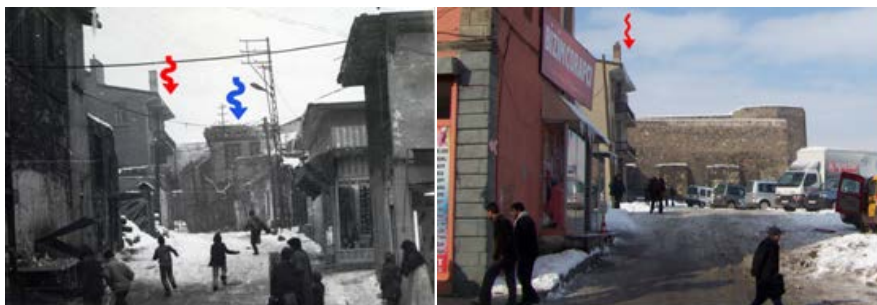
a) (Anonymous, 2006), (Fractal value: 1,445)

b) (Original, 2007), (Fractal value: 1,682)

Figure 9. Physical alterations in the passage between Cumhuriyet Street and the city Castle and its location

The passage seen in Figure 9a shows the characteristics of a quite beautiful spot displaying the traditional structure of the city, where there are some small shops. Today some of the old structures around this street were demolished and the ones seen in Figure 9b are in the list of structures to be demolished.

While the traditional street characteristics is preserved in the photograph on the left taken from Erzurum Castle Street, it is seen that most of this area has been demolished in later constructions and it is still being demolished. This type of traditional street structures displaying the city culture are no longer met. It stems from a big change in traditional city texture and urbanization concept. It is one of the most outstanding indicators proving that the street textures reflecting the city culture are on an extinction trend (Figure 9, Table 8).

There is a big difference between the fractal values of the two photographs; and this implies that there are considerable differences in the settings between the times when the two photographs were taken. Despite the change is not visually significant, the high difference in the fractal value indicates that the structure of the setting has shown a progress today and in the past within a socio-cultural and physical interaction independent of each other. In addition, that the fractal value indicates a change to a great extent and in an increasing trend implies an unplanned change pattern in the setting.

Table 8. Physical alterations in the passage between Cumhuriyet Street and the city Castle

Stress type	Distorted urbanization
Stress degree	High
Field preservation	Absent
Structure preservation	Absent
Perception	Middle
Image alteration period range	Approximately 5 years

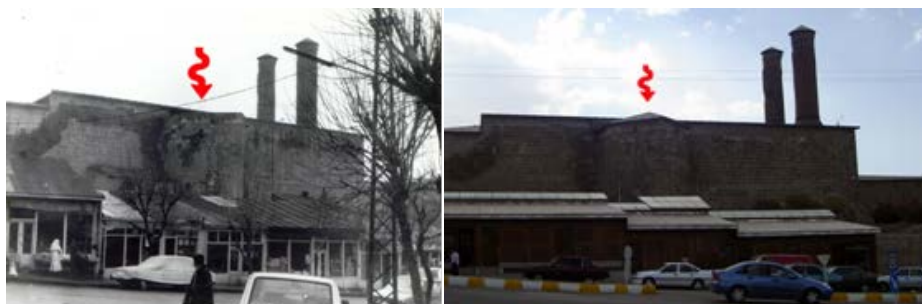
a) (Anonymous, 2006), (Fractal value: 1,34)

b) (Original, 2007), (Fractal value: 1)

Figure 10. Physical alterations in the close proximity of Double Minaret Medrese and its location

Çifte Minare Madrasa is at the junction of Tebrizkapı Street and Cumhuriyet Street. It is the symbol of Erzurum and the biggest Madrasa of Anatolia. It is considered to have been built in the late 13th century since it does not have an epigraph. The shops next to the castle walls near the Madrasa were demolished two years ago.

After the old shops had been demolished, the castle walls were restored and the front side was opened

completely. However, today new shopping centers have been built in the same place by the municipality, the aim of which is not understood (Figure 10, Table 9).

These shopping centers were built identical to their originals. They reflect all the characteristics of old shops and they are more aesthetic and compatible with the historical texture. It would have been possible to obtain positive outcomes if they had been placed in a more appropriate location of the historical texture. However, the castle walls and front side of the Madrasa is again covered with new structures.

The fractal values of the two photographs are rather low; however, the value of the old photo is comparatively higher. The removal of the electric post, the tree seen in the old photo and the restoration of the in-harmonious shops in front of the historical structure cause the setting in the second photo to become plain and the value to decrease. The setting in the old photo is much more in-harmonious and denser in comparison to its new state.

Table 9. Physical alterations in the close proximity of Double Minaret Medrese

Stress type	Traffic density, faulty planning
Stress degree	High
Field preservation	Low
Structure preservation	High
Perception	Middle
Image alteration period range	Approximately 5 years

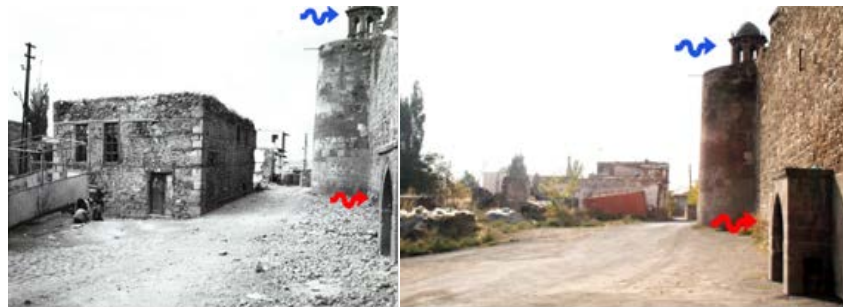
a) (Anonymous, 2006), (Fractal value: 1,876) b) (Original, 2007), (Fractal value: 1,745)  
Figure 11. Physical alterations on the southern walls of the city castle and its location

Figure 11a belongs to 1970s. We can see the inner walls of the castle, the clock tower, a fountain and a sample of traditional civilian architecture just next to the fountain. Today, the walls of the castle, the clock tower and the fountain still stand (Figure 11b). However, the house, one of samples of the traditional architecture, was demolished in order to widen the street.

The castle, the clock tower and the fountain are public buildings. They are registered and protected by the government. Therefore they have succeeded to stand though the architectural structure near them is demolished. This is an important sample proving that cultural and structural transfer is possible through a protection and handling balance (Figure 11, Table 10).

The fractal values of the two photographs are high; however, the value of the old photo is comparatively higher than that of the new photo. The structure in the old photo and the density it causes lead this result. In the new photo of the setting, this building does not exist as it has been removed. This decreases the fractal value by making the setting plain.

Table 10. Physical alterations on the southern walls of the city castle

Stress type	Traffic density, faulty planning
Stress degree	High
Field preservation	Low
Structure preservation	High
Perception	Middle
Image alteration period range	Approximately 5 years

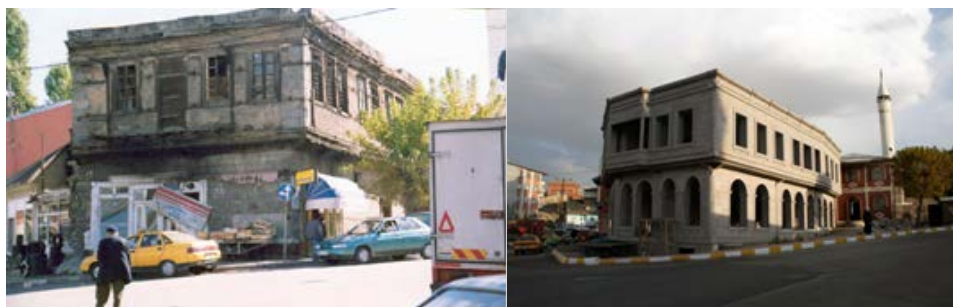
a) (Yeşil, 2003), (Fractal value: 1,694) b) (Original, 2007), (Fractal value: 1,478)  
Figure 12. Physical alterations in the Tebrizkapı Street and its location

We can see one of the most beautiful samples of traditional residence structure in this image, which belongs to 2000s (Figure 12a). The owners deserted the house long time ago. The spot is located in an area which is densely filled with the historical texture. Image (Figure 12b) belongs to 2007. The house on the left was demolished and it was reproduced in the same traditional architecture. The building intended to be a restaurant is still under construction (Figure 12, Table 11).

This is an important sample in revealing a misconception that a historical structure can be demolished and it can be reproduced using modern equipment and techniques instead of restoring it and that new version can replace the original.

The fractal value of the old dated photo is higher than that of the new dated photo. The ragged and deserted state of the old house in the old photo and the density of the setting cause this difference. On the other hand, the old structure has been restored and its surroundings have become plain in the new dated photo; and this has caused the fractal value to decrease.

Table 11. Physical alterations in the Tebrizkapı Street

Stress type	Traffic density, inconvenient restoration
Stress degree	Very high
Field preservation	High
Structure preservation	Absent
Perception	High
Image alteration period range	Approximately 5 years
