Investigation of Istanbul Kartal Example within the Scope of Urban Transformation

Abstract - Due to the increasing migration from rural to urban areas in the world from past to present for various reasons, cities need to be renewed and transformed in future times with the irregular construction occurring in the cities. In this direction, States develop and implement urban transformation policies with various methods.

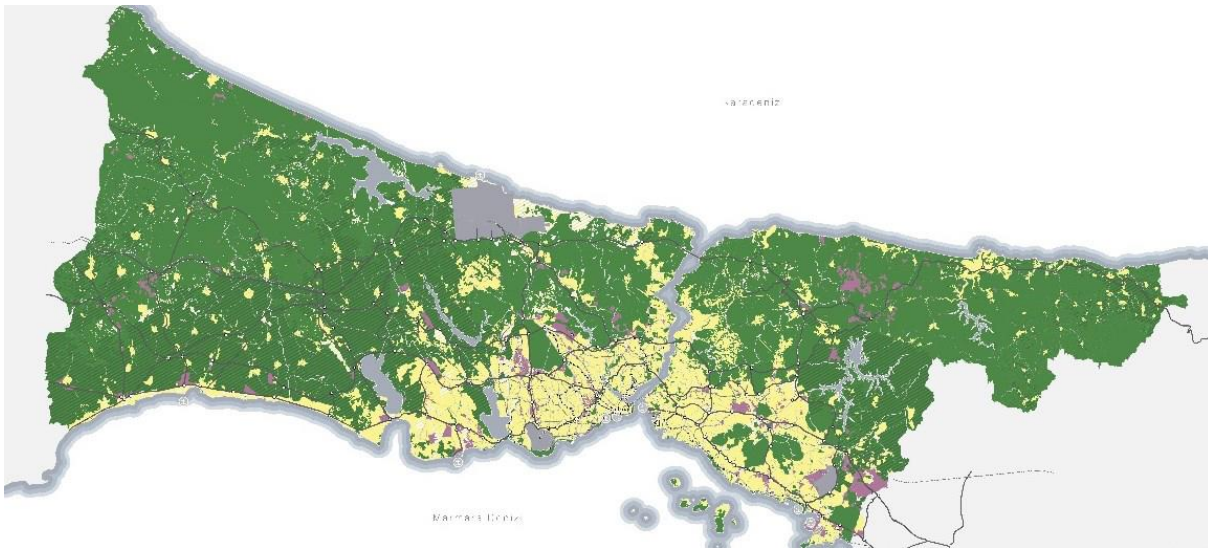
Figure 2. Istanbul's Existing Urban Area

In Figure 2, the current general structure of Istanbul is shown, yellow areas show urban settlement areas, purple regions show industrial areas and finally, green areas indicate agriculture and green areas. Considering the current structure of Istanbul, the excess of green areas stands out, and the residential areas are predominantly concentrated in the coastal regions of the Bosphorus overlooking the Marmara Sea.

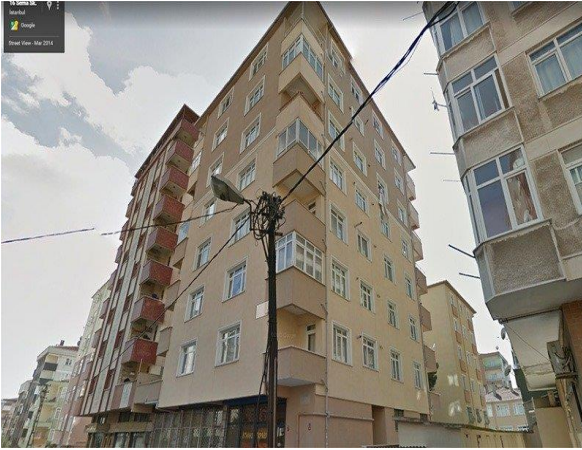
Figure 8. Yeşilyurt Apartments Before Collapse

The building on the block number 12580 and 101 parcels located in Orhantepe District collapsed at an unexpected date on 06.02.2019 and 21 people died due to dent and 14 people were taken out from the dent. The mentioned structure was built in 1992 with a total of 9 floors, including basement + ground + 7 normal floors. In the license certificate of the building dated 20.10.1992, there is a 7-storey construction permit,

including 1 basement floor + ground floor + 5 normal floors. The building was built as 2 floors more in violation of the license given by the relevant administration. Basement and ground floors are used for commercial purposes and other normal floors are used for residential purposes. Basement and ground floors are used for commercial purposes and other normal floors are used for residential purposes. The mentioned structure consists of 14 residences and 3 commercial units. The parcel area is 493 m² and the construction area is 1122 m² according to the current zoning plan. However, the current construction area of the building is 2209 m² with illegal floors.

The building was designed as basement + ground + 5 normal floors in its project in 1992, and the concrete class was designed with B160 and single foundation system according to 1985 TS 500. In the investigations made on the building wreckage, it was observed that unstructured and unwashed sea sand was used in concrete and there was rust in concrete steel.

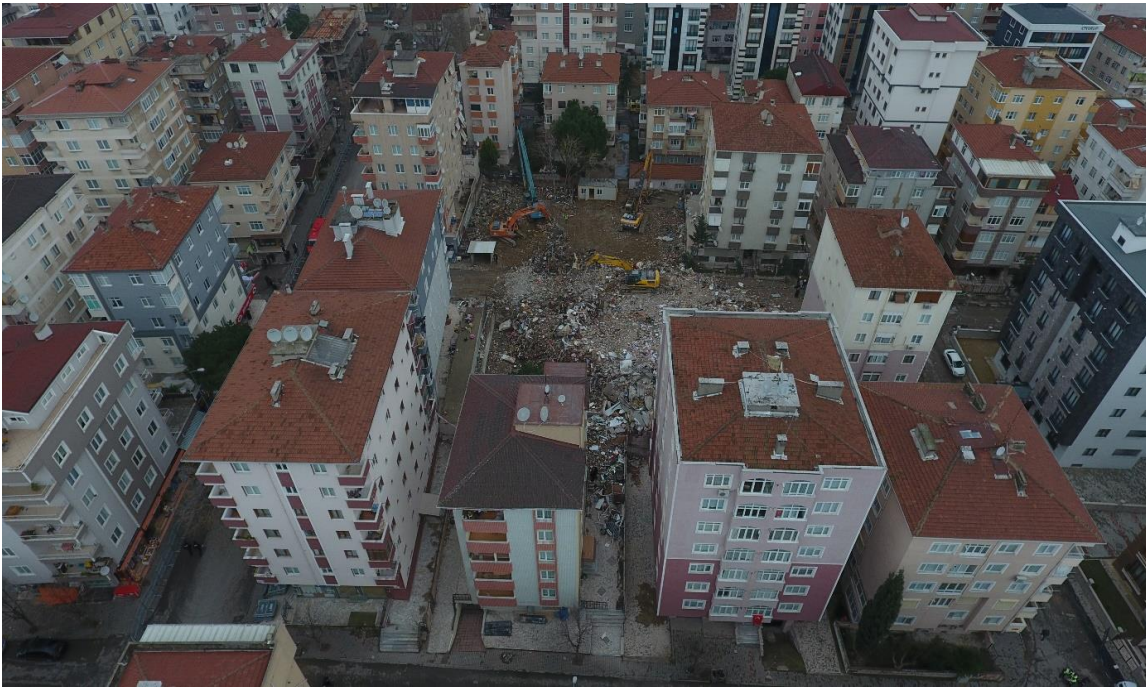
Figure 11. The View After Removal of The Wreckage of Yeşilyurt Apartments

After observational determinations from the mentioned structures, drilling core samples were taken within the scope of Law No. 6306 and necessary reinforcement stripping was done. As a result of the examination of the data obtained; It has been determined that the buildings are in a position to endanger the safety of life and property, and that there is intense deformation in the buildings, and accordingly, the buildings located in the mentioned parcels except İhya and Çam Apartments have been declared as "Risky Buildings" within the scope of Law No. 6306. The buildings identified as Risky Buildings were immediately evacuated by the authorities to avoid any danger and demolition of the buildings was carried out.

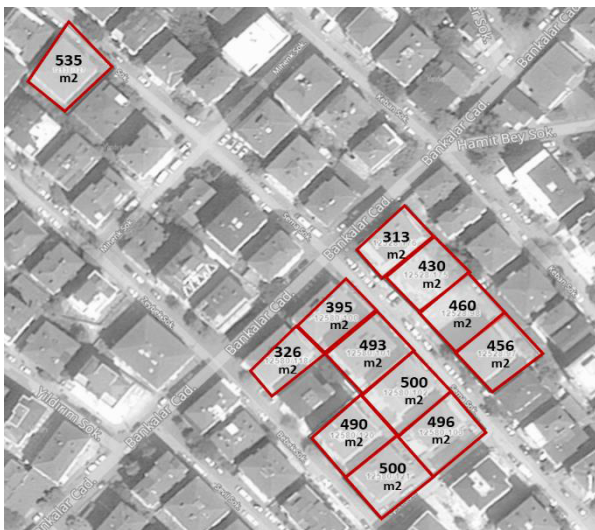
Figure 13. The Reserve Building Area

The Reserve Building Area was declared on 11.03.2019 within the scope of Law No. 6306, in order to prepare Yeşilyurt Apartments and the surrounding buildings for earthquake risk, and to provide a liveable area for the protection of life and property security. The 1/1000 scale Implementation Development Plan change and plan disclosure report for the mentioned Reserve Structure Area was approved on 14.03.2019.

The buildings within the borders of the Reserve Building Area consist of 129 residences and 29 workplaces. Following the announcement of the Reserve Building Area and the planning processes, the construction process of the construction in the area was started by TOKİ. Along with the mentioned project, 105 houses and 25 workplaces are produced. Approximately 11 months after the date of the incident, 06.02.2019, residences and workplaces were delivered to the beneficiaries on 23.01.2020.

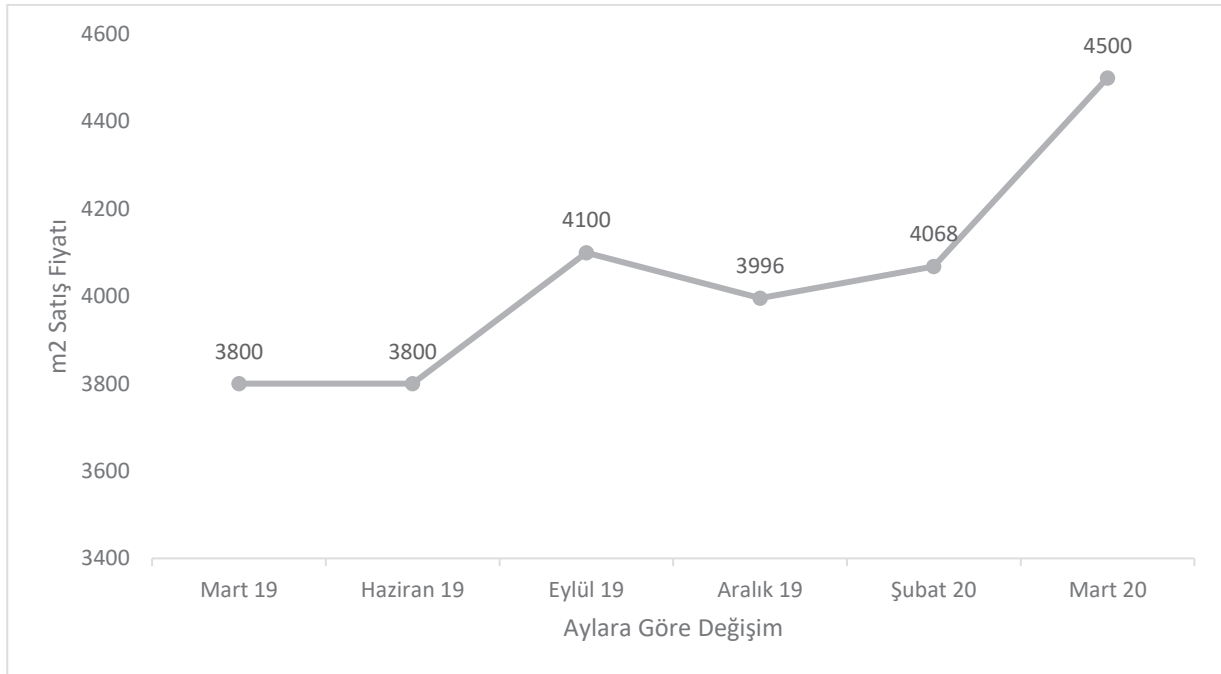
Figure 15. Orhantepe District Real Estate Index

After the delivery of the houses and workplaces, a significant change was observed when the real estate values statement around the area where the crash occurred. After the apartments were handed over to the beneficiaries in February, a significant increase was observed in March.
