# Decreasing Defects in Plastic Injection Molding and Vibration Welding Processes Through Statistical Process Control

**Abstract** - The goal of this study is to decrease a particular defect seen on condenser dryer water tanks, which are manufactured through plastic injection molding and vibration welding. Water leakage problem encountered on these tanks were aimed to be minimized through statistical process control techniques. Initially, the water leakage problem and its criticality was determined by presenting the cost of this problem. After determination of the problem, manufacturing workflow was provided. Next, cause-and-effect diagram presenting the potential causes of water tank leakage was created and the root causes were discussed in detail. Then, control charts were created to examine the process stability. In addition, initial process capability analysis was conducted through which poor capability was revealed. It was determined that both injection molding and vibration welding processes were among the root causes of water leakage problem. Therefore, improvement efforts made included mold maintenance and cleaning, and usage of custom fixtures on the welding machine. Afte

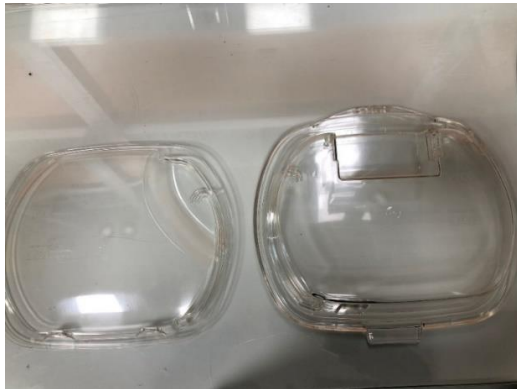
Figure 1. Water tank upper and lower covers

A clothes dryer machine, also called as tumble dryer, is a white good which removes moisture from textile products such as clothes and bedding, after they are washed. There are two types of dryers, vented tumble dryers and condenser tumble dryers. In a condenser dryer the humid hot air is transferred to a condensing chamber where it is condensed into water. Then, this condensed water is collected and stored in a container, known as water tank, which is located at the bottom of the dryer. Therefore, a condenser dryer does not pump humid air out to its environment. In condenser dryers it is critical that water tank should be manufactured appropriately and does not leak. Water tank consists of two parts, upper and lower covers, shown in Figure 1. These parts are manufactured via plastic injection molding and assembled via vibration welding process.

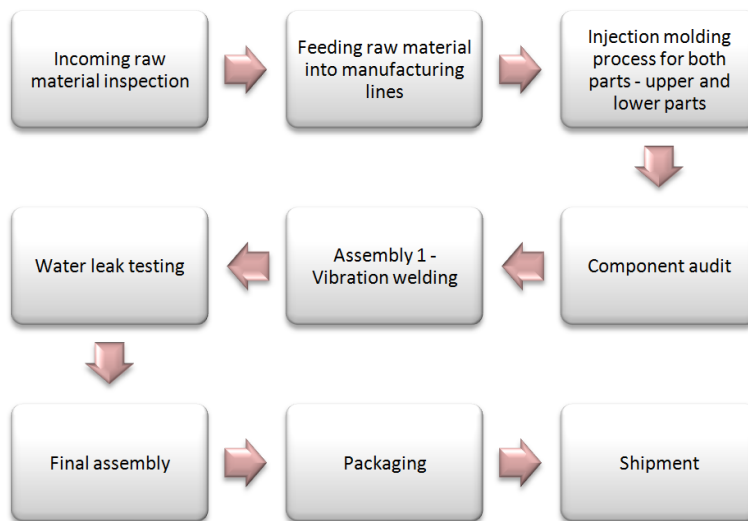
Figure 2. Process workflow

The water tank production workflow starts with inspection of incoming raw material, i.e. plastic pellets, then continues with feeding of these material into production lines, in which injection molding process takes place. Injection molding, through which a wide range of products are manufactured, is the most frequently used process for production of plastic components. In the injection molding process, initially plastic pellets are placed in the feeder hopper, then the plastic is melted in the injection barrel and finally, hot melted plastic is pushed into the mold, where it cools and solidifies into the final part. After both upper and lower parts of the water tank are manufactured via injection molding, visual audit is conducted. Then, vibration welding process takes place in order to join the two components. Vibration welding uses heat generated by friction at the interface of two components to produce melting in the interfacial area. When the surfaces-to-be-joined are heated, they are plasticized and subsequently welded together.

After main assembly takes place via vibration welding, the water tanks are subject to water leak testing. Finally, the tanks that pass the leak testing are sent to final assembly where final ring cap is assembled. Packed components are then shipped to the customer. The process workflow is given in Figure 2.

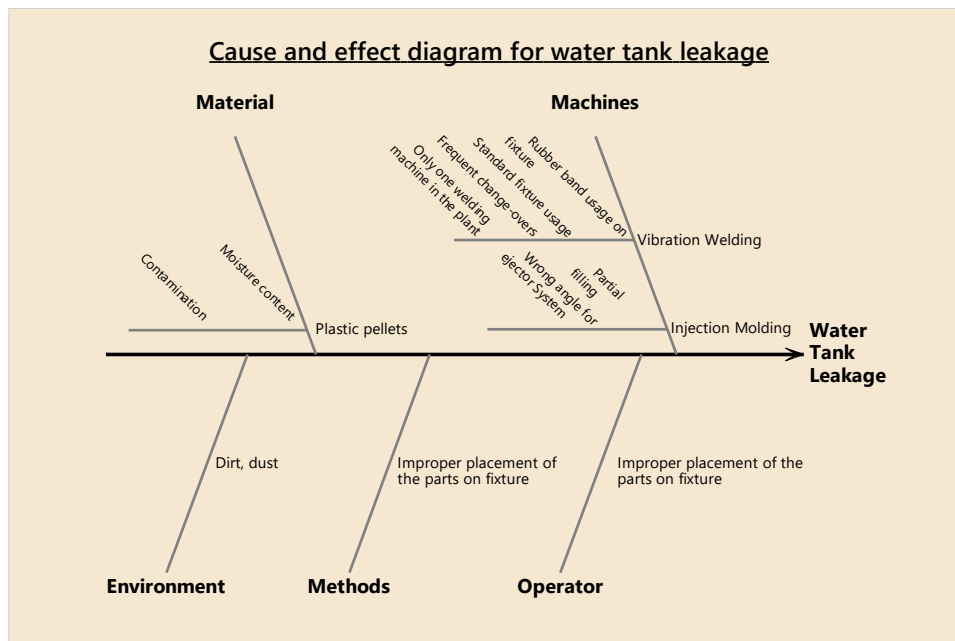
Figure 3. Cause and effect diagram

The cause-and-effect diagram presenting the potential causes of water tank leakage was created via Minitab (Figure 3). Water tank leakage issue can be attributed to causes related to machine, method, operator and material.

Machine related causes may be due to vibration welding machine as well as due to injection molding machine. When *vibration welding machine* related causes were examined it was seen that there was only one welding machine in the manufacturing plant, whereas, frequent model changes of produced parts were required. However, standard fixtures were used instead of custom ones for each

different part-to-be-welded to save changeover time. For this reason, about 10 to 15 parts were scrapped whenever the model of the produced part was changed. Usage of standard fixtures were also causing slippage of the parts-to-be-welded which caused leakage problem. In addition, in order to adjust the fixture to the size of the parts-to-be-welded, a rubber band was attached to support the parts during vibration welding. It was examined that the rubber band, which wears out over time, causes dimensional differences in the final product produced leading to leakage problem.

On the other hand, when *injection molding machine* was examined it was seen that the ejector system was losing its required angle as it pushed the parts off of the mold. In addition, the molded parts, i.e. water tanks, had incomplete and partial fillings due to mold being old and its poor maintenance.

Regarding both *method* and *operator errors*, it was found that cracks occurred in the welding area of the water tanks produced during welding process due to improper placement of the upper and lower covers of water tanks on the fixture in the welding machine.

Finally, no issues regarding *environment* or *raw material* were found. Therefore, the main causes of water leakage problem were due to vibration welding machine.

It was determined during root-cause analyses that both injection molding equipment and vibration welding equipment were among the root causes of water leakage problem. Standard fixtures were being used during welding operations to save changeover time. However, this situation resulted in scrapped parts, as well as, slippage of the parts-to-be-welded, which ultimately caused the water leakage problem. In order to eliminate these issues, the fixtures in the vibration welding was planned to be changed in every model change. Therefore, customized fixtures rather than standardized ones were started to be utilized during welding process.

Additionally, a rubber band was being attached to the welding machine to accommodate small dimension changes and to prevent parts from slipping during welding process. However, this band wears out easily and therefore, cannot provide full support for the parts for extended periods. This causes dimensional differences in the final product leading to leakage problem. As an improvement action, standard controls are set in place at the beginning of each welding process to change/renew the rubber band.

Moreover, the ejector system in the injection molding machine failed to run at its required angle as it pushed the parts off of the mold. In addition, the molded parts, i.e. water tanks, had incomplete and partial fillings due to poor mold maintenance. In order to overcome these issues, a detailed mold maintenance was conducted. First, the mold was completely disassembled, cleaned, and greased with new lubricants and inspected for signs of wear. Any part of the mold that was defective or damaged, including ejector pins, was repaired. Then, the mold was reassembled and a final systems check was run. In addition, shorter mold cleaning and greasing cycles were planned for proper tool maintenance and general preventative maintenance was scheduled. Also, it was planned that the molding machine operator would check the ejector system prior to each injection process initiates.

Finally, because cracks occurred on the water tanks due to improper placement of the upper and lower covers of water tanks on the fixture in the welding machine, welding operators had refreshment training on the welding machine components.

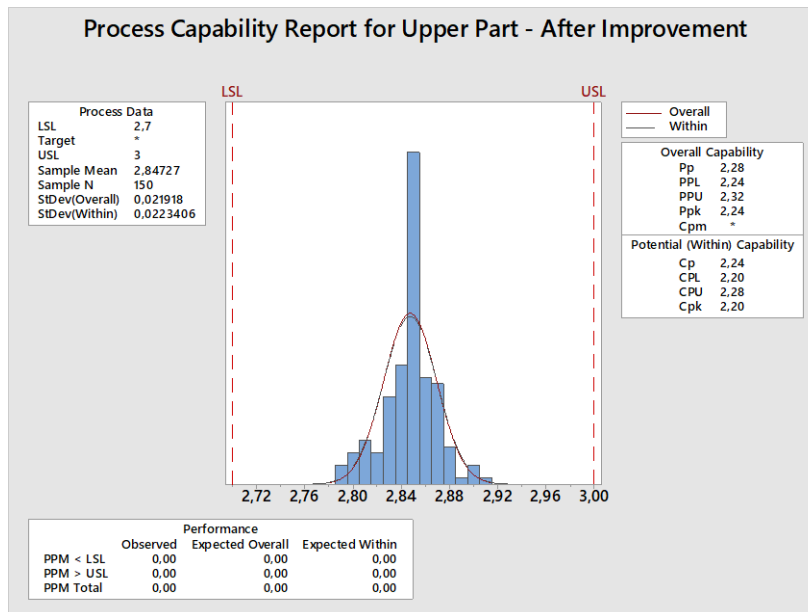
Figure 8. Final process capability analyses - after improvement

In addition, final process capability analysis was conducted to determine the level of improvement (Figure 8). The results revealed the fact that both  $C_p$  and  $C_{pk}$  values were improved.  $C_p$  value increased to 2.24 indicating very small variation with respect to specification interval, whereas,  $C_{pk}$  value was increased to 2.20 indicating a perfectly centered process on the nominal value. Since both indices were above 1.33, the required value, final process was capable of meeting specifications.

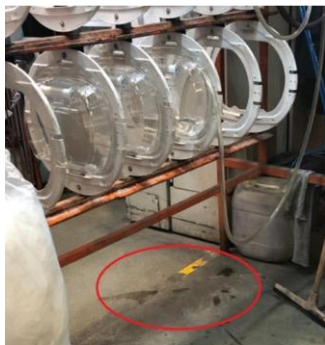
Figure 9. Water spill under the manual leak testing area

It was determined that water level in the tank during the leak testing was below the max level, i.e. the specified level. This problem occurred due to the early removal of the filling hose from the tank by the operator. Also machine pressure-related errors existed. In addition, the water tank was being scratched while testing due to manual operations.

Moreover, at some times, leakage was failed to be detected due to the water remaining in the hose. This remaining water in the hose were spilled on the floor by mistake and it could not be understood which product had water leakage problem (Figure 9).

Finally, 100% leak testing could not be performed on all water tanks, because filling and draining of water from the tanks were performed at the same station. Therefore, some water tanks were being packaged and shipped to the customer without being tested due to confusion.

In order to prevent all these above mentioned problems due to manual operations, a new water leak test automation system was designed and started to be utilized. With this newly designed automated testing system, the primary purpose is to conduct 100% inspection on the final products and to ship them to the customer with zero defects (Figure 10).

With the new water leak testing automation system, the dependency on manual operations is eliminated. In the previous system, because the hose was manually attached and removed, water remaining within the hose used to spill on the floor and created a confusion about the leakage problem. This problem has been completely resolved by means of special plates in the new water leak test automation system. In the new system, water filling and drainage is done by the machine itself and a sensor is activated and a red light turns on as soon as water drops on the plate. After the red light turns on, the machine automatically stops and does not initiate until a new tank is installed and the plate is fully cleaned.

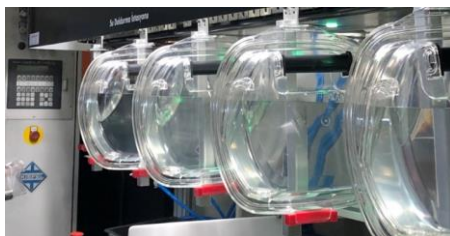
Figure 10. Automated leak testing system

18 water tanks can be attached to the newly designed system. In this system, while filling operation is carried out in a water tank at the same time, drainage operation can be performed in a different water tank. Also, the problem of water pump pressure has been resolved.
