## Retaining Wall Failure due to Poor Construction and Design Aspects A Case Study:

Hanifi BINICI\*, Huseyin TEMİZ\*, Cafer KAYADELEN\*, Hasan KAPLAN\*\*, Muhammed Yasin DURGUN\*

A retaining wall which is the subject of this paper collapsed without any indication on May 25, 2006 at city center of Kahramanmaraş, Turkey. While there were no life losses, a building was severely deformed and damaged. Just after the failure of the retaining wall an investigation carried out locally provided relevant results concerning the quality of the materials used in the construction of the wall. Detailing the reinforcement is crucial in reinforced concrete structure as it affects the rigidity of the structure. The consequent studies have shown that the failure has taken place primarily due to low material quality and poor workmanship. There was also design of project errors. Furthermore, the design and construction were not made in accordance with the TS 7984 Turkish standard.

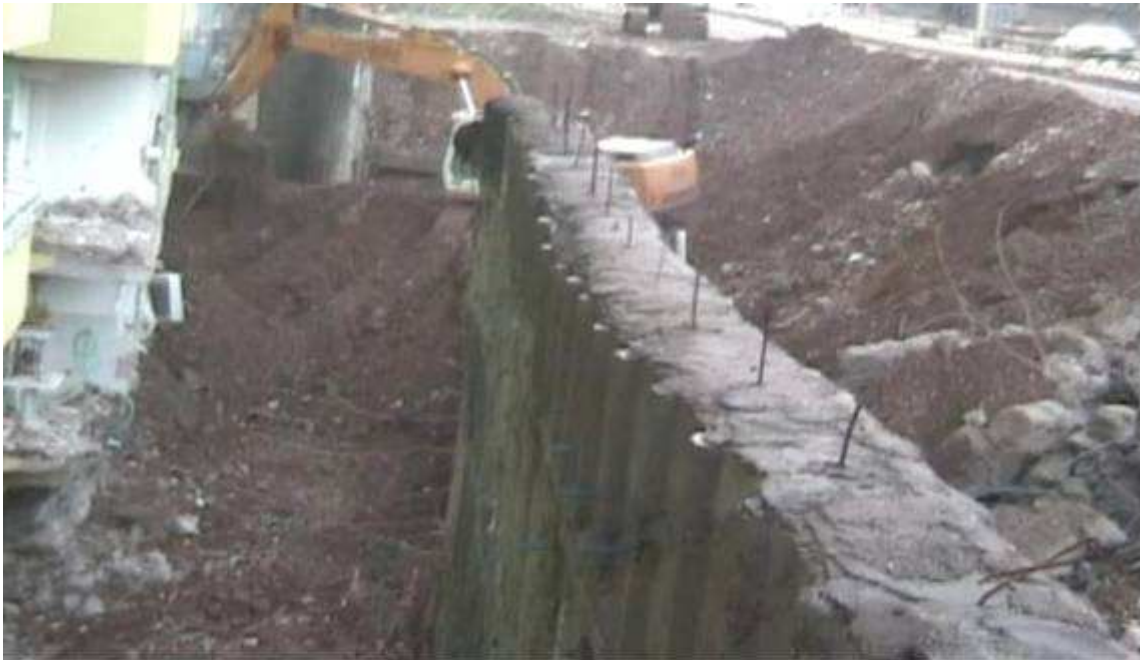
The failure was occurred in May 2006. The primary reason for the failure seems height of the wall (8.9 m) and the development of water pressure due to a heavy rain behind the wall which has not draining system. On the other hand the additional surcharge loading is not taken into consideration for the design such as weight of the vehicles parking above the wall. Some heavily damaged patterns of the collapsed building and the RW can be seen in Figs. 1-3. The failure occurred in some sections of the wall and start the bottom of the foundation and upper section of RW were suffered from failure. This failure occurred during or shortly after significant rainfall induced. Pore water pressure appeared to be the trigger for this failure. Observations after the failure revealed some evidence of seepage erosion or water movement at the soil face. The near vertical face appeared to consist of uniformly damp relatively undisturbed aggregates. A few days after the failure, a heavy rain caused water flow out of the pavement base course at the collapsed section of the wall.

Fig. 1. Retaining wall failure

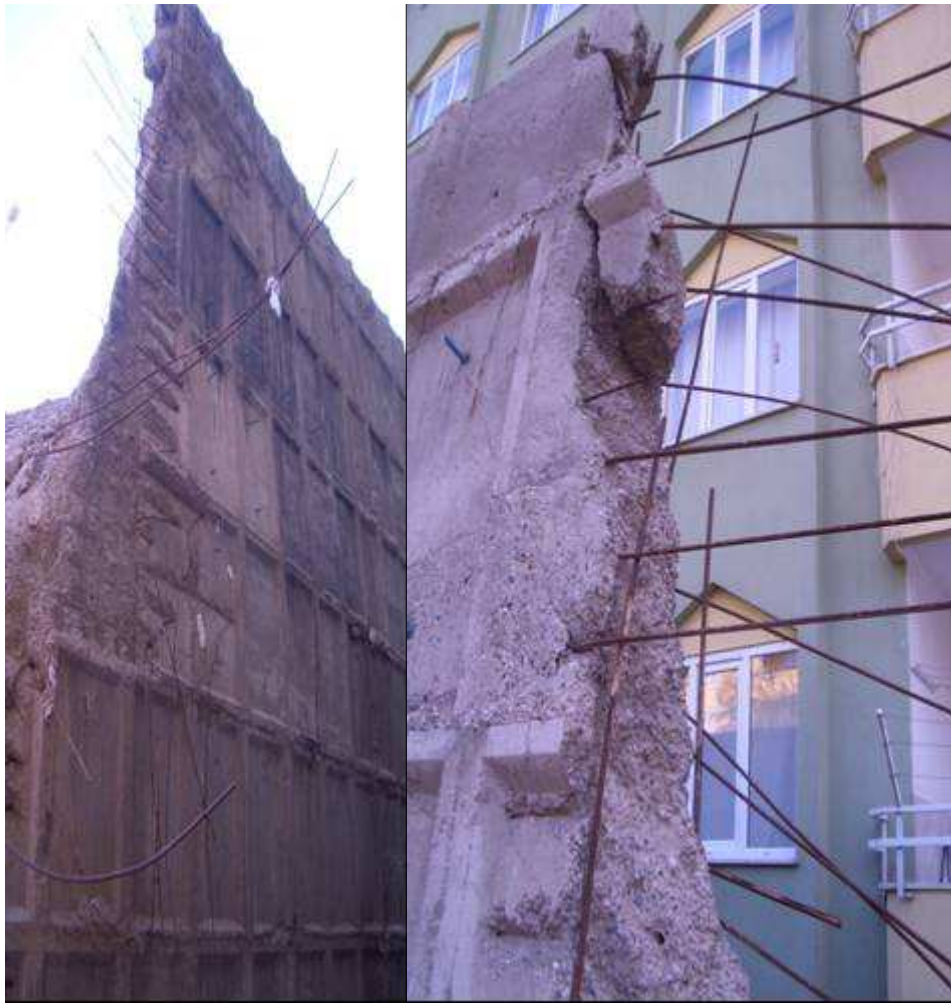
Fig. 2. Collapsed retaining wall

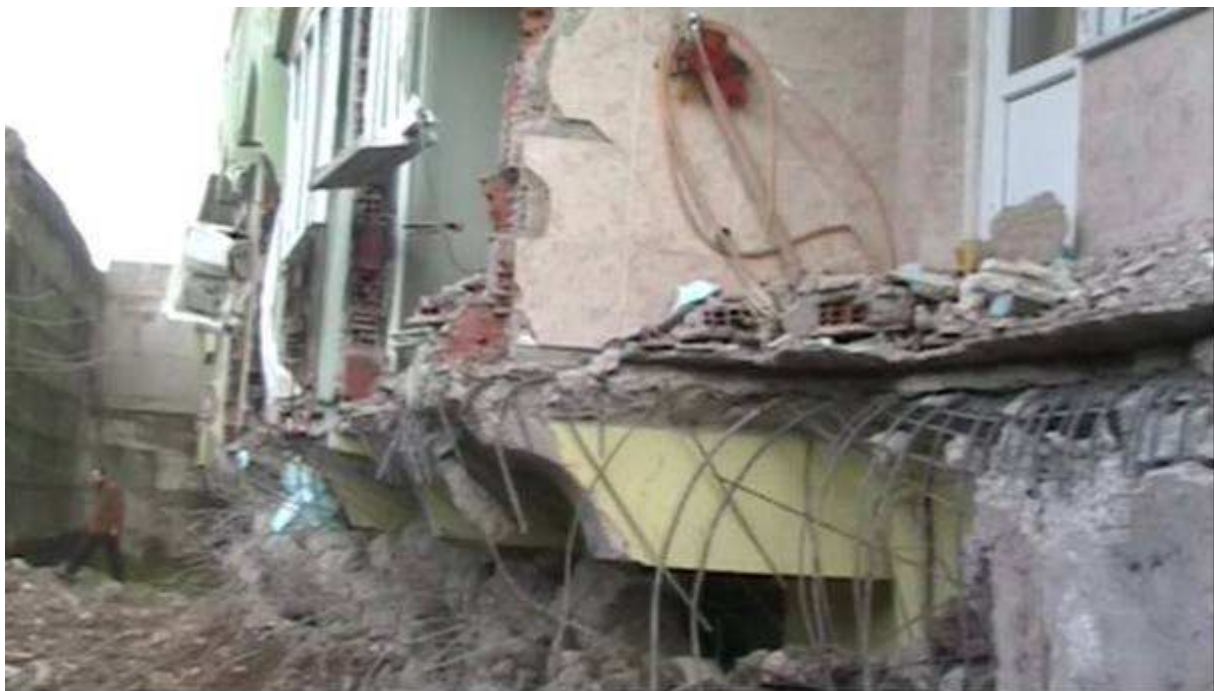
Fig. 3. Severe damage of the building knocked by the retaining wall

The main purpose for the construction of the retaining wall was to protect the building, however its failure caused a great risk for the lives of people living in the building as the collapse of the retaining wall caused serious damage to the building (see Fig.3). A total collapse of the retaining wall would result in considerably greater damage to the building.

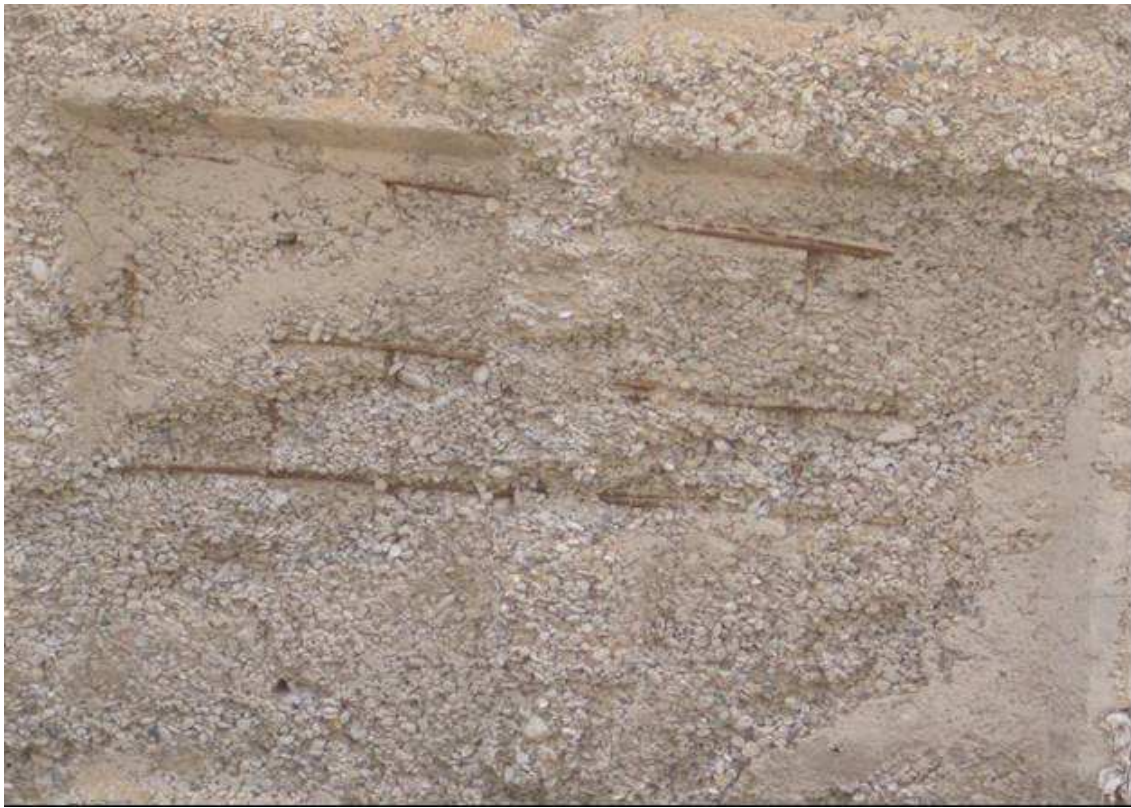
In this case study, low material quality is considered to be one of the causes of the damage. The poor concrete quality and poor design despite the requirements of the code are the real causes of destruction. Moreover, the concrete segregations were observed (Fig. 5.) and the aggregates had bad particle size distribution (Fig. 6.). Particle size distribution of aggregates used is given in Fig 7. The aggregates had been taken from a dry river bed very near to the site and included a high percentage of organic materials. Compressive strengths of RW concrete and damaged building (with hammer test and Core tests) are given in Table 1. Reinforcement detailing is crucial in RC structure as it affects the rigidity of the structure. The poor concrete quality and poor design despite the requirements of the code are the real causes of destruction.

Fig. 5. Segregated concrete of the RW

2- The aggregate used was not clean and the cure process of concrete was not adequate and aggregate used was pit-run gravel type. Concrete used in the collapsed RW did not contain a proper crushed aggregate and it had poor adherence characteristics.

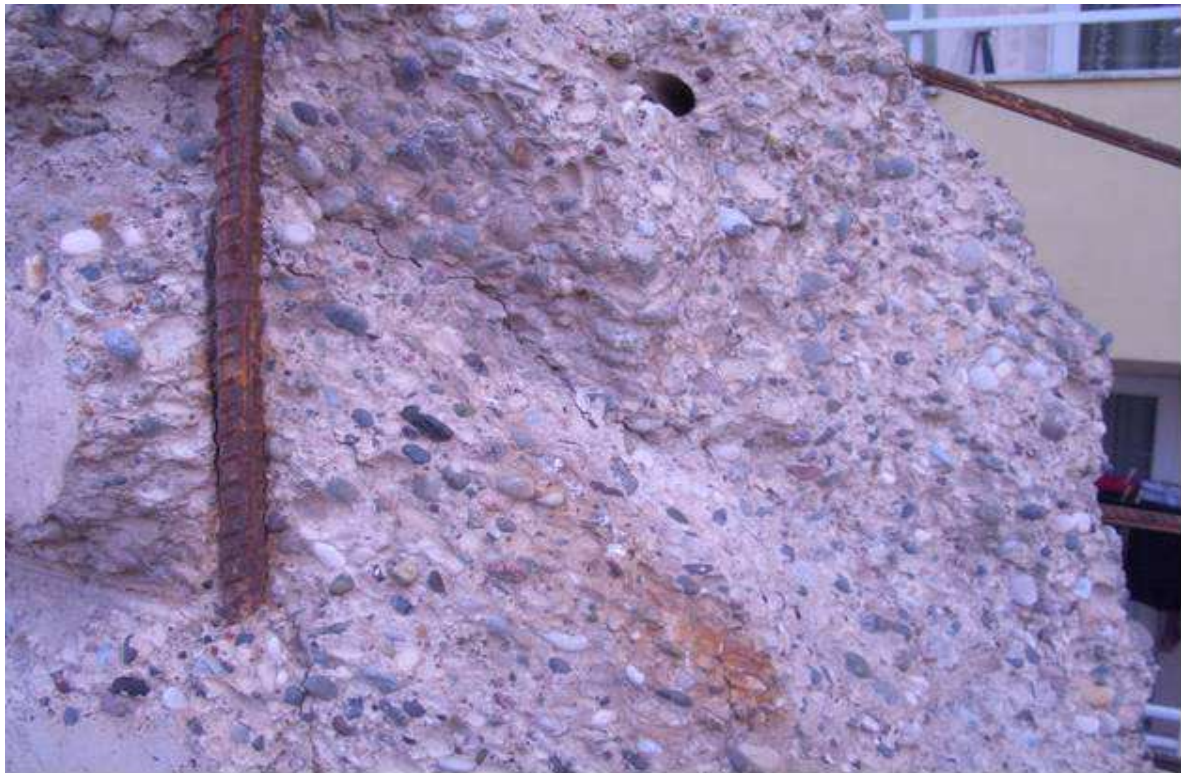
Fig.6. Aggregates with no particular particle size distribution
